Architectural Restoration and Seismic Strengthening of Gönpa Gang

U.S. Ambassadors Fund for Cultural Preservation, Award No.SNP40022GR0039

Project Report, First Year – April - June 2023

Norbusum Foundation (NGO)

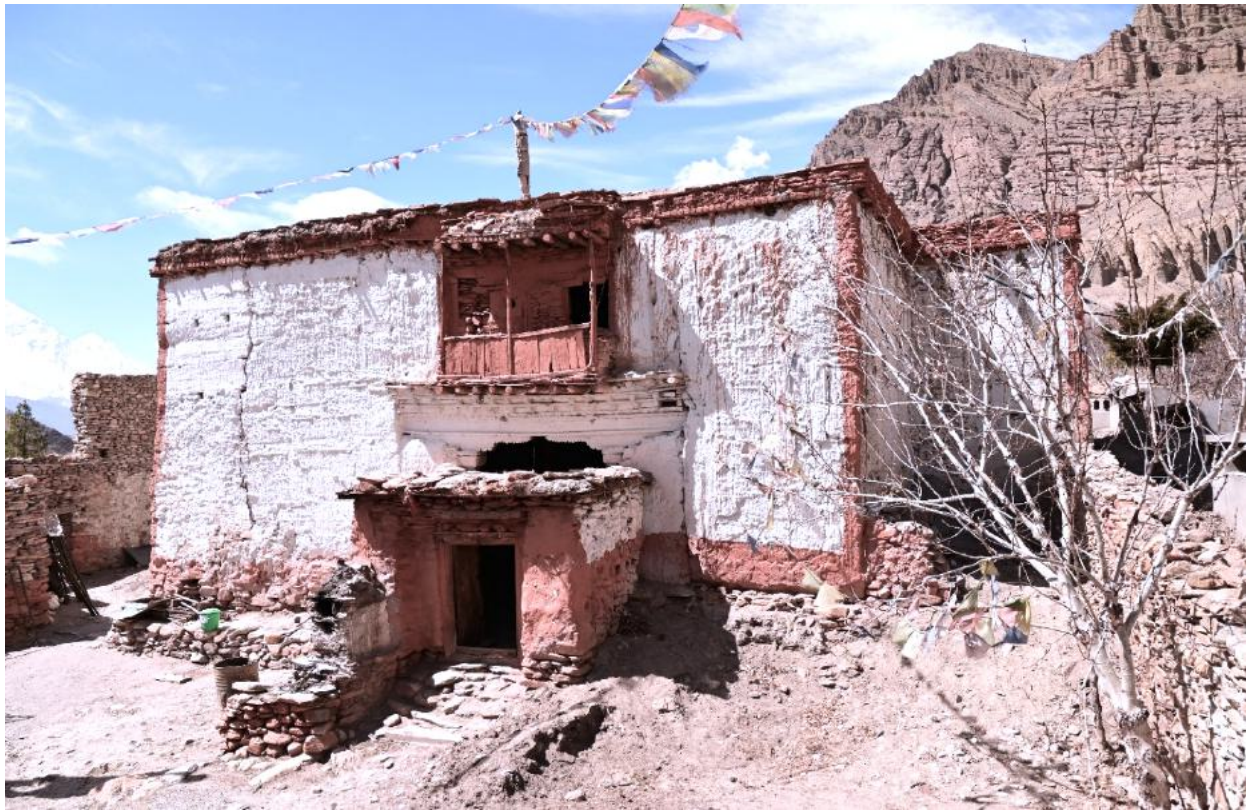
Figure 1: Photo taken before work started to dismantle the interior of the entry hall of the building.

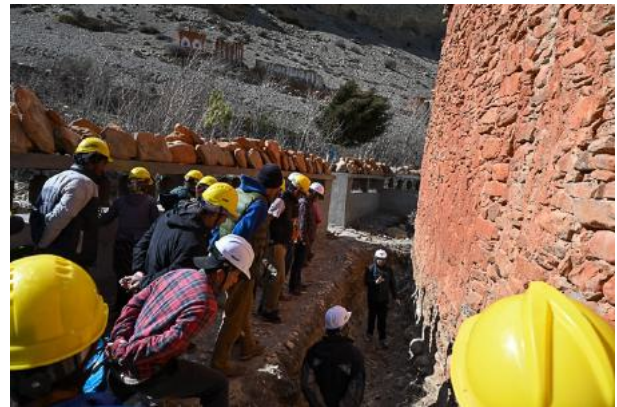
Figure 3: Villagers looking at existing foundation's condition after a dig around the outer wall.

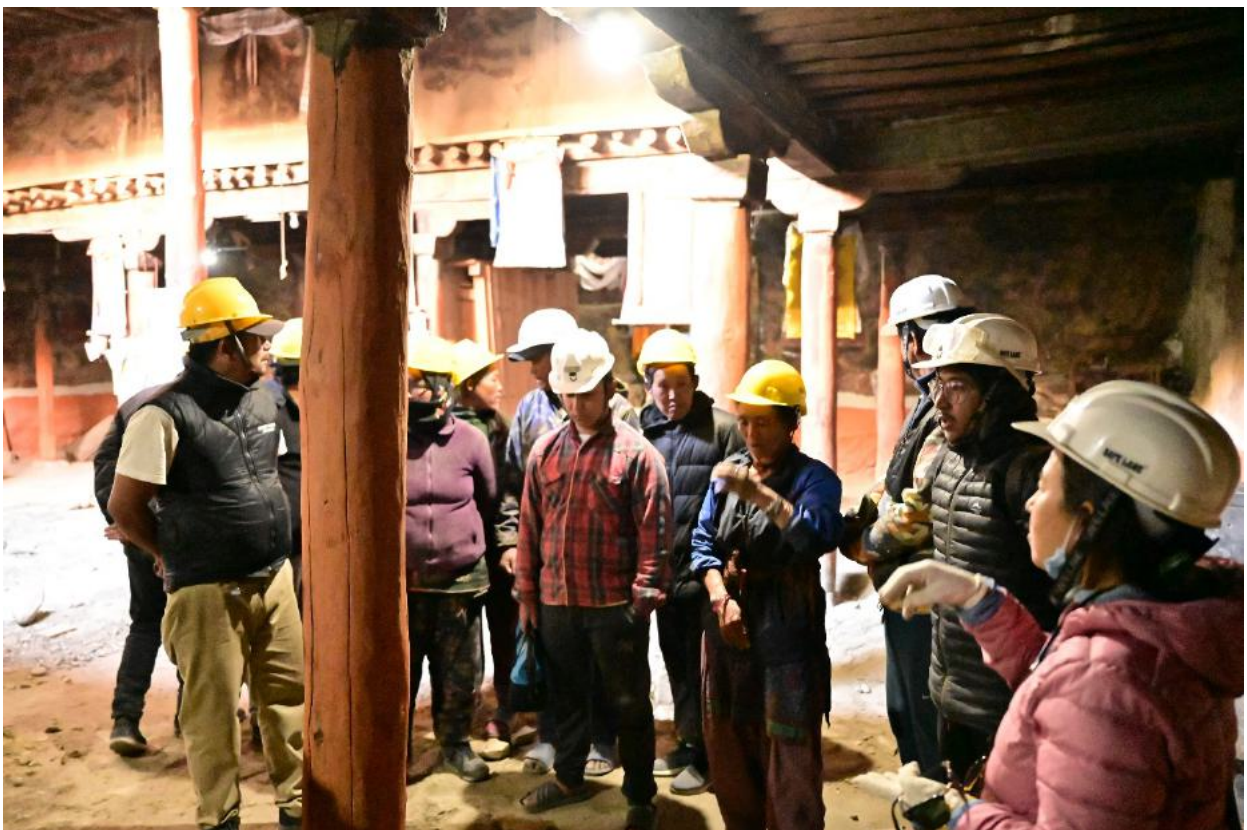
Figure 4: Villagers observing the assembly hall area's post plague caused by roots of the trees surrounding the building.

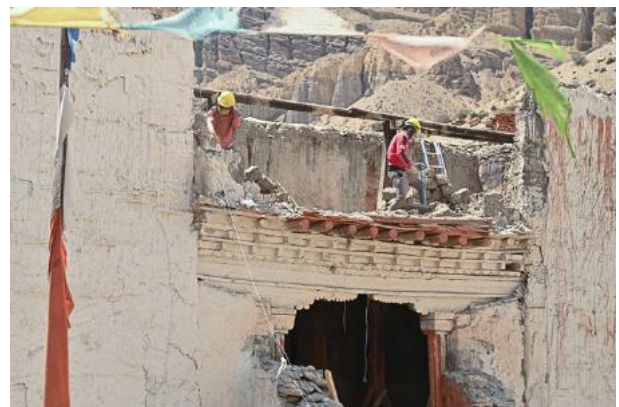
Figure 6: Then the entire often restored and poorly constructed balcony was dismantled.

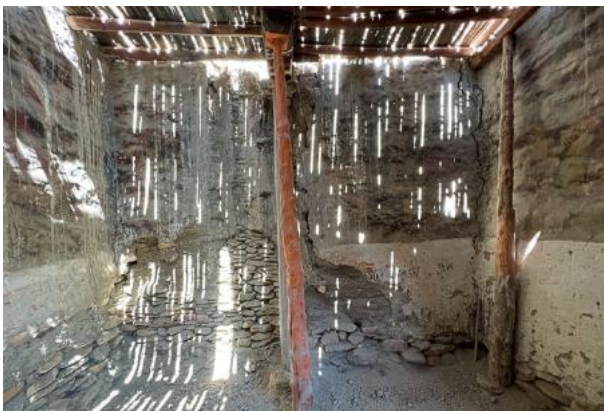
Figure 9: View of the entry hall wall with severely damaged murals during dismantling of the upper floor.

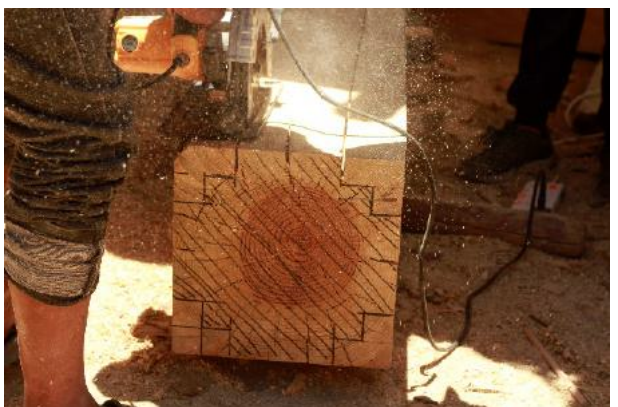
Figure 22: The massive pillars of the porch needed to be replaced. Here the new pillar's shape is prepared.

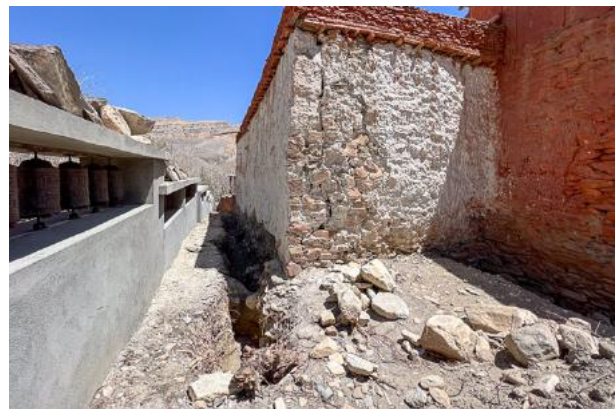
When excavating along the wall, it turned out that the foundation of the building was weak. It thus needed to be strengthened throughout to ensure its long-term stability and safety of the structure.

Figure 24: The most precarious parts of the foundation in the northwestern corner of the building.

After analyzing the current condition of the foundation and identifying potential risks (damages and distress) weaknesses, we concluded that it is necessary to build a continuous stone wall adjacent to existing foundation to increase its load-bearing capacity. In addition, the wall was covered with a thick layer of mud to maintain its slope toward drainage dug along the building.

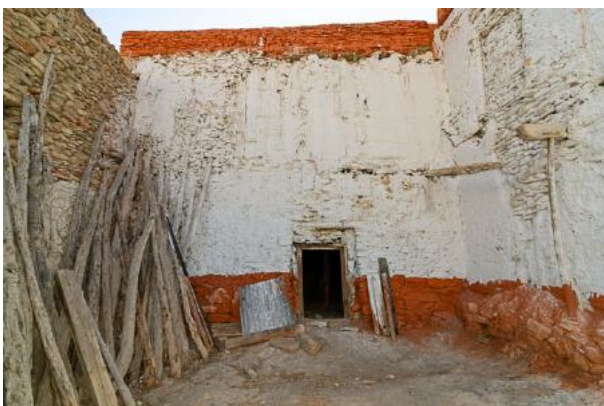
Due to an increasing bulge in the stonewall at the southeast corner, our team concluded to reconstruct the stonewall. The issue was observed during the daily site inspection. In this case the wall tie could be added in the middle of the stone wall and also serves as the support for the joists on the ground floor. The stonewall work was carried out using mud mortar.

Figure 36: The structure in the southwest corner before dismantling the corner area of it (2019).

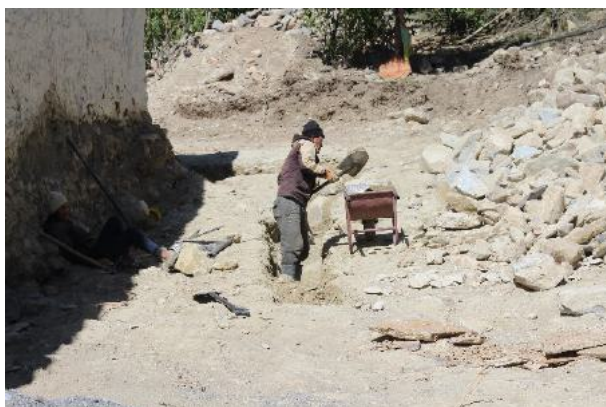
The temples main problem are the result of moisture and dampness affecting both the outer walls as well as painting walls inside. Considering this, our team concluded to establish the proper drainage for the site. The drainage was designed in such a way that even rainy season water could not collect and cause dampness in future. The drainage system was established at a distance from the wall and its foundation, the latter built with a slope leading away from the building.

Figure 50: Digging a drainage at a distance to the temples walls.

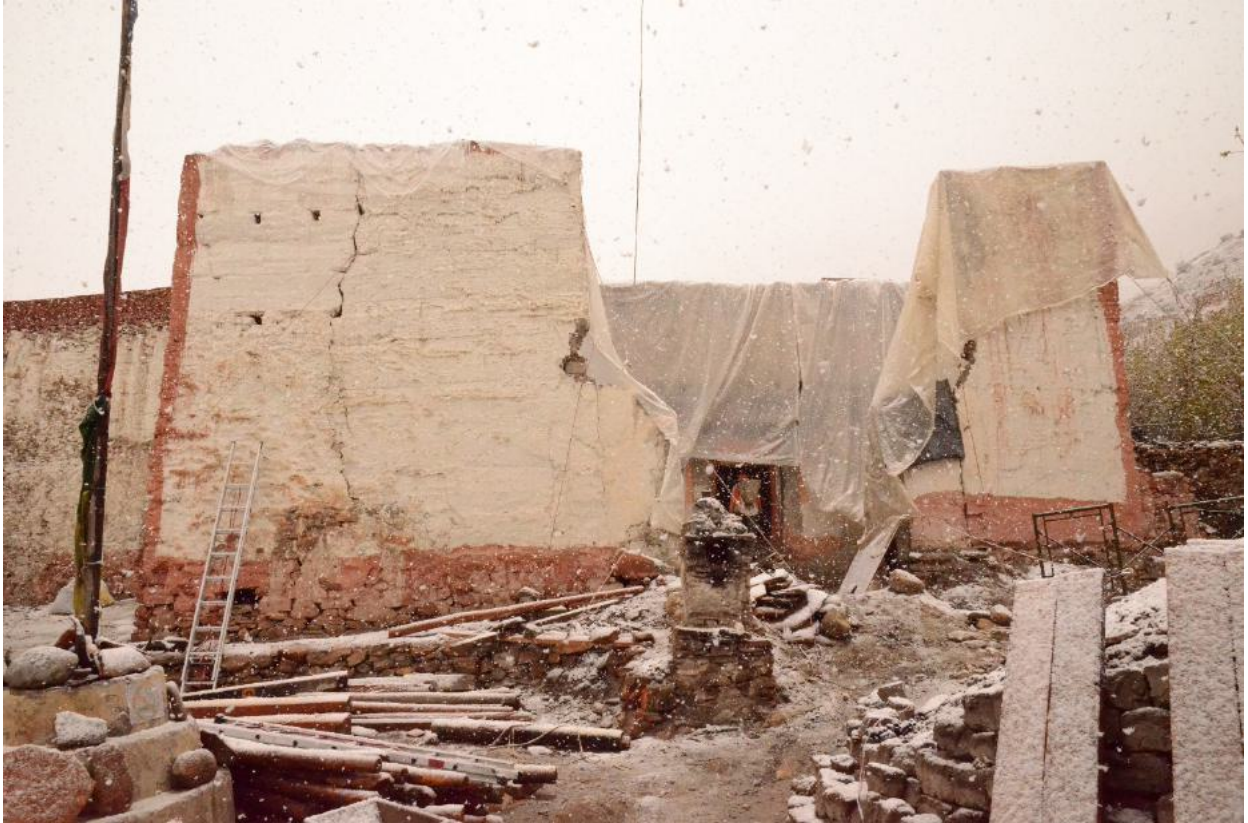
Figure 51: The entry hall with its murals covered with tarpoline to prevent damage from rain and snowfall.
