# Architectural Restoration and Seismic Strengthening of Gönpa Gang

U.S. Ambassadors Fund for Cultural Preservation,  
Award No. SNP40022GR0039

**Project Report, First Year – July to September 2023**

**Norbusum Foundation (NGO)**

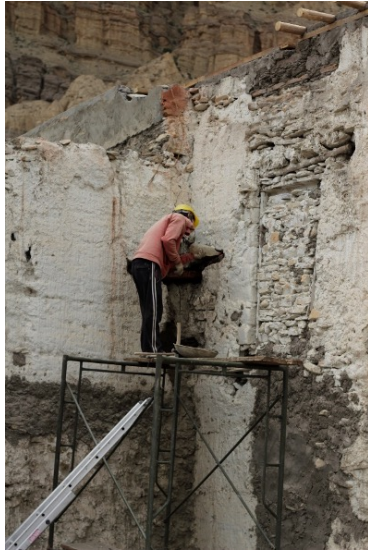
Figure 30: Repairing the old wall in front of the southern building with wooden ties.

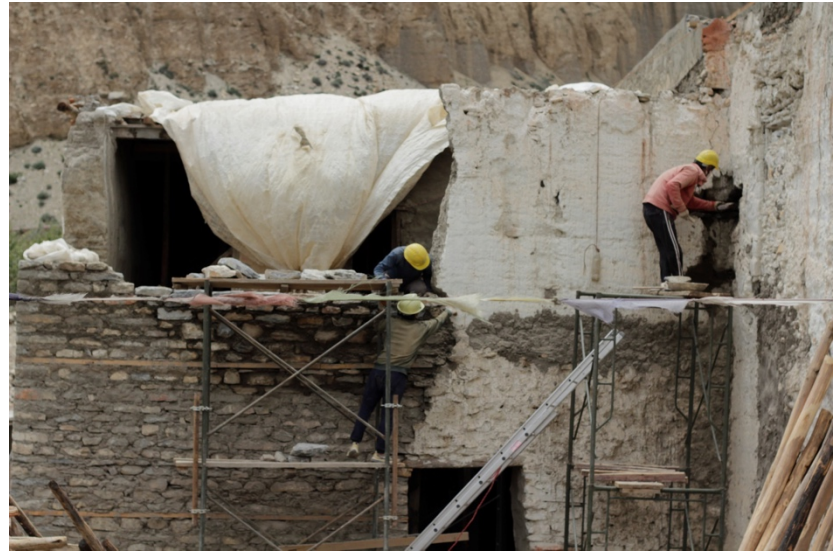
Figure 31: Constructing the new wall in the southeast corner and repairing the older walls.

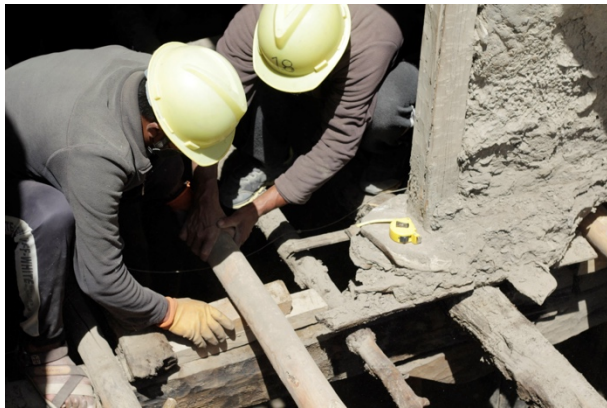
Figure 38: Replacing the old joist with new one maintaining the level.

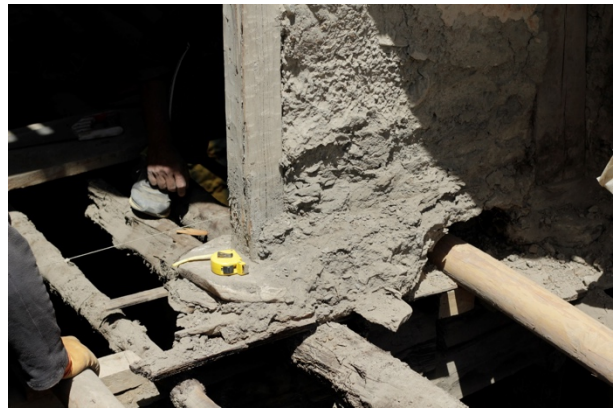
Figure 39: Placing new joist as needed underneath the partition wall.

In terms of construction, one of the biggest challenges was the replacement of the old joists underneath the partition wall that has old painting on it. This wall was constructed on top of a beam, and we could only replace three joists a day.

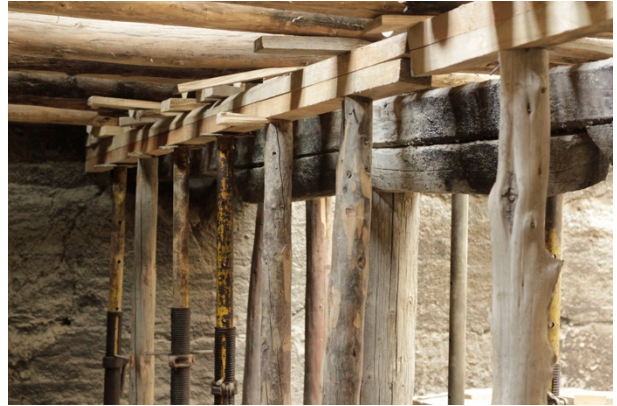
Figure 41: Supports installed to preserve the painted partition wall above during reconstruction.

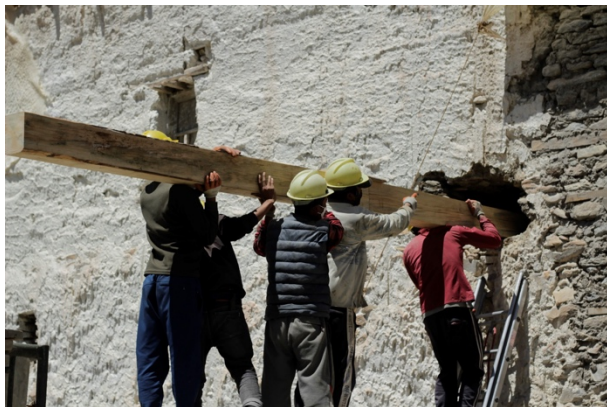
This quarter the restoration moved to the space underneath the painted room. First, we prepared the foundations; a large bed stone with a joint for the post were placed to support the new beams. The original beams needed to be replaced by new ones due to their poor condition. We faced many challenges while changing wooden members under the painted walls, but succeeded in changing the entire wooden structure under the partition walls on the first floor. Then, a new flooring with minimum thickness of mud was constructed. Some of the original wooden members could be retained to be reused in the upper floor. Wall plates and a wall tie were installed on the upper level for seismic strengthening. The new stonewall in the southeast corner was continued to be constructed and tied to the old walls by wooden plates and wall-ties.

Figure 42: Inserting the new beam to replace old one through a hole in the wall.

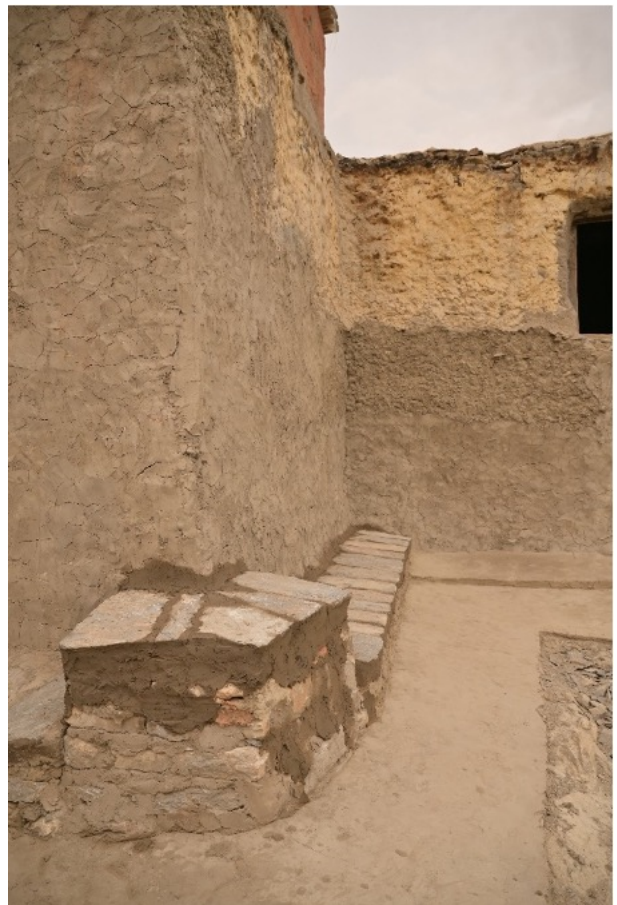
We also constructed the buttress stone wall at southwest corner to consolidate the corner wall. It had weak and loose wall at that corner.

*Figure 53: A higher corner buttress to consolidate a corner on the west side of the Gönpa.*

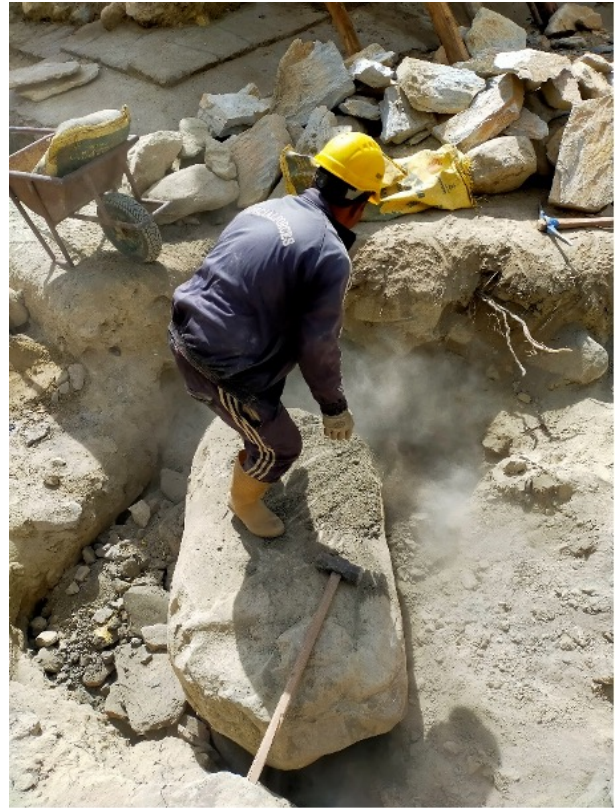
*Figure 55: A big stone found while digging the foundation and drainage.*

As can be seen in Figure 55, our team also faced difficulties while digging for the foundation and drainage.

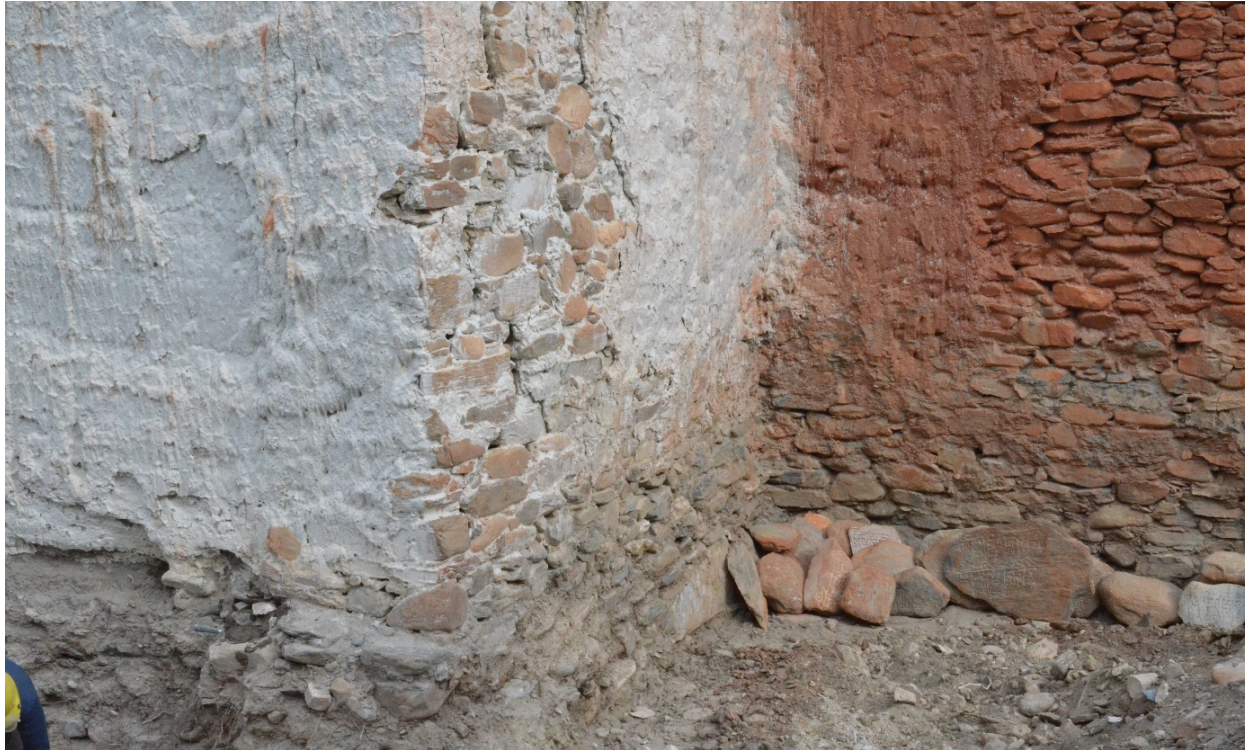
The stonewall in the northwest corner of the temple bulged as it was filled with loose stones. On the ground floor of this corner are some of the most important paintings of the temple including a depiction of the founder of the monument. It thus was deemed important to repair this section comprehensively without damaging the murals on the inside. Our team prepared the repair of this wall carefully to be prepared for potential issues.

Figure 57: Vie of the northwest corner with the wall cracked and bulging.

First, we shored the bulging wall with wooden members and constructed an extra 16" wall up to halfway. Then the old wall was dismantled from the roof to the floor level of the first floor, and from there the outer section of the wall was carefully removed, leaving the inner layer of the original stone wall with the murals. Finally, the wall was reconstructed from bottom up and tied to the old wall sections. The following images document the different stages of this process.

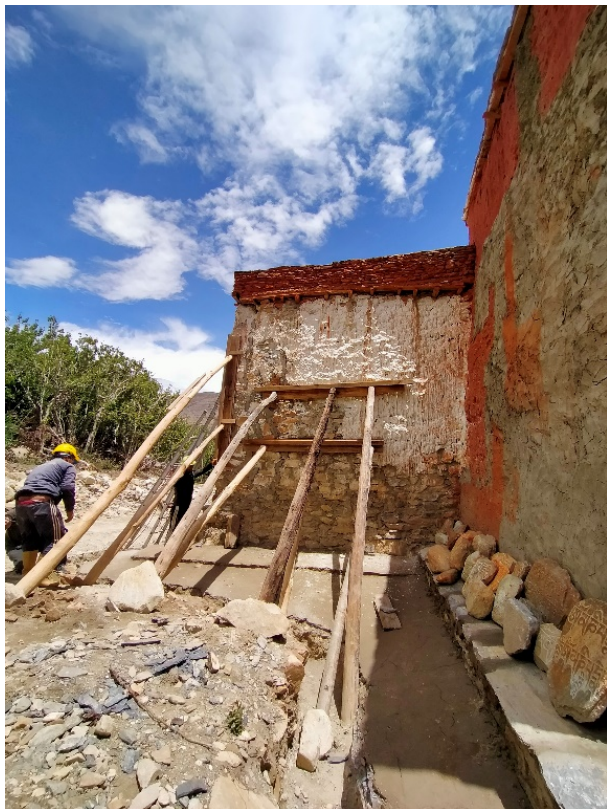
Figure 58: First the wall was shored up to prepare the dismantling from the top.

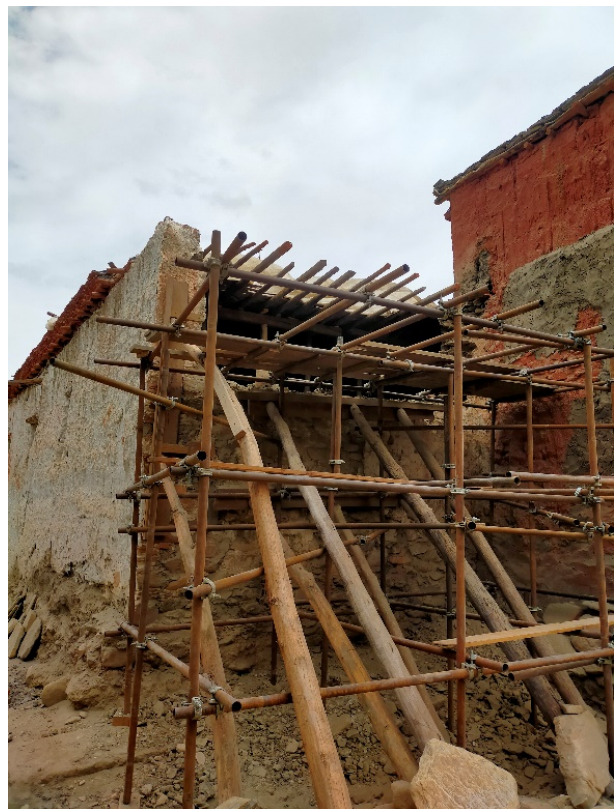
Figure 59: Then a scaffolding was erected and, after opening a section of the roof, the wall was dismantled from the top.

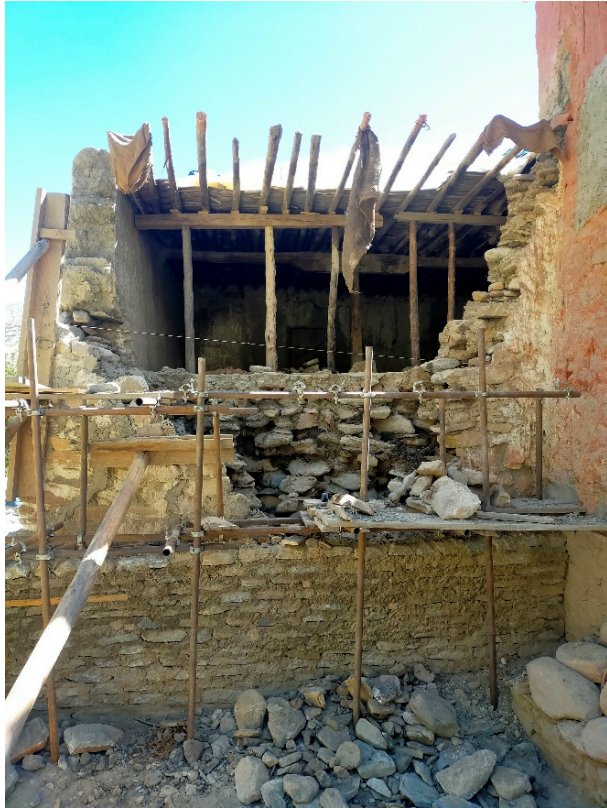
Figure 60: An extra wall was constructed in front of the problematic wall as support.

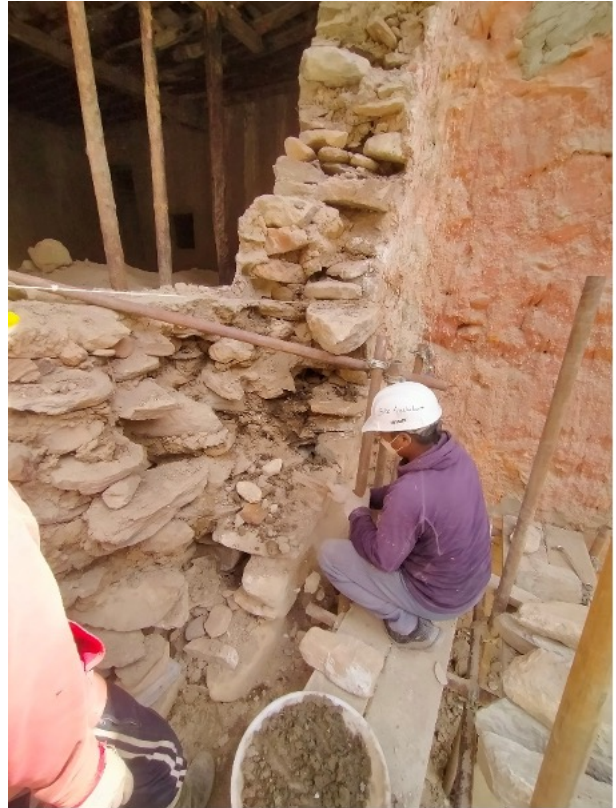
Figure 61: Investigating the condition of old wall by the site architect to decide on for further steps.

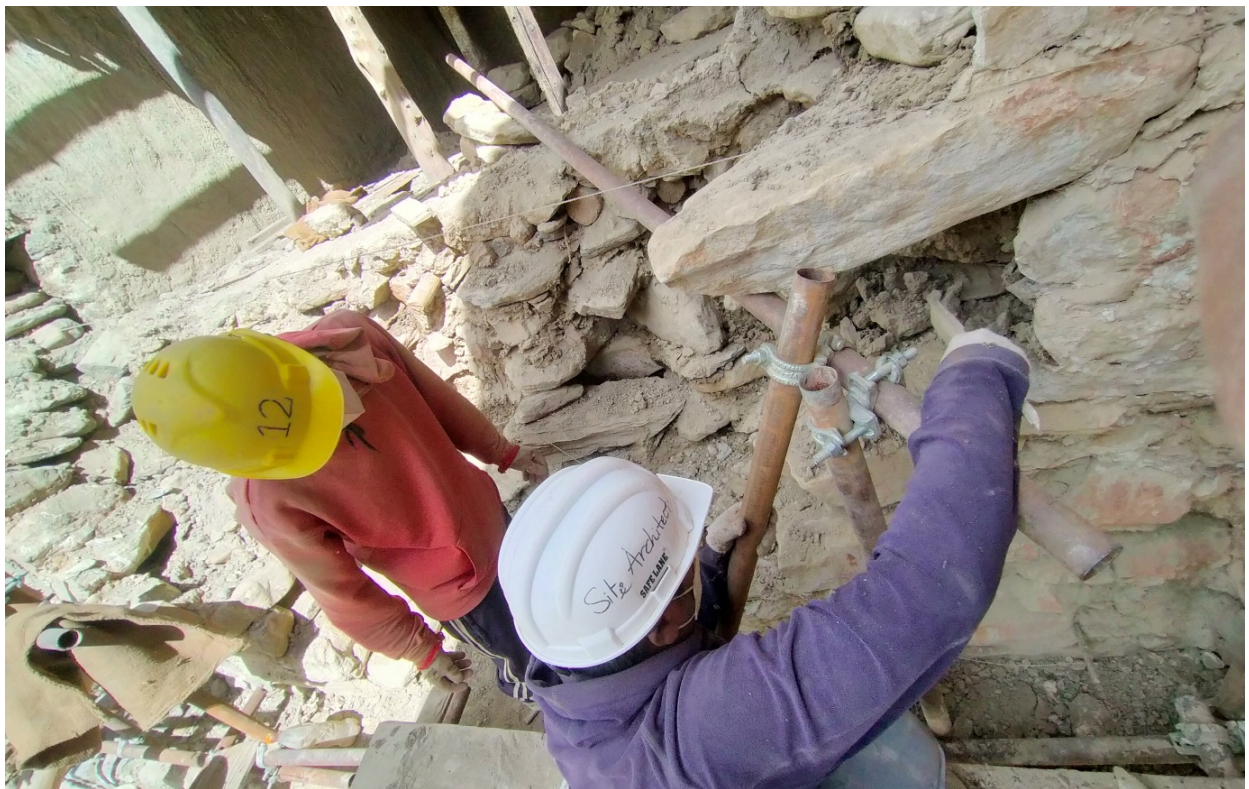
Figure 62: Supporting a large stone from the original wall that can serve as connector between the old and new walls.

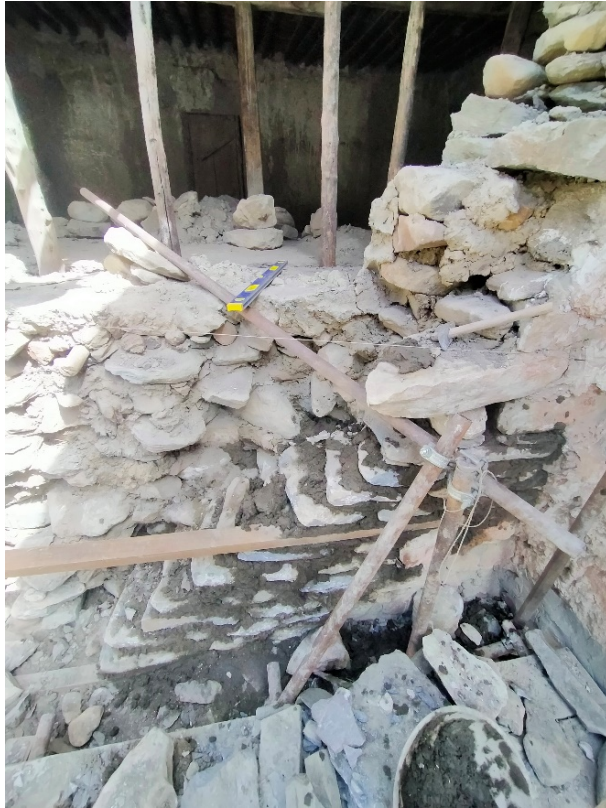
Figure 63: Construction of the new wall along the lower section of the wall and connecting it with the old one.

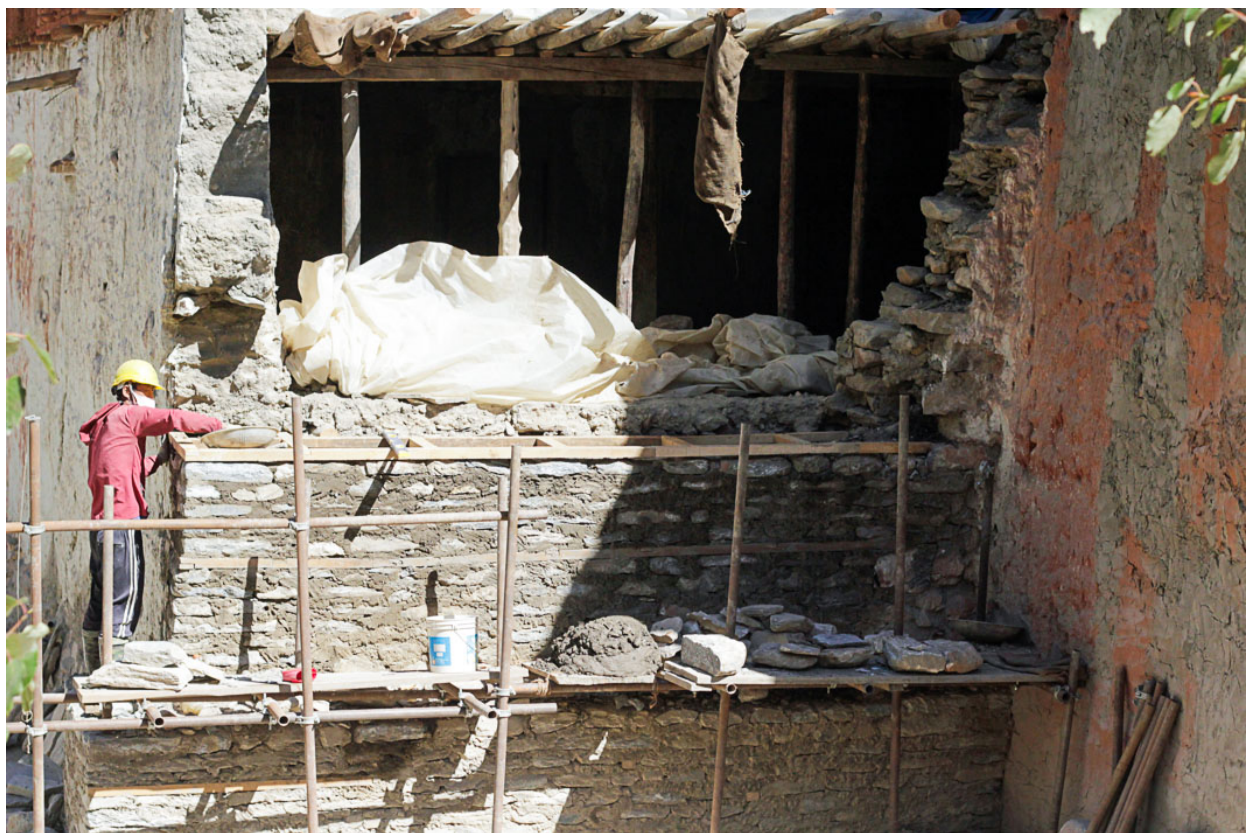
Figure 65: The wall reconstructed to the level of the first floor, where a wall-tie was inserted.

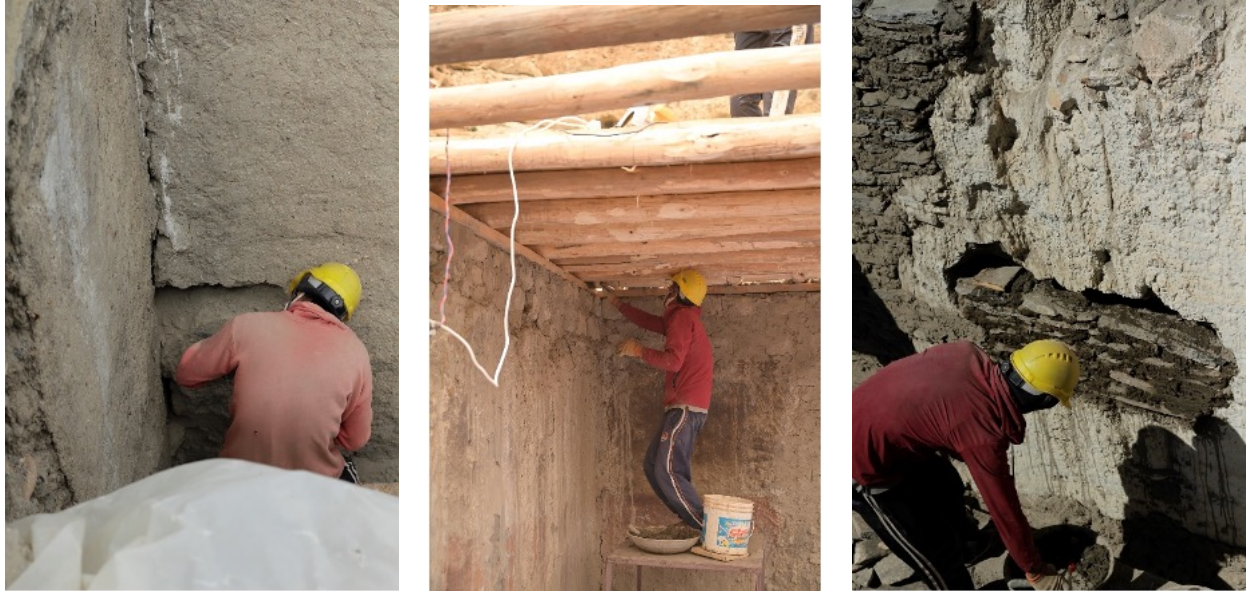
Sections of the monasteries' wall had cracks that needed to be fixed. These were filled with stone, mud and/or wooden ties as appropriate. We also strengthened the partition wall, with paintings by tying it to the adjacent wall. The following images show some examples of such works.

*Figure 66: These images show repair work in different areas of the temple using different techniques as required.*

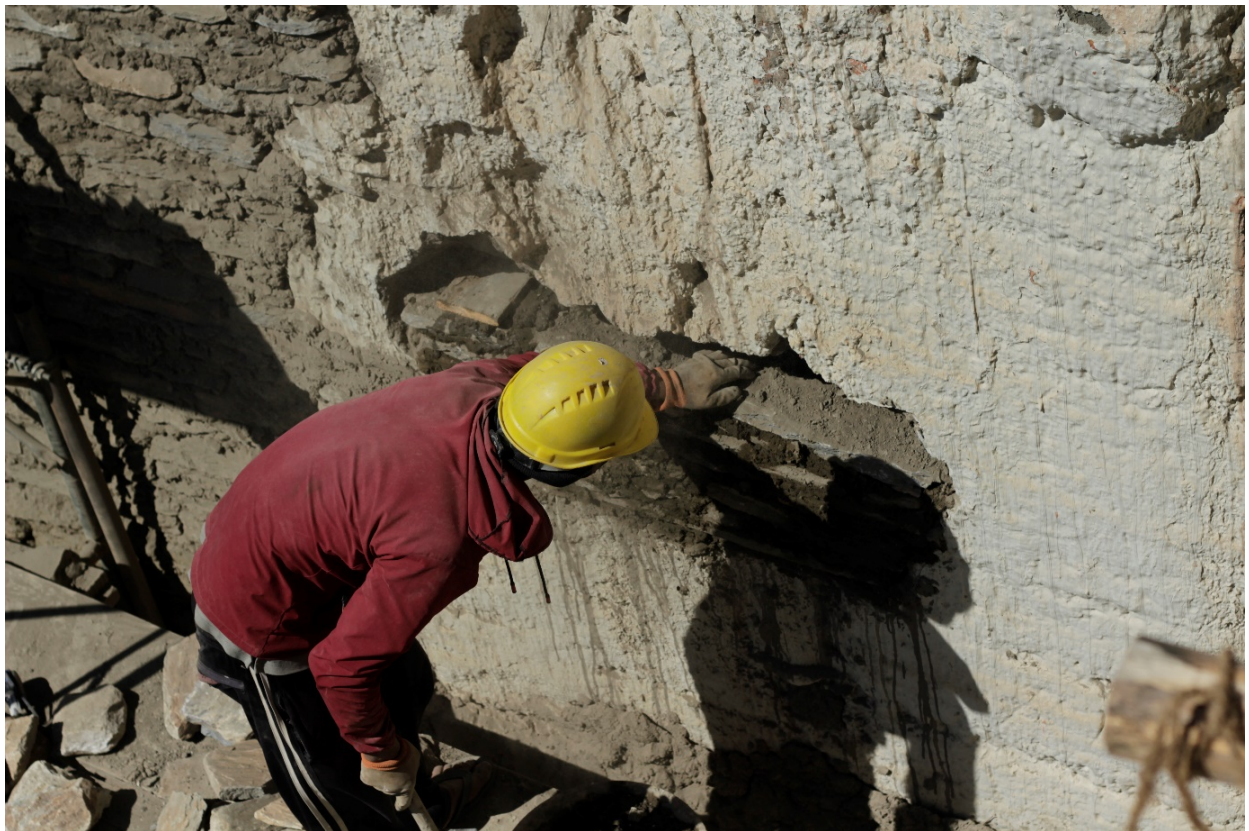
*Figure 67: View from top during the repair of a stone wall showing wooden members to connect the repair to the original wall.*

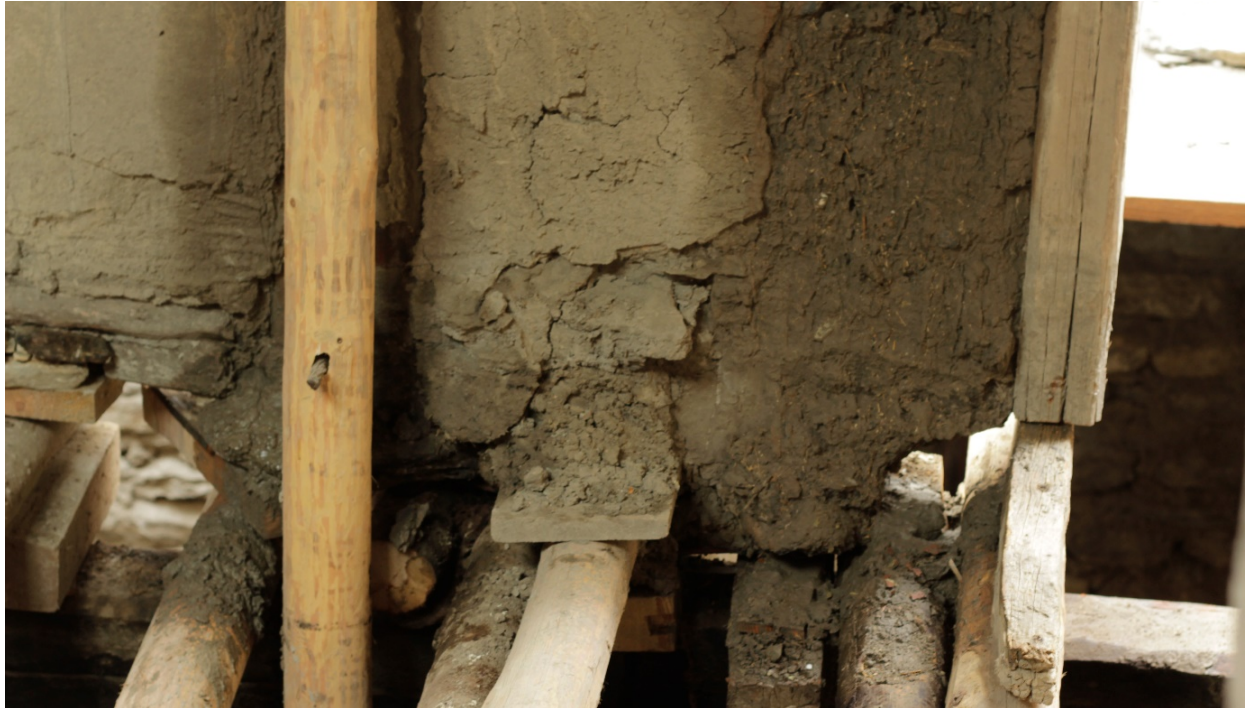
Figure 68: Rain damage to an exposed section of a wall which was repaired later on.

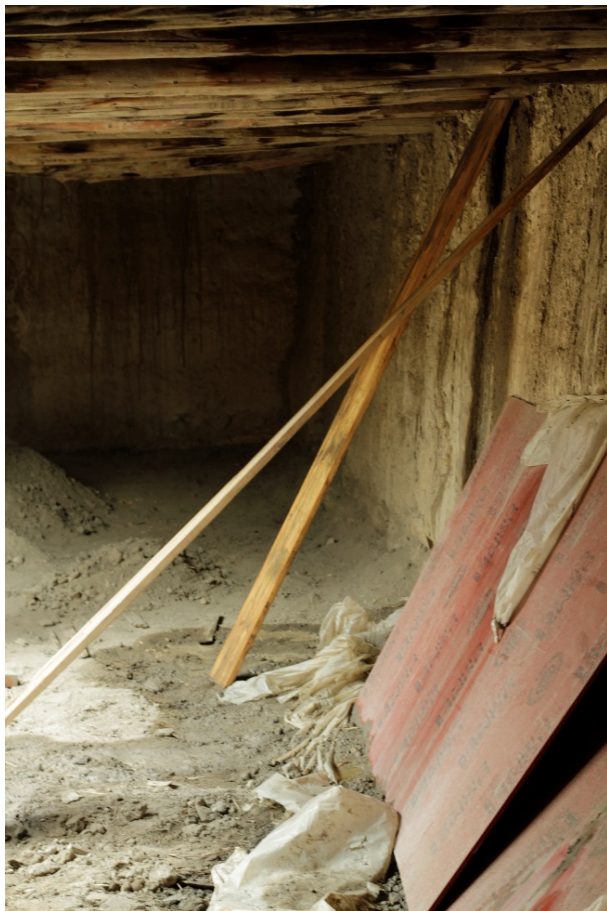
Figure 69: Plastic sheets and plywood used to prevent water affecting the wall paintings on the floor underneath.
