## **SEISMIC STRENGTHENING AND RESTORATION OF GONPA GANG**

DAMAGE ASSESSMENT AND RESTORATION CONCEPT

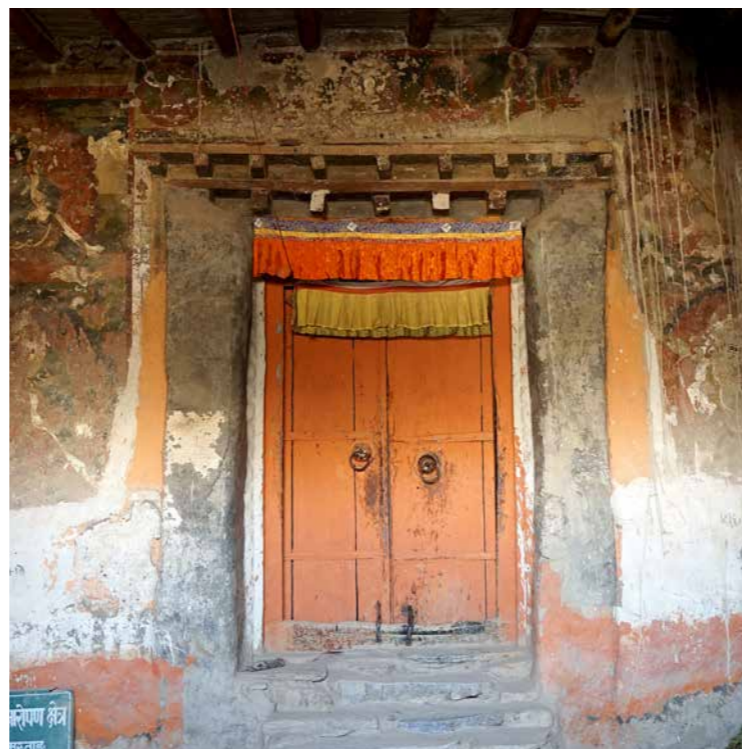
DAMAGE ASSESSMENT AND RESTORATION CONCEPT

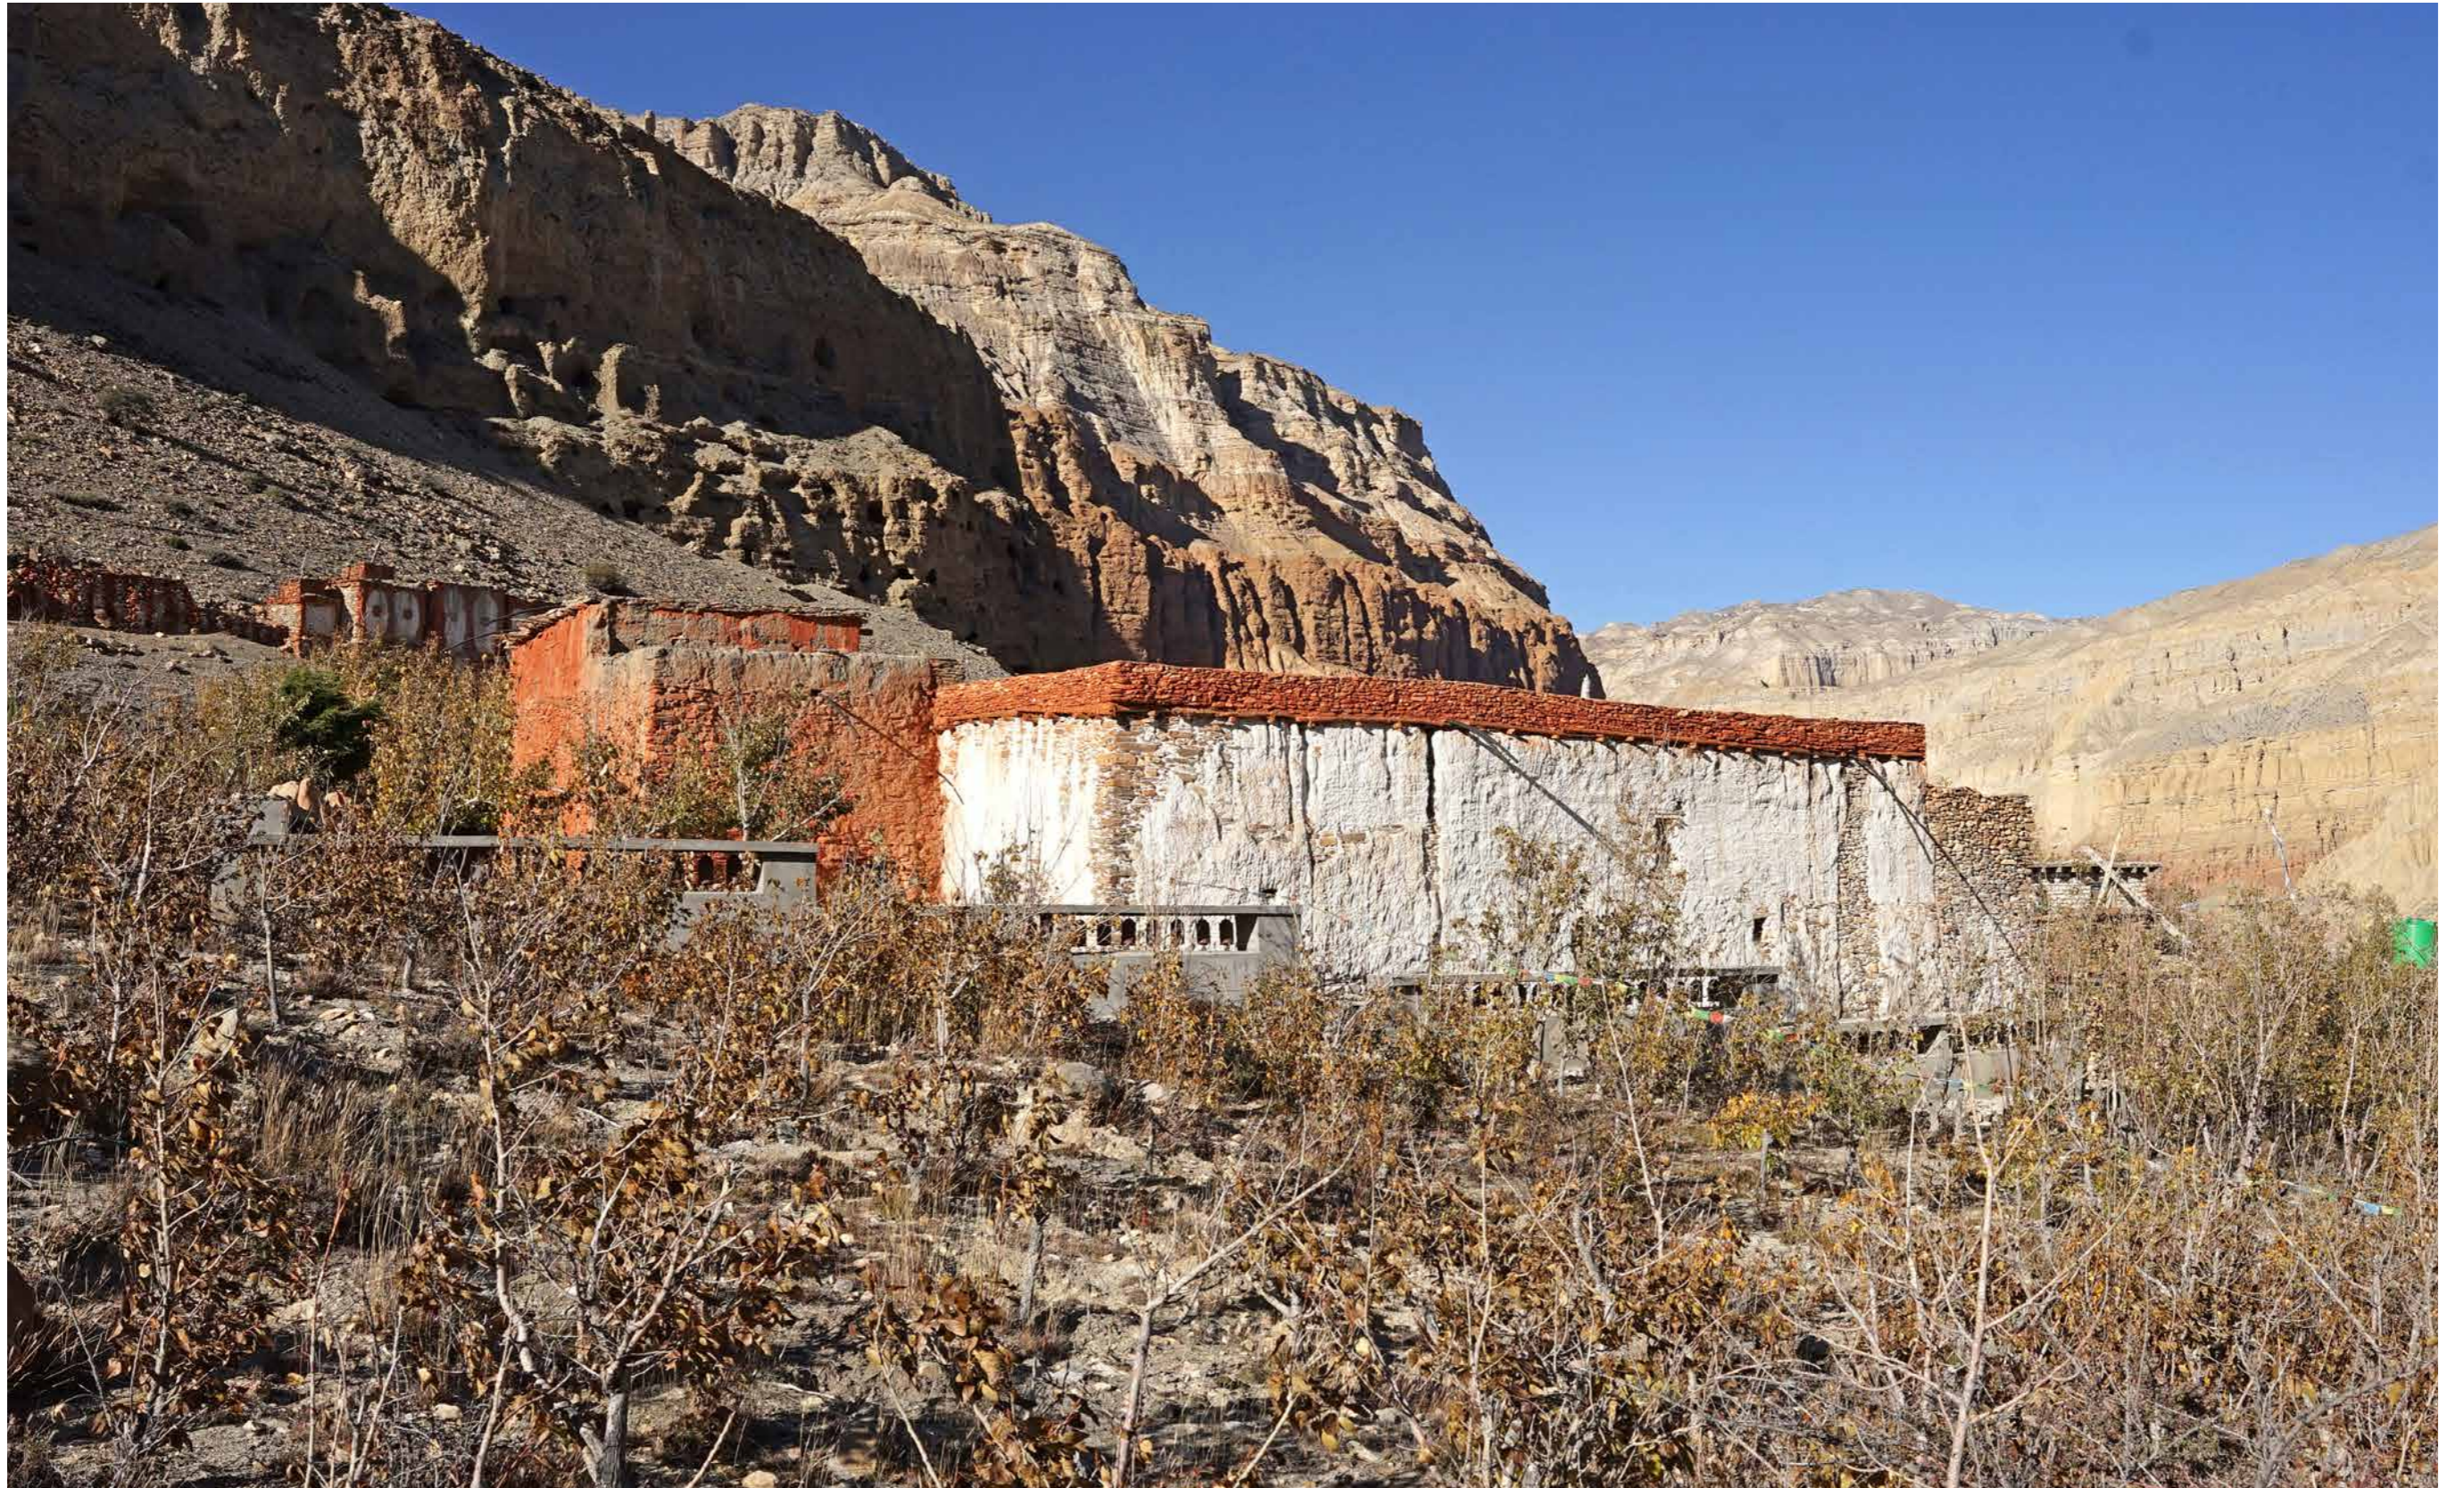
Cover image: PRINCIPAL FACADE, VIEW FROM EAST  
Photo by Christian Luzcanits  
2017

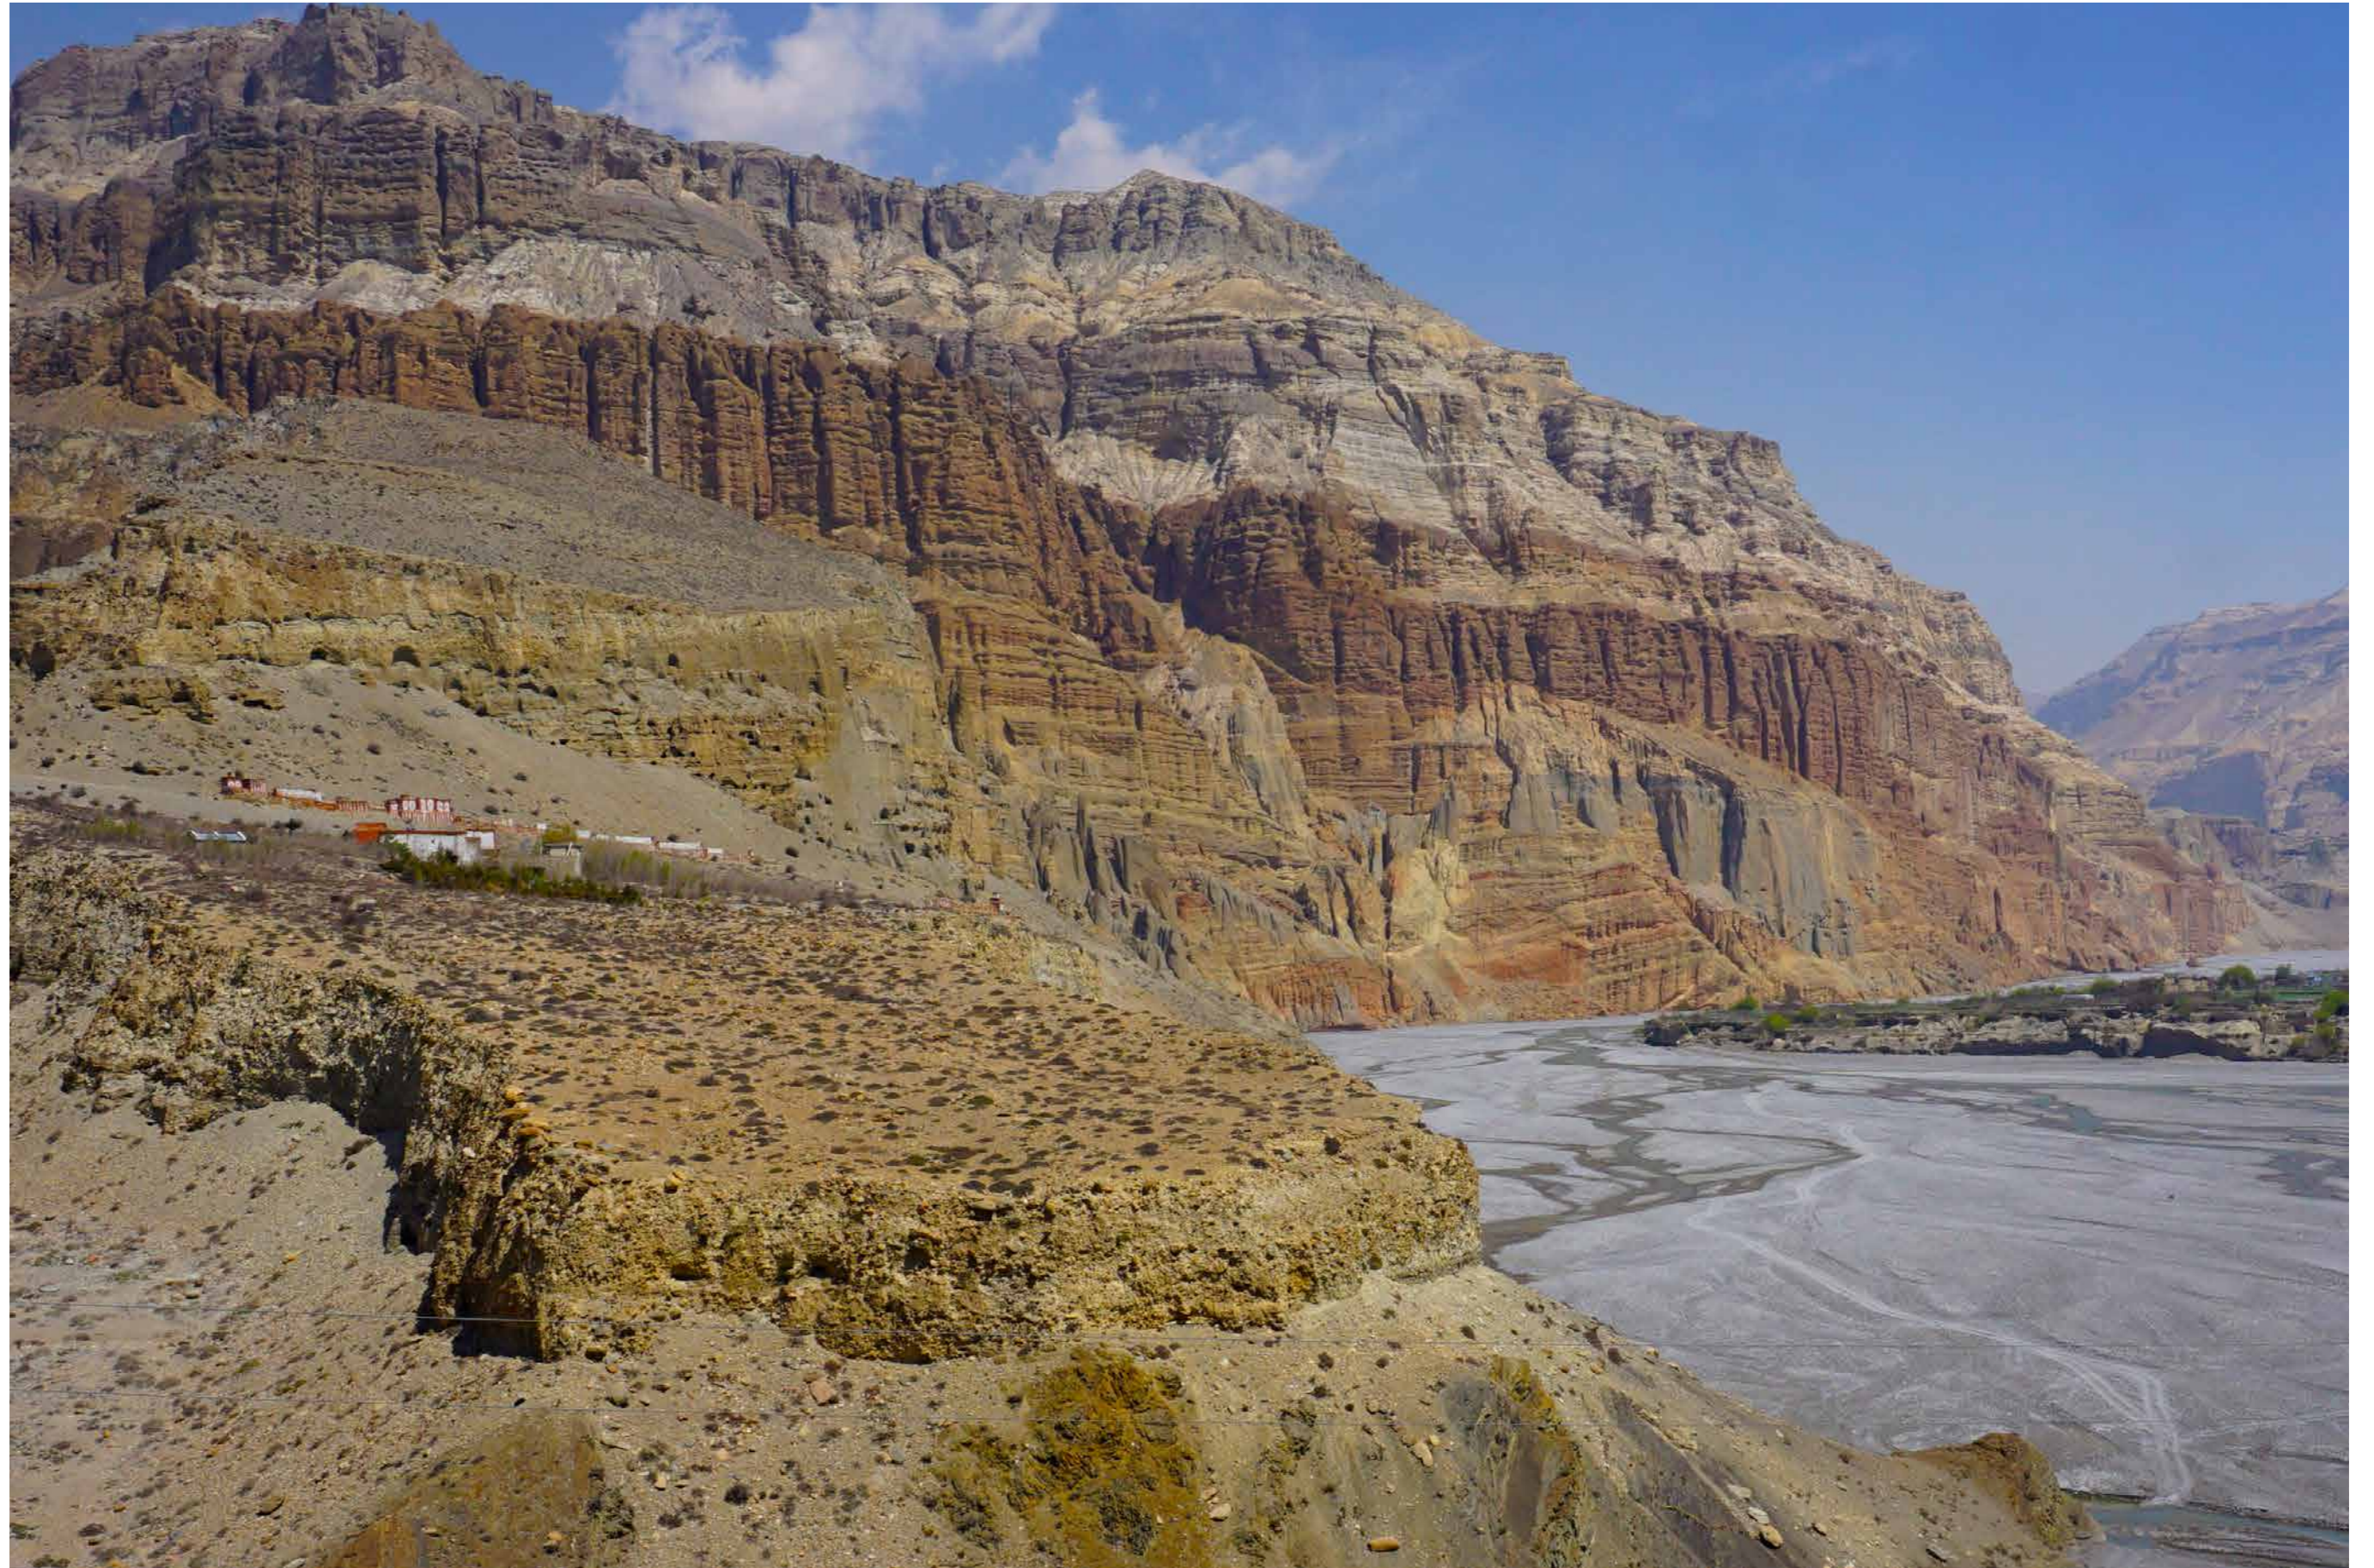
*above:* VIEW FROM SOUTH  
The deep vertical grooves in the white-washed facade are the results of many years of leaking roof drainage spouts. The gray cement-plastered wall with prayer wheels was recently constructed.  
Oct 25, 2022

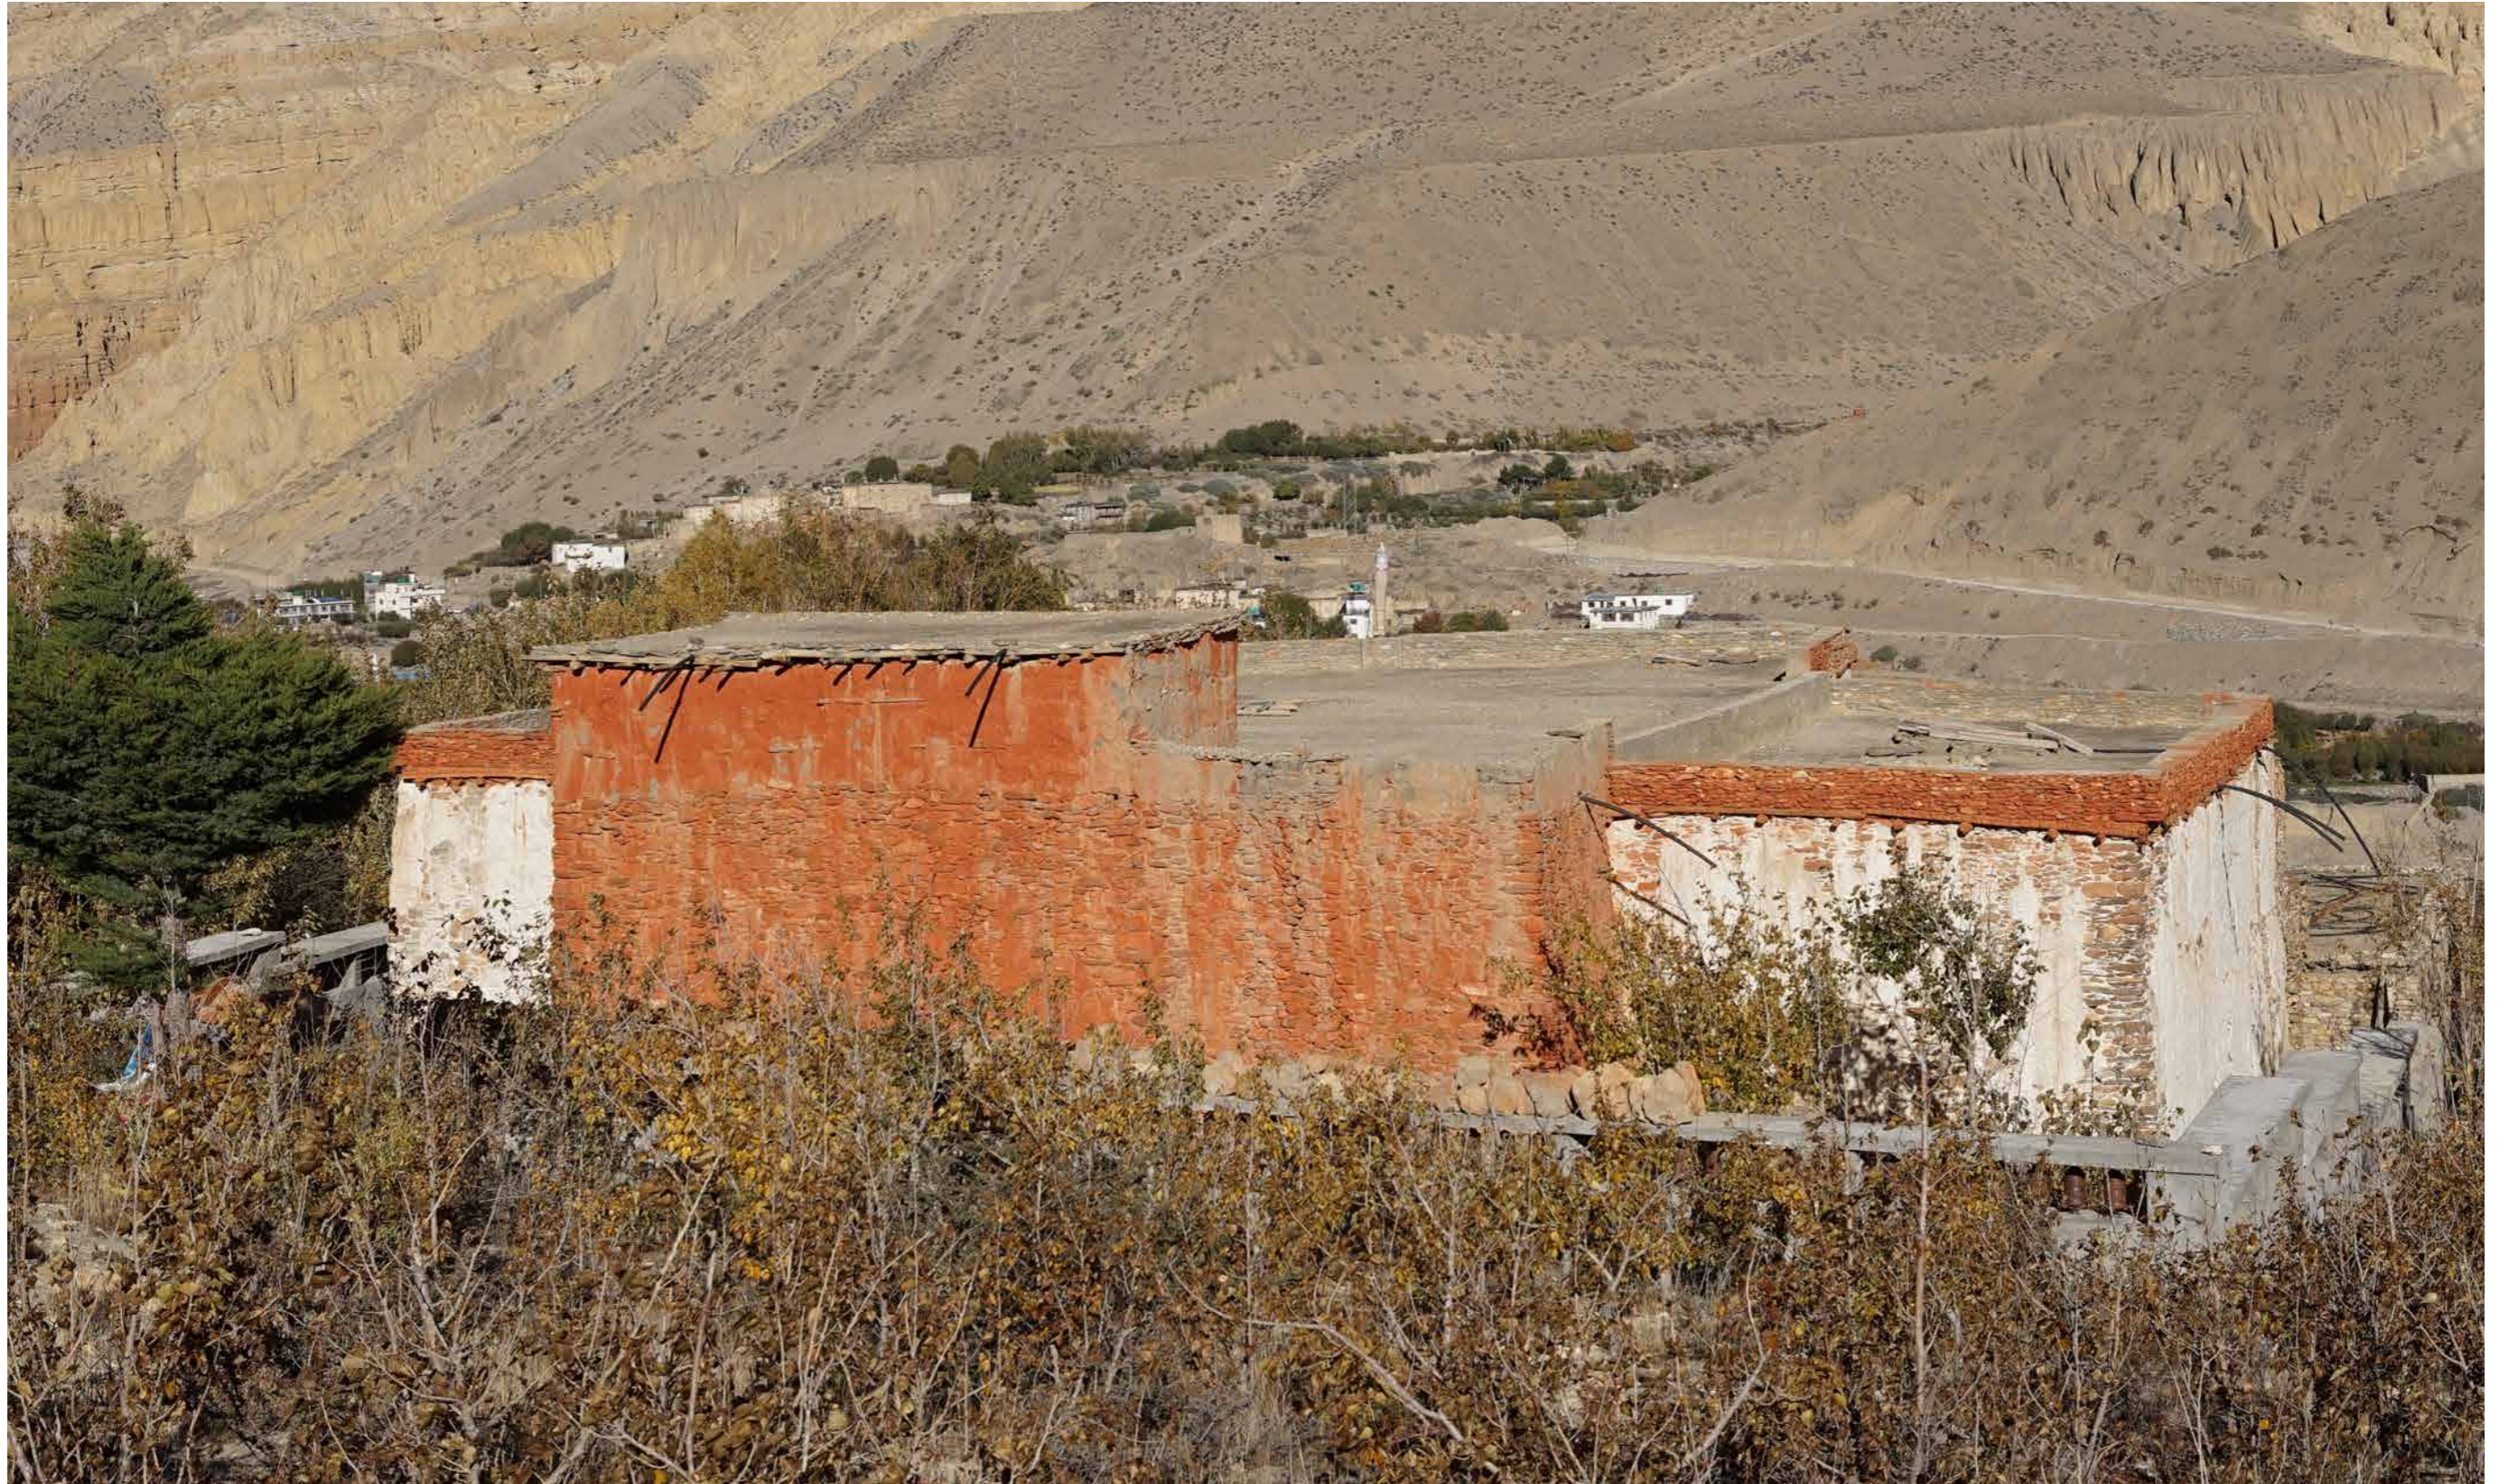
7	INTRODUCTION
10	ARCHITECTURAL DESCRIPTION
12	DOCUMENTATION DRAWINGS
18	THE PRINCIPAL FACADE
20	INVENTORY OF ROOMS
52	DAMAGES IDENTIFIED AND PROPOSED INTERVENTIONS
54	RESTORATION DRAWINGS
60	RESTORATION COST ESTIMATES

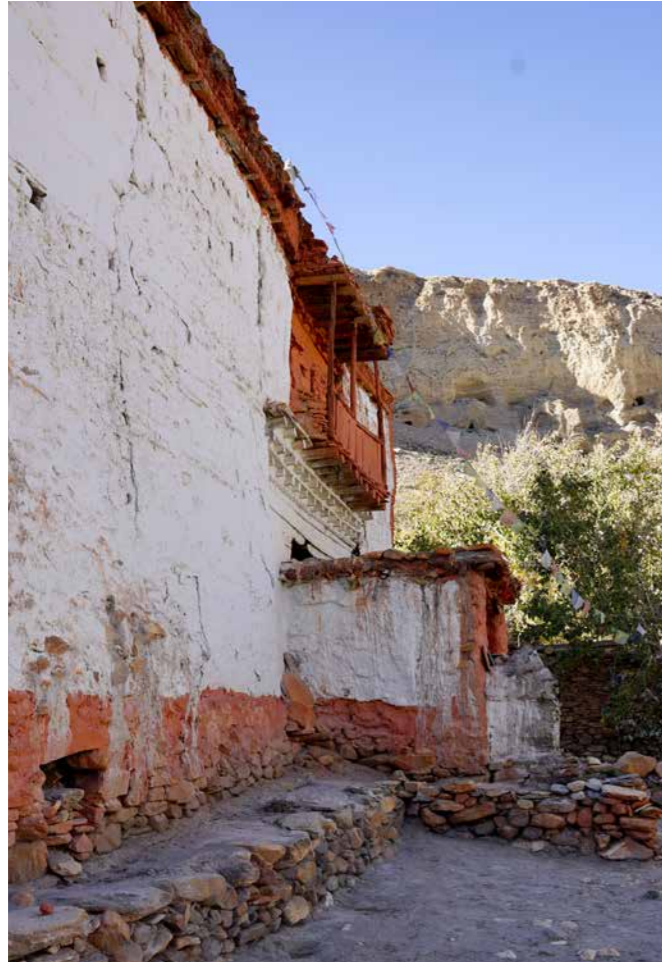
**PRINCIPAL FACADE**  
View from the south. The stone masonry porch obliterating the formerly open entrance will be removed.

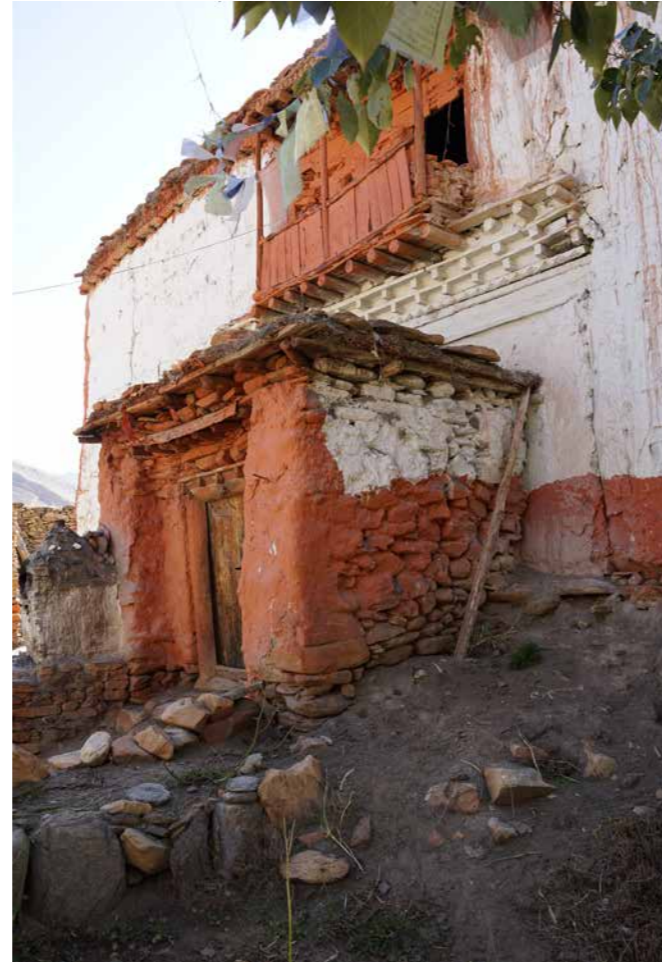
**PRINCIPAL FACADE**  
View from the east. The balcony will be rebuilt to its original design. The stone wall blocking the opening will be replaced with new windows.

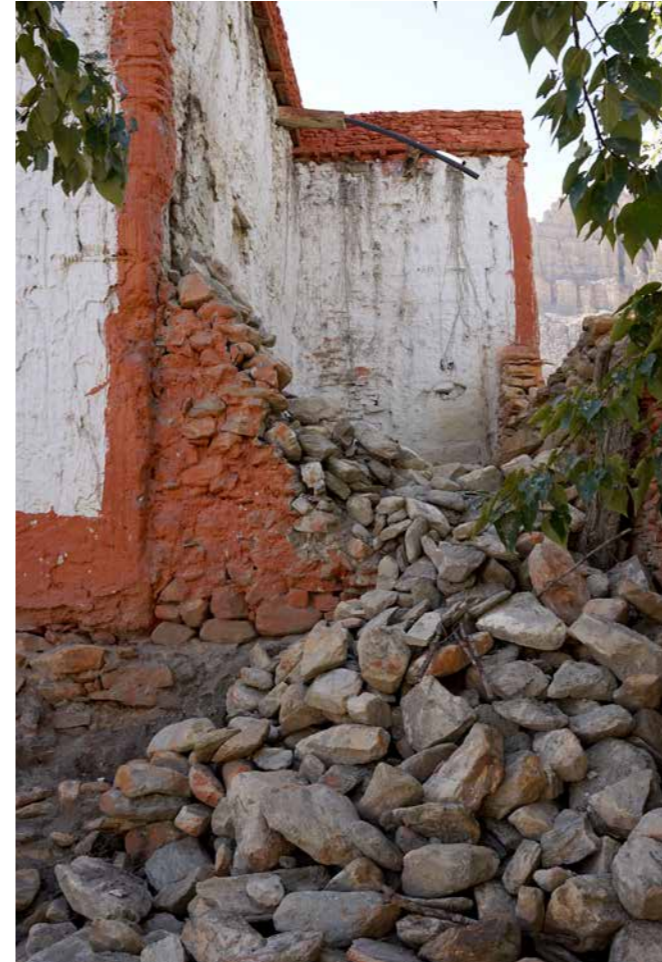
**NORTH-EAST CORNER**  
The partly collapsed stone wall enclosure will be completely removed which will allow better drainage from the roof water spouts.

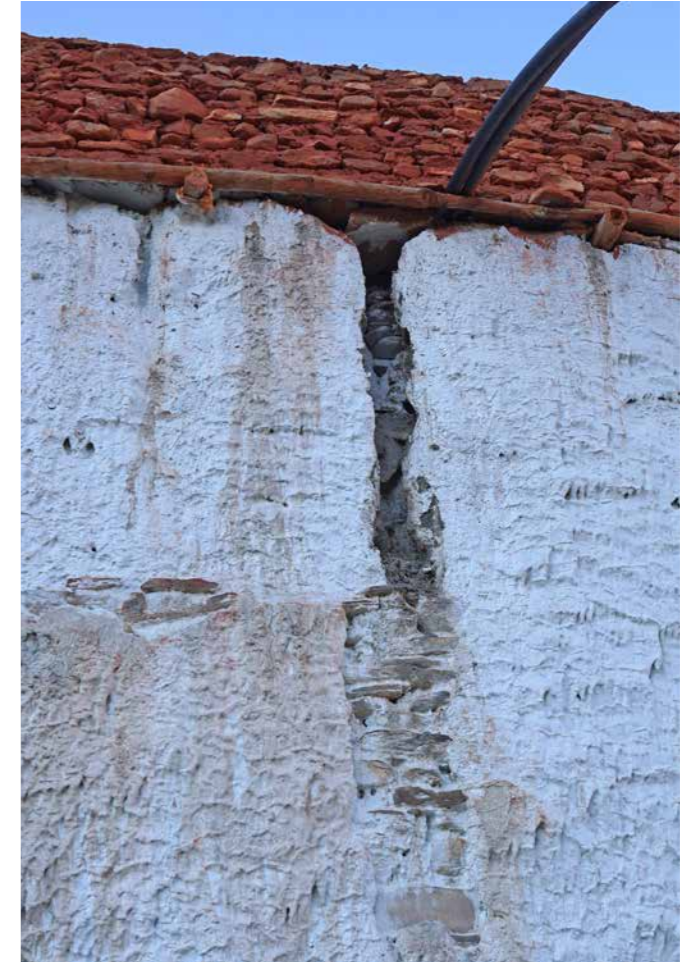
**WALL DAMAGE**  
View from south. This type of damage can be observed at several locations where water from a damaged roof spout has eroded the stone masonry. Often water penetrated to the inside and damaged wall paintings as well.

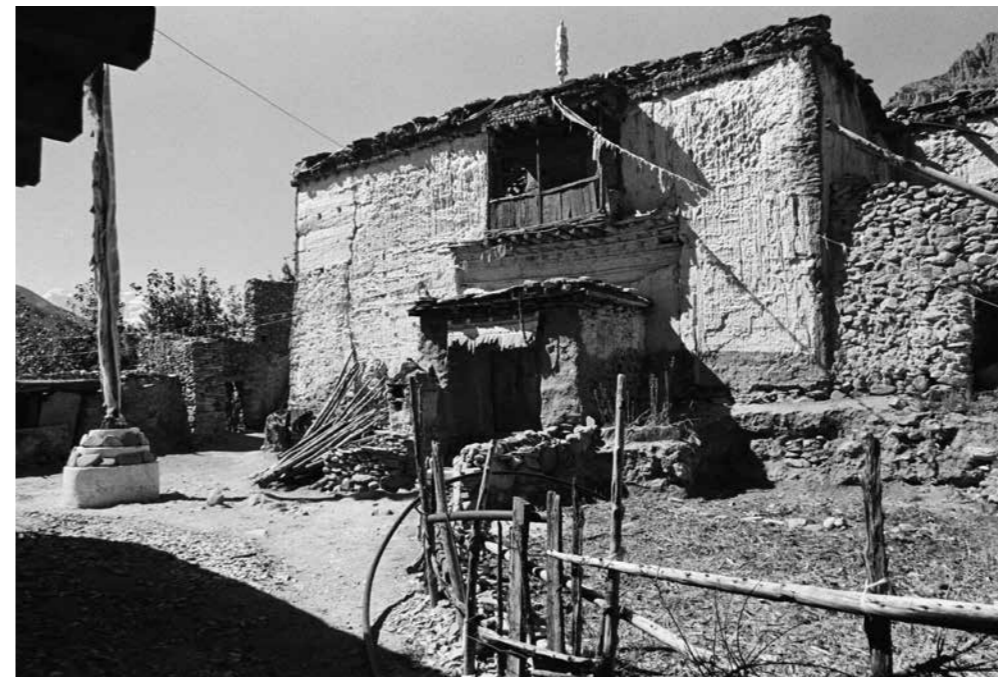
**PRINCIPAL FACADE**  
View from the south.  
Photo by John Harrison, 2005

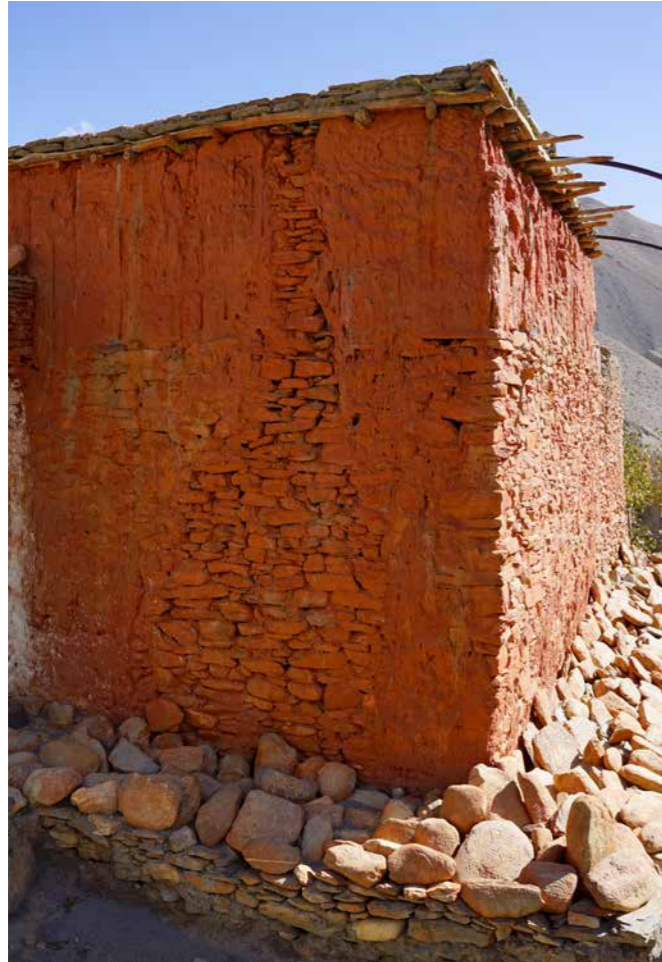
**SANCTUM**  
View from north. The hybrid construction combines rammed earth and stone walls. The wedge-shaped stone infill is a poorly executed repair of an area that was washed out by water leakage from the roof. The mane stones piled up around the building will need to be removed as they trap snow and water that subsequently leaks into the wall.

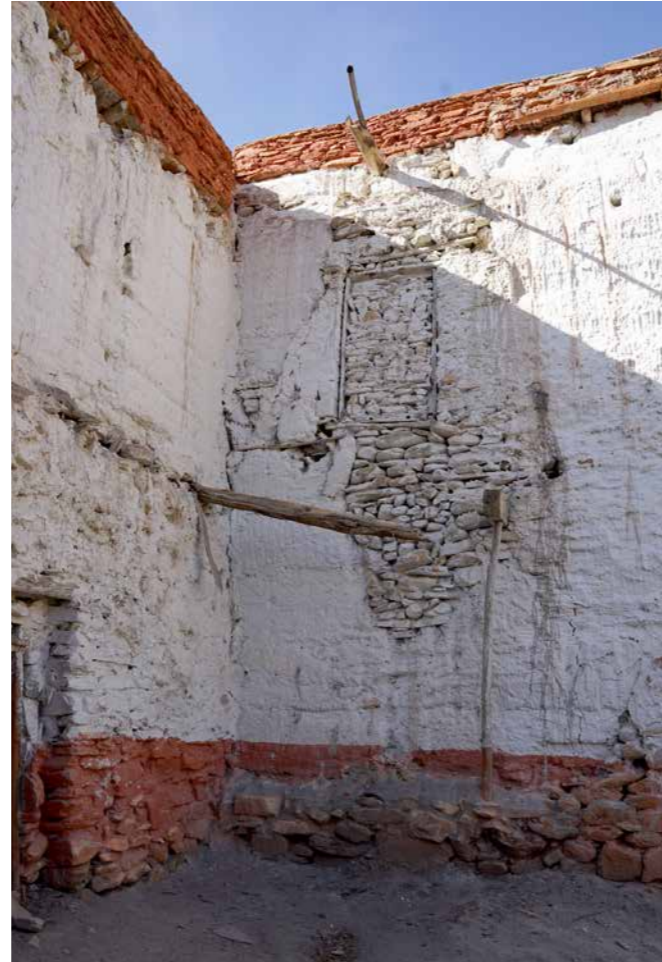
**SOUTH-EAST CORNER**  
View from south. The area was once covered by a two-story porch and balcony. Only a single round joist projecting from the wall remains. The wall on the right was heavily eroded by roof leaks. The damaged wall and door formerly leading to the balcony was filled in with stones.

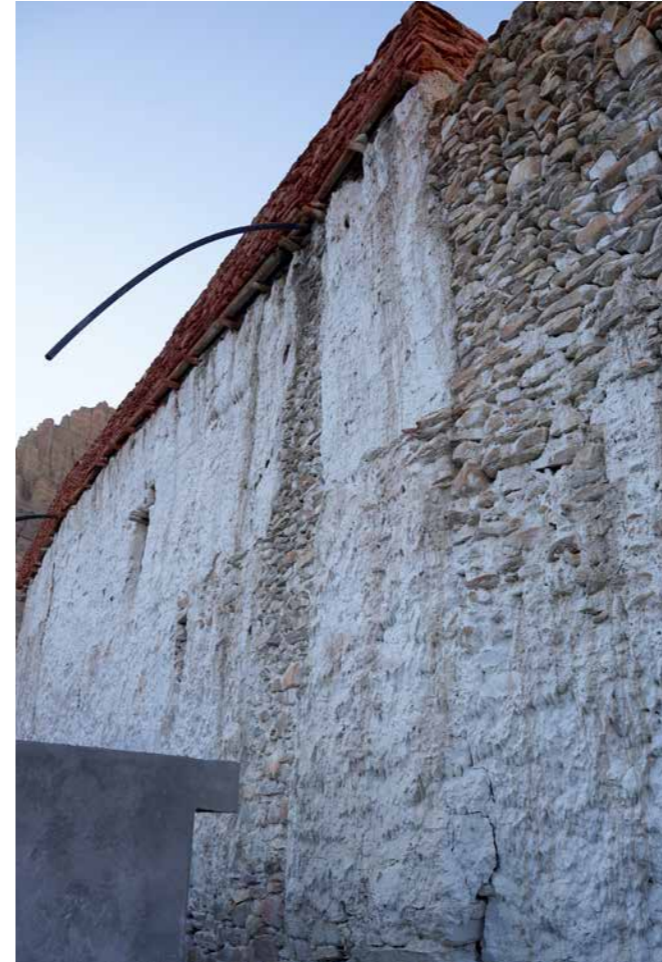
**BULGING WALL**  
View from the south-east. The wall, weakened by water infiltration from the roof and failing foundations, is precariously bulging. Compare to the photo on the right taken from the inside of the building.

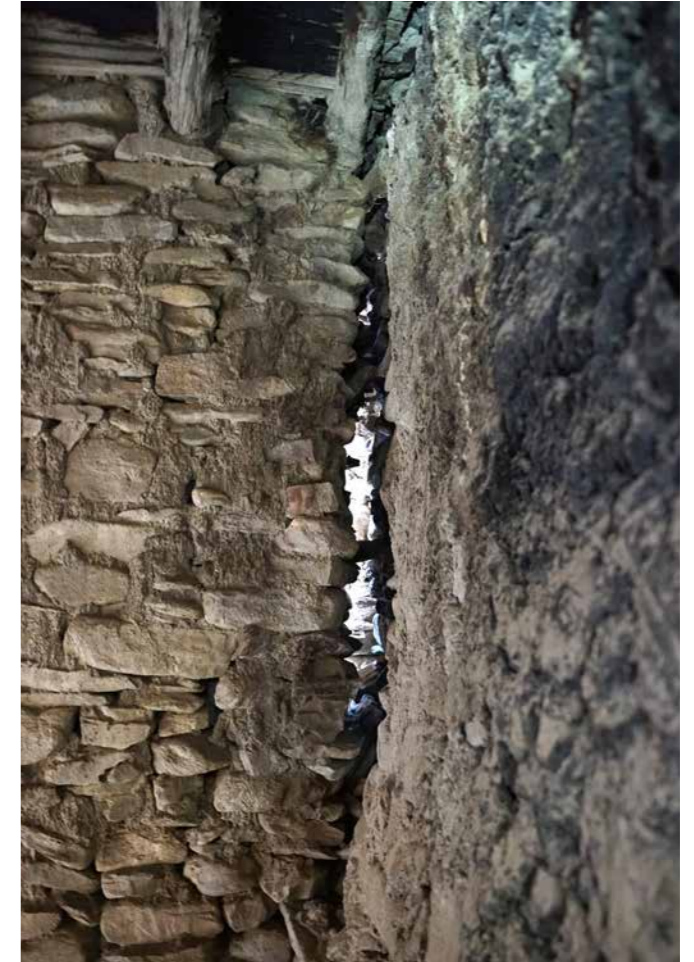
**WALL SEPARATION**  
View from inside the stable (Lo5). The wall to the right has been weakened by many years of leaks from the flat roofs. It is bulging to the outside (see photo on the left) and will have to be rebuilt.

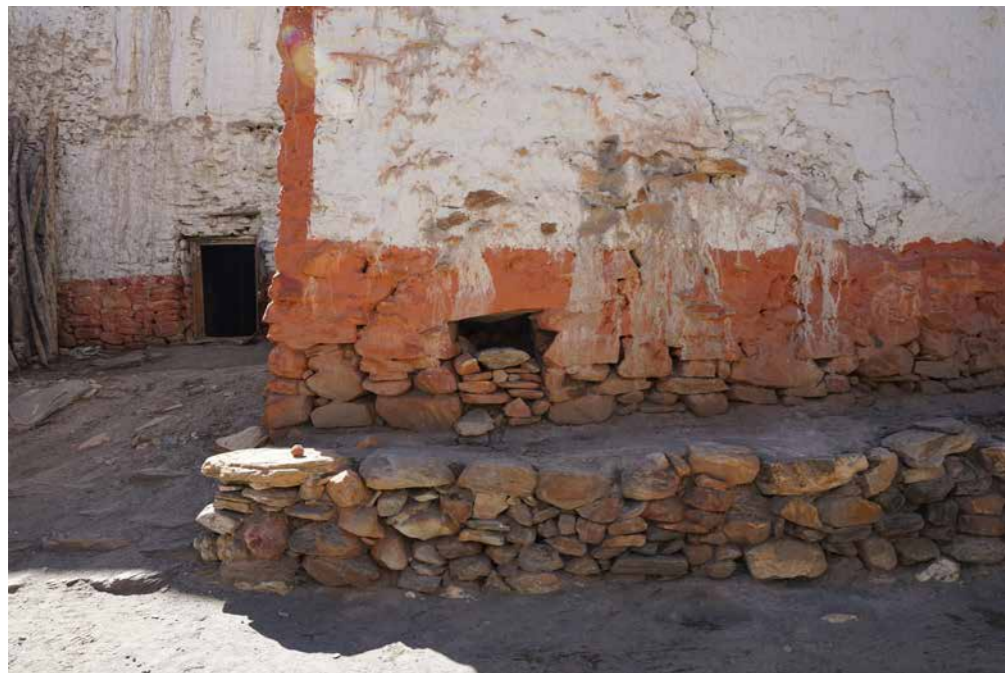
**OPENING TO TOILET PIT**  
View from east. This damaged corner section will be repaired and covered with mud plaster and lime wash.

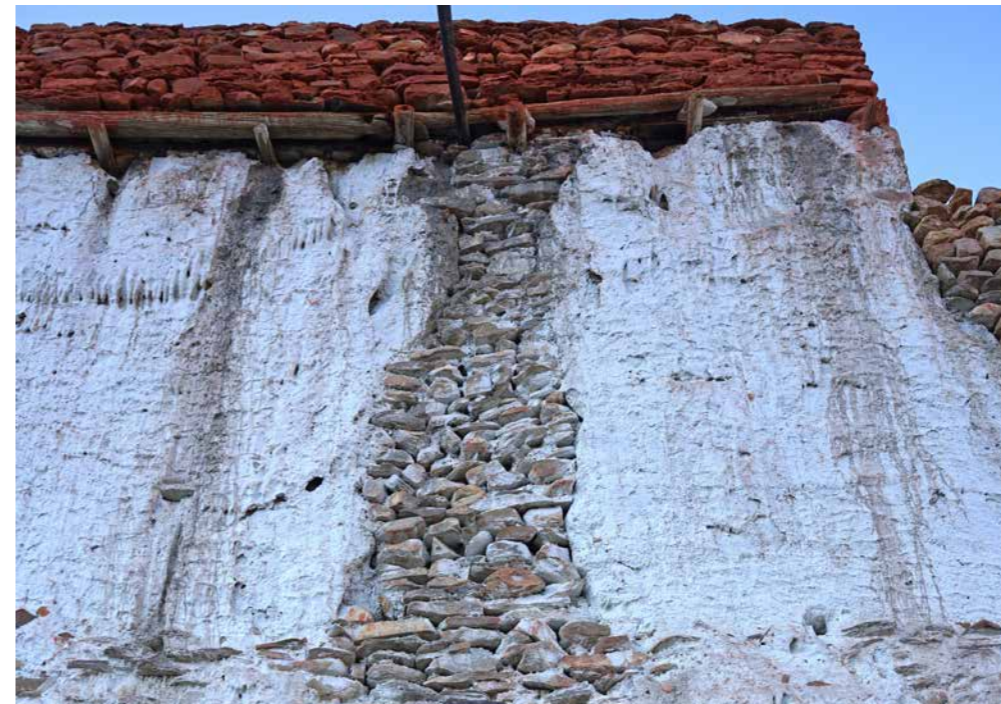
**DAMAGED RAMMED EARTH WALL**  
View from south. Water leaks from a damaged roof drain have severely eroded the mud wall. The void was temporarily filled with rubble rock.

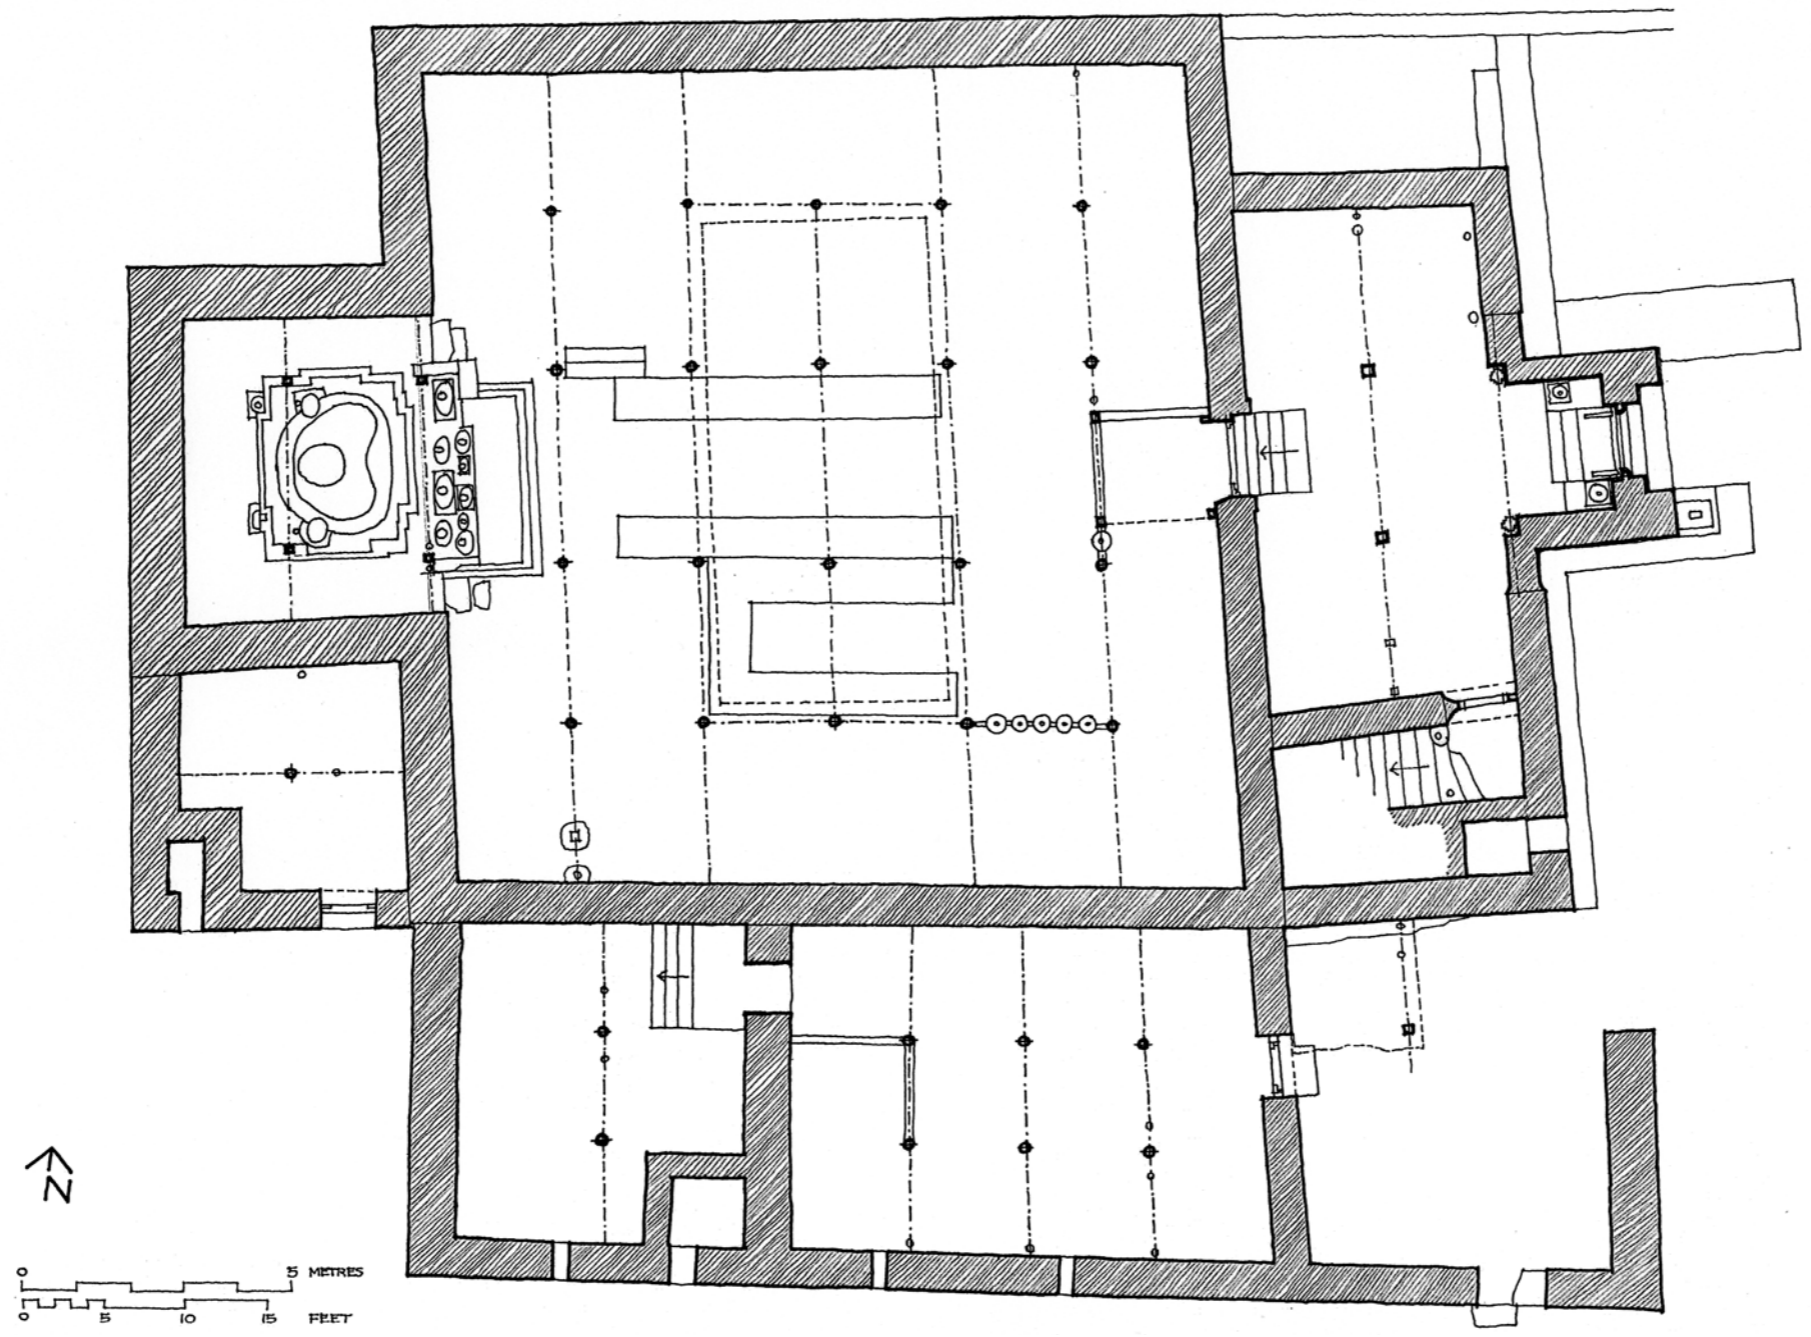
GROUND FLOOR PLAN | EXISTING CONDITIONS, 2005  
 Drawing by John Harrison
