## **SEISMIC STRENGTHENING AND RESTORATION OF GONPA GANG**

DAMAGE ASSESSMENT AND RESTORATION CONCEPT

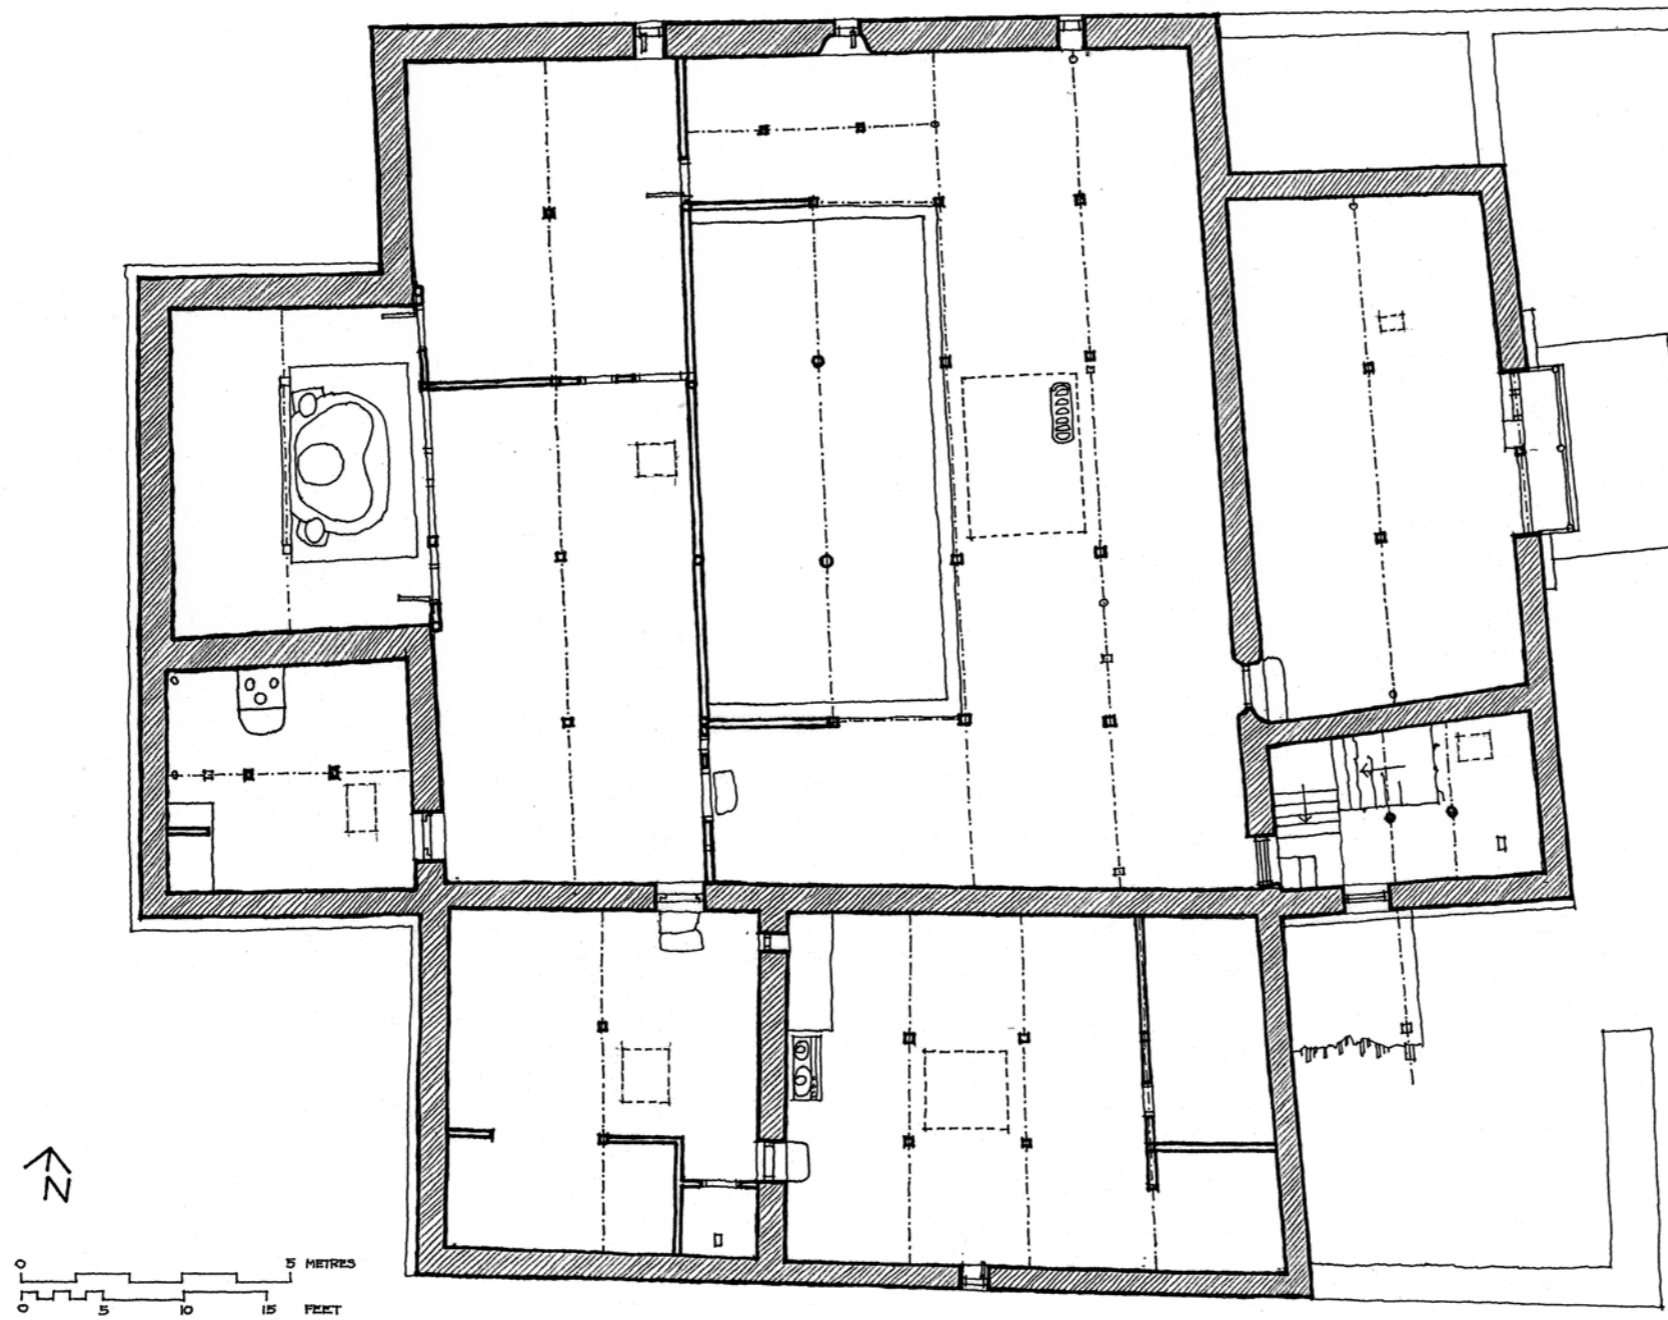
UPPER FLOOR PLAN | EXISTING CONDITIONS, 2005  
 Drawing by John Harrison

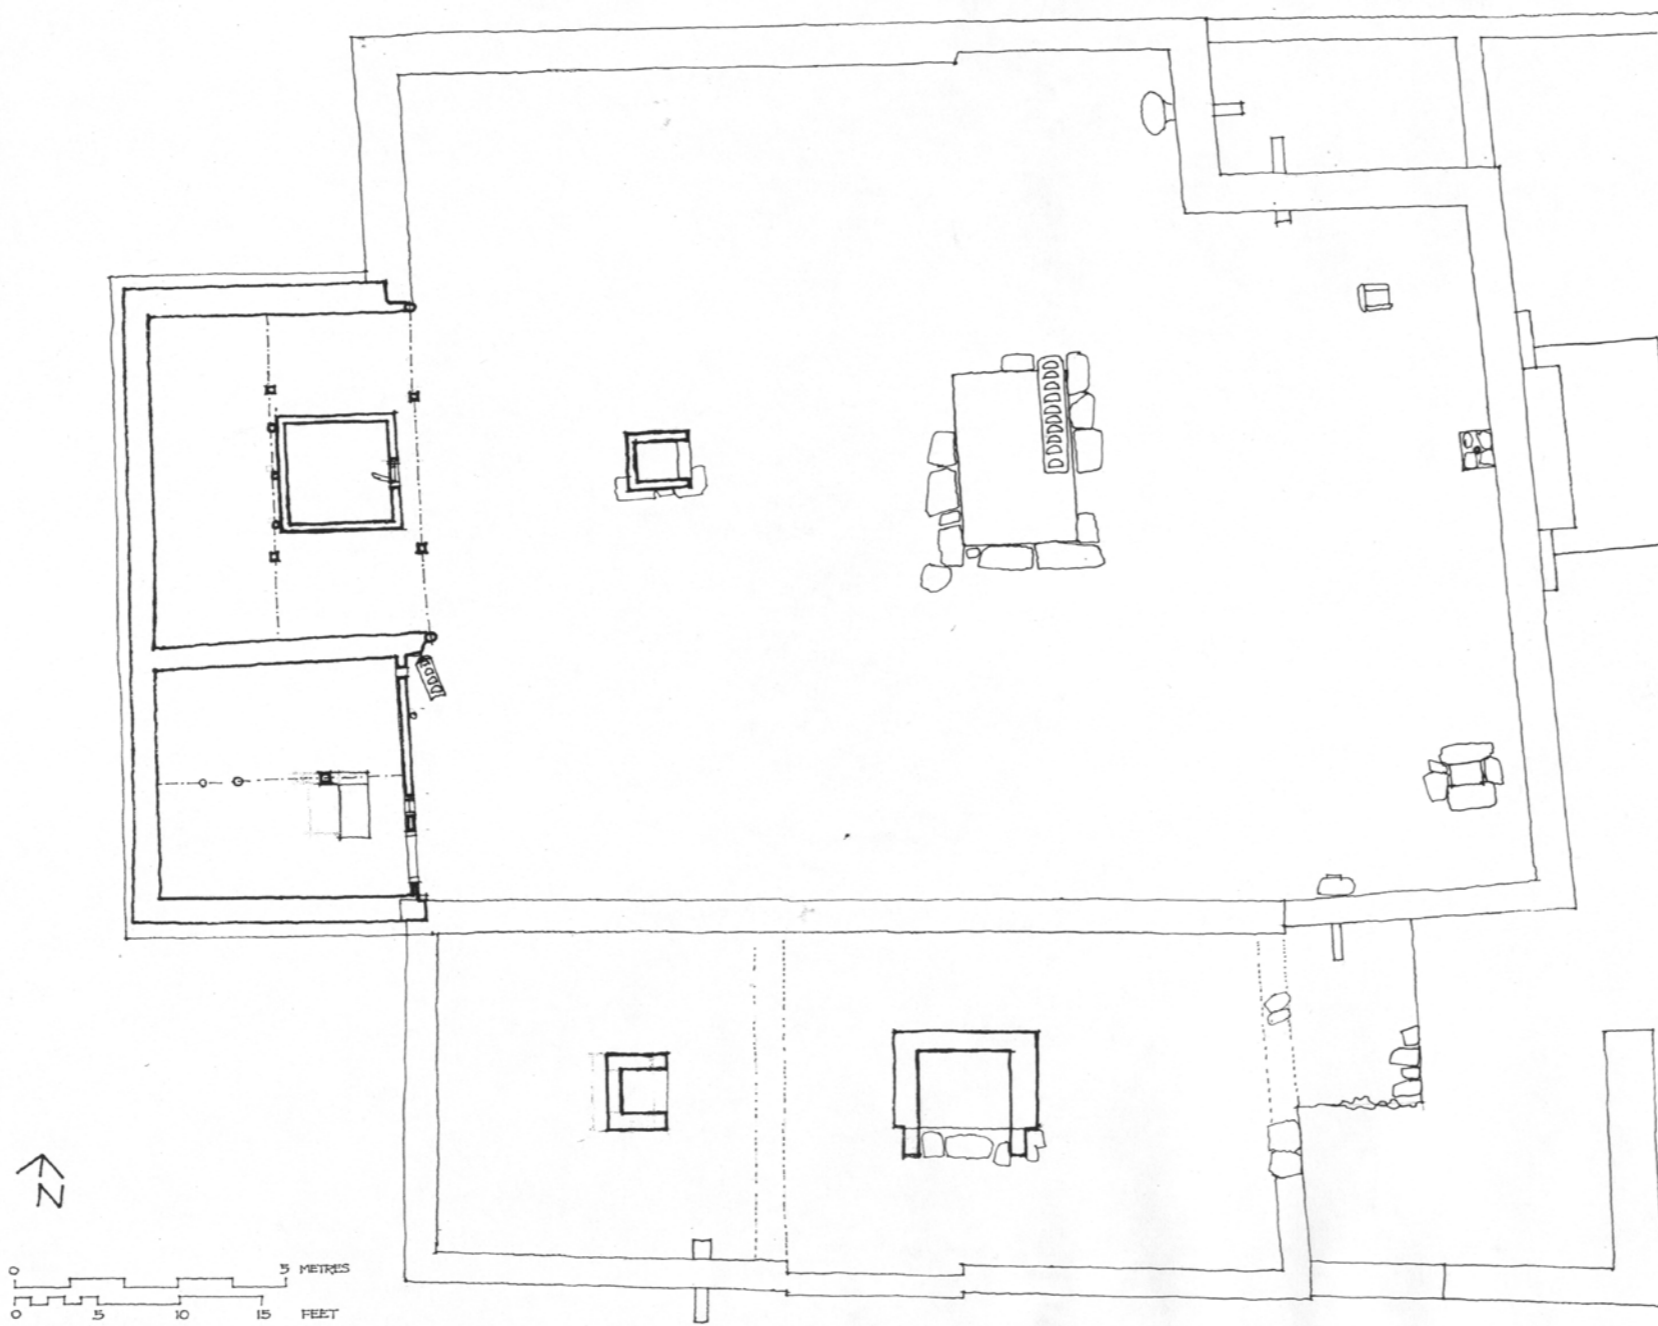
JOHN HARRISON 2005  
 GOMPA KANG  
 ROOF PLAN

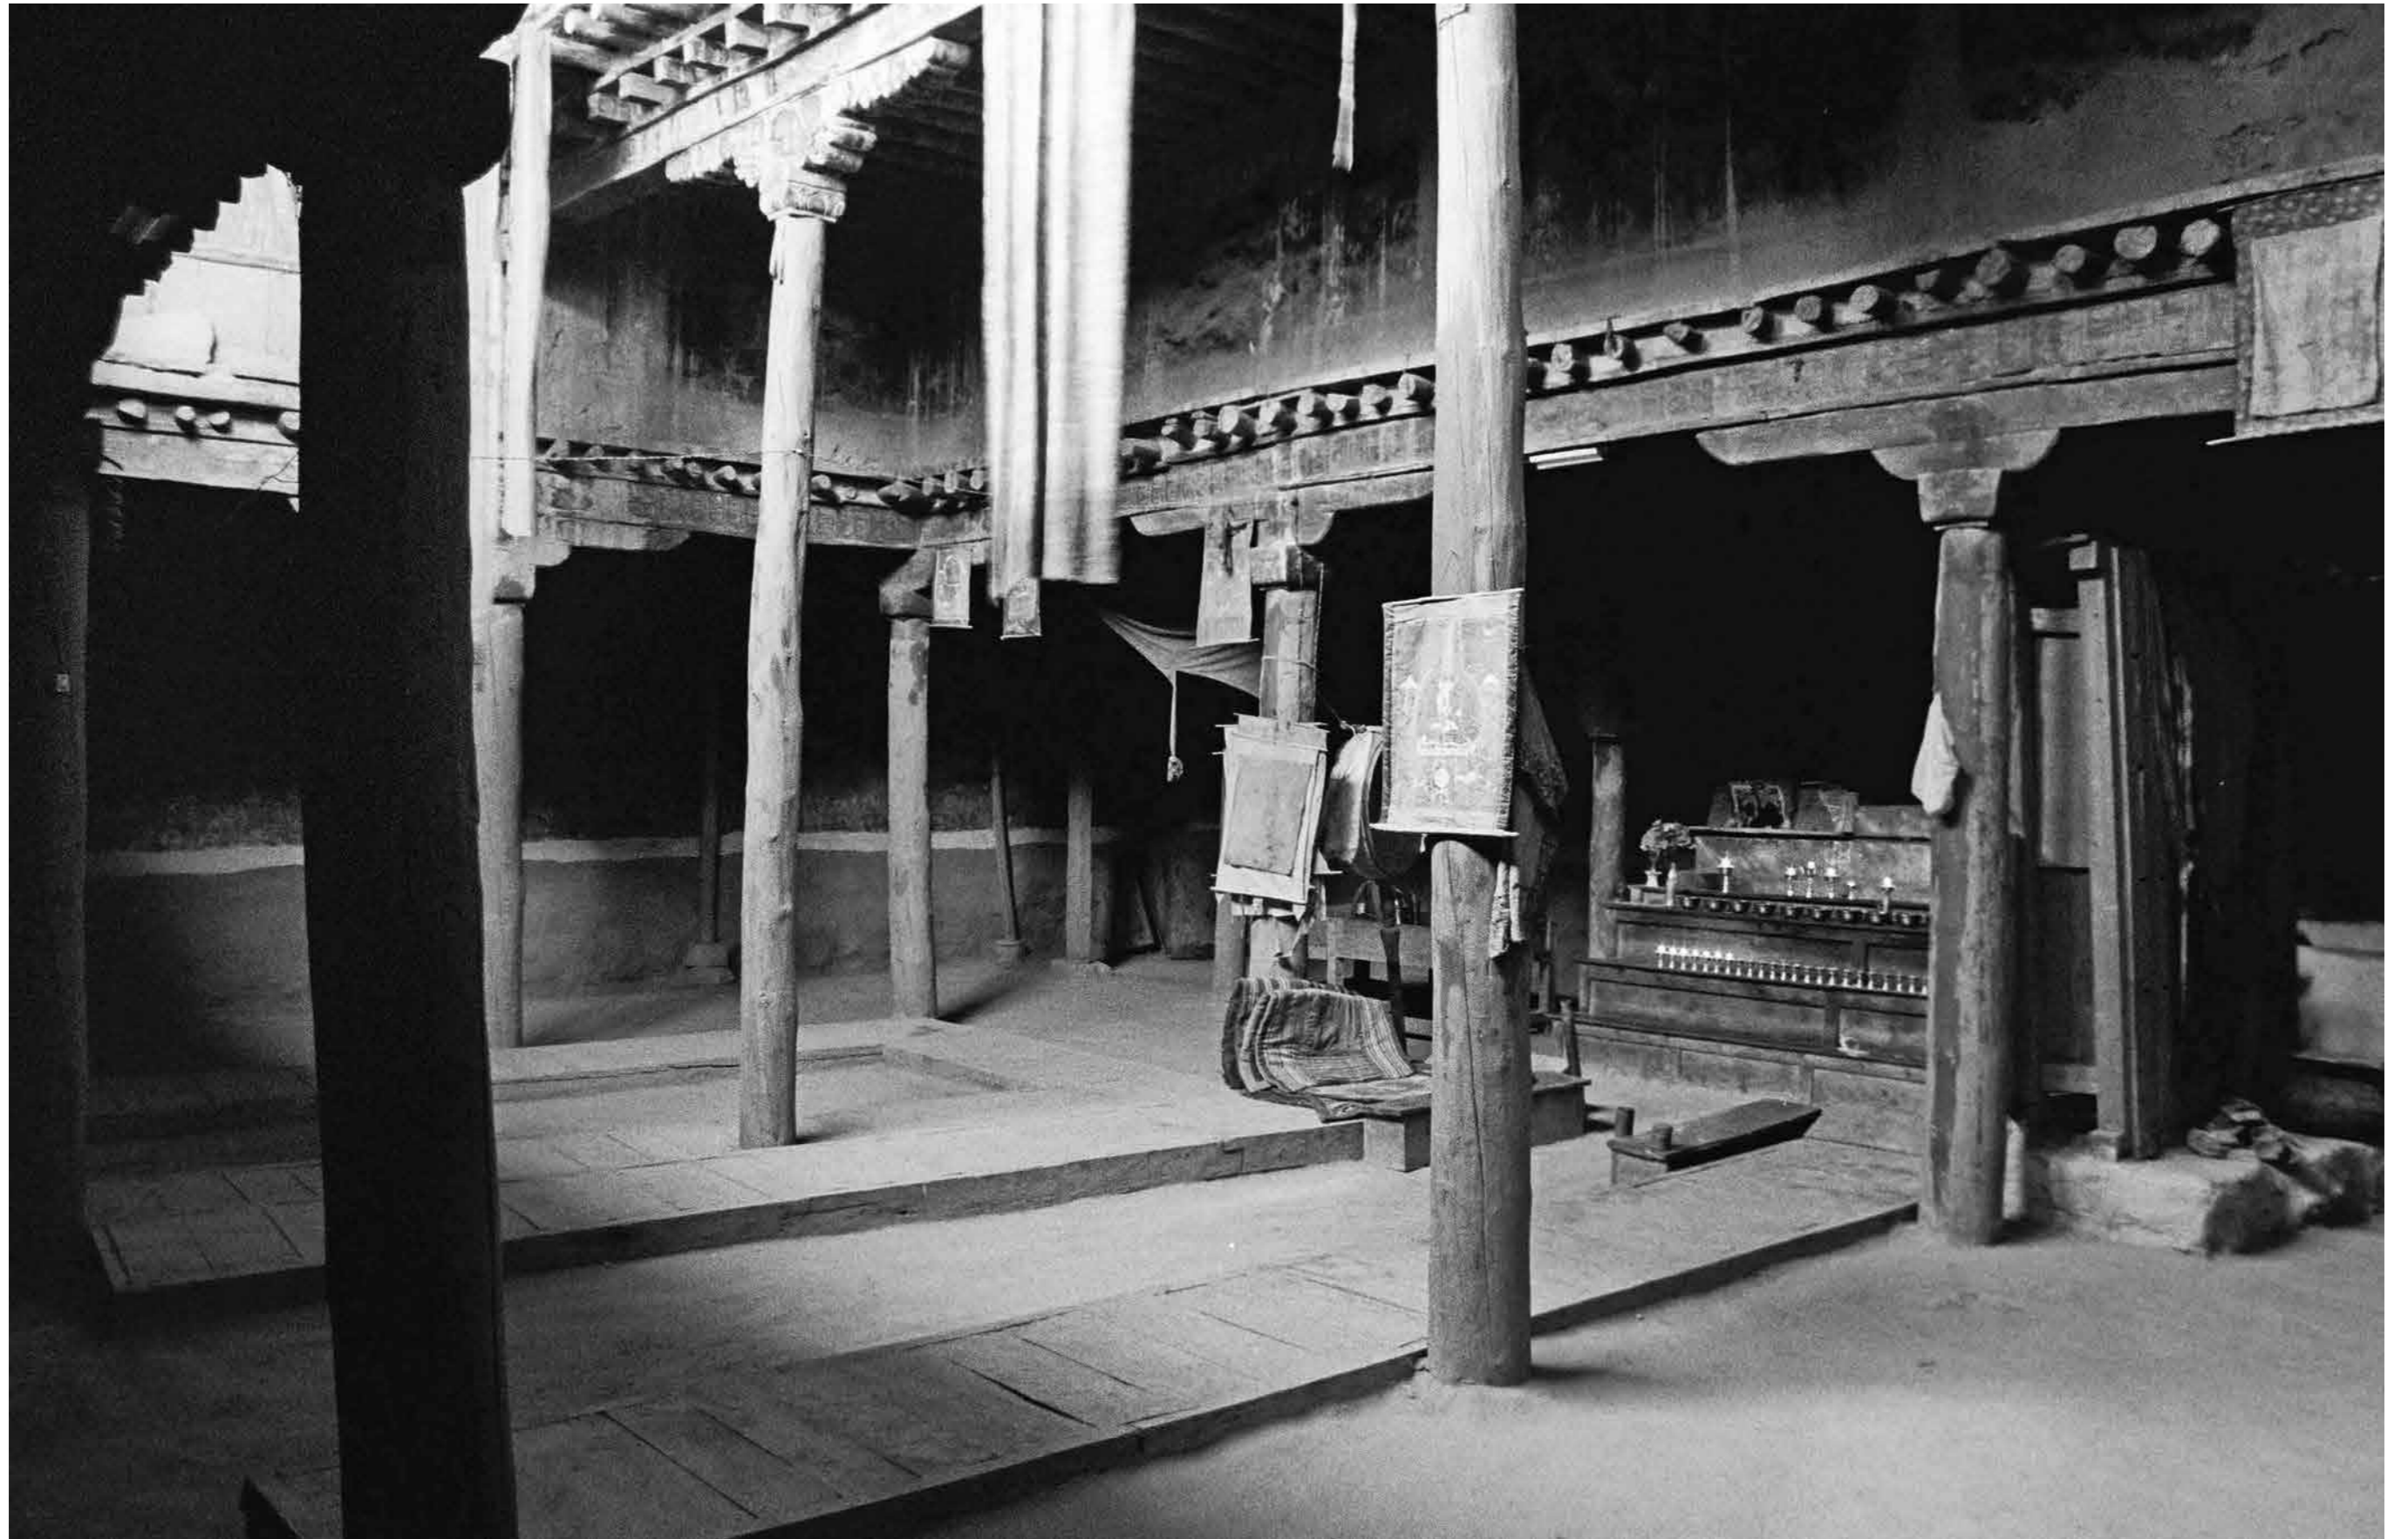
VIEW OF THE DHUKHANG  
 Photo by John Harrison, 2005

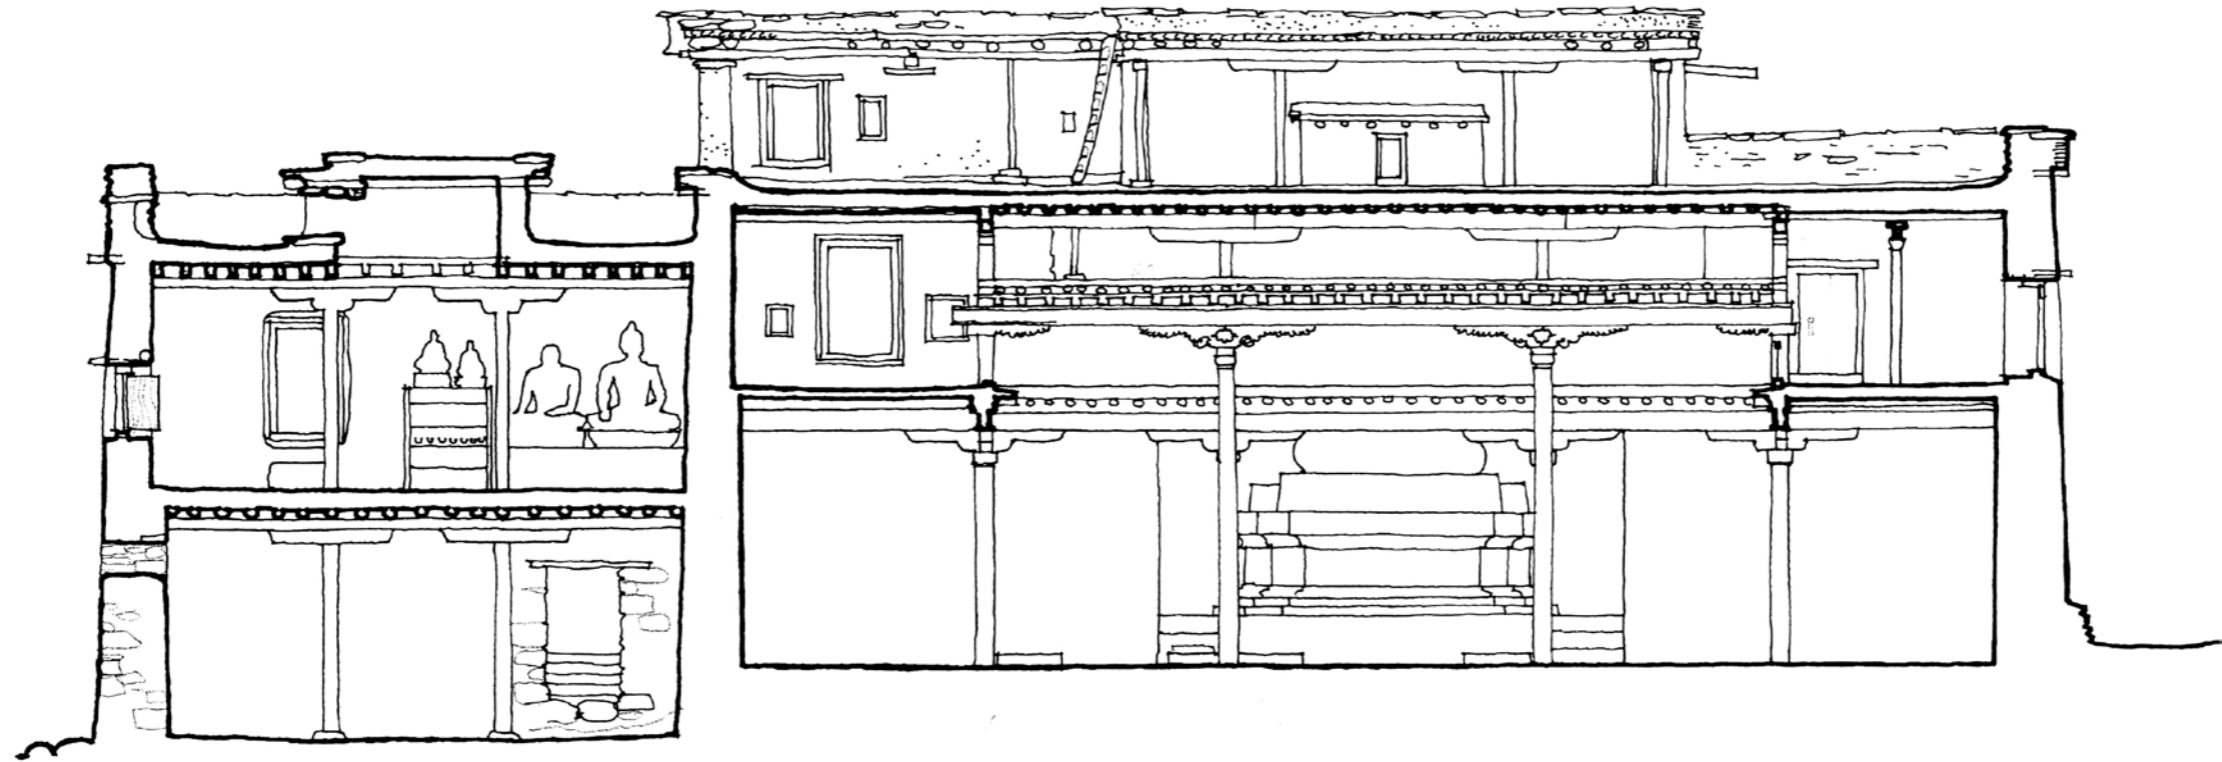
SECTION WEST-EAST | EXISTING CONDITIONS 2005  
 Drawing by John Harrison

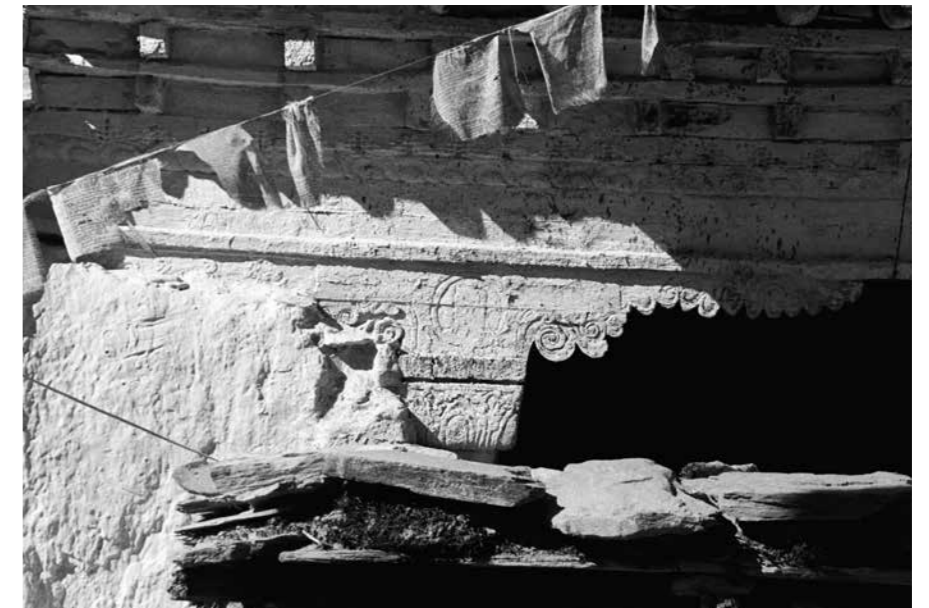
The left corner section, demarcated by a vertical crack, houses the interior staircase. It is likely a later addition. The main entrance used to be open but was at some point closed off with stone walls and a masonry porch. The balcony above has also been closed off with stone walls. By 2022 the balcony collapsed.

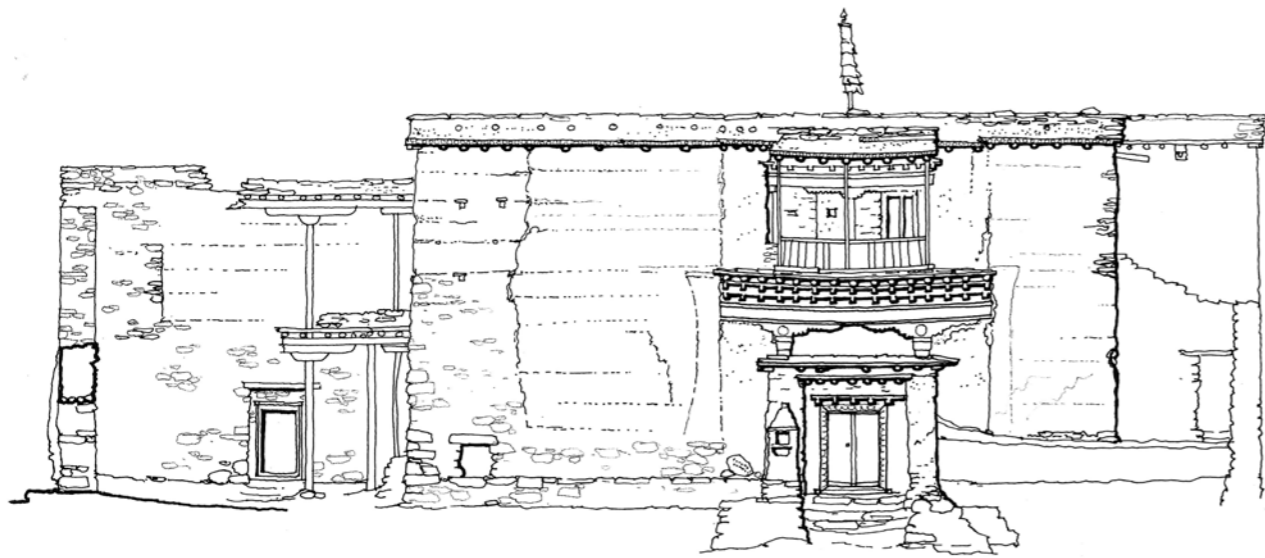
PRINCIPAL FACADE | EXISTING CONDITIONS 2005  
Drawing by John Harrison

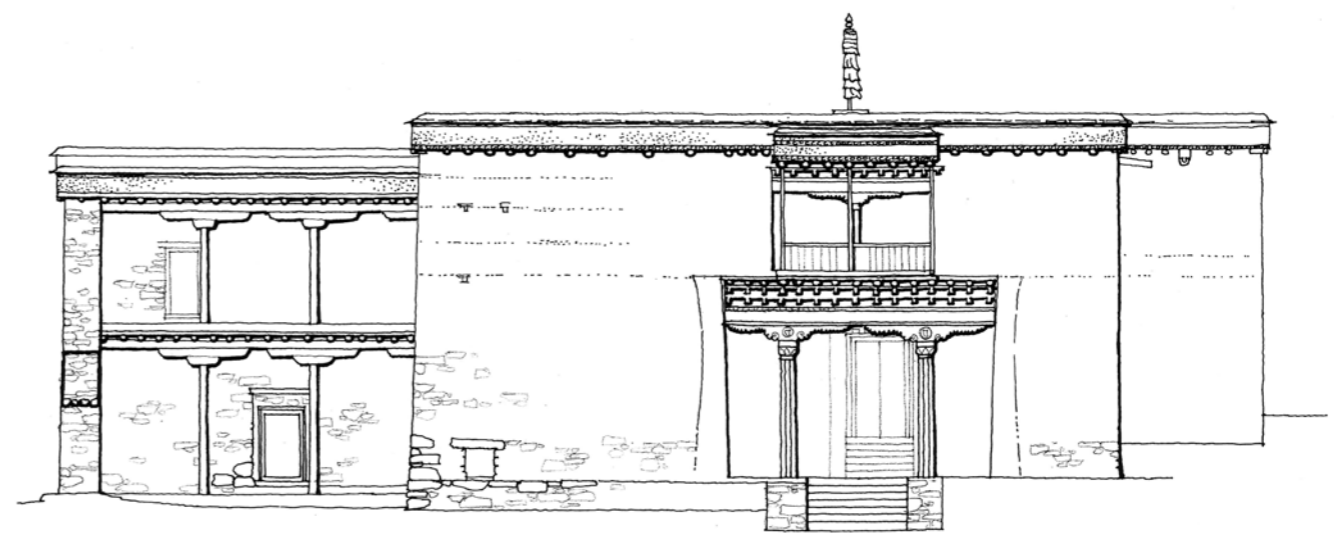
PRINCIPAL FACADE | PROPOSED RESTORATION  
Drawing by John Harrison

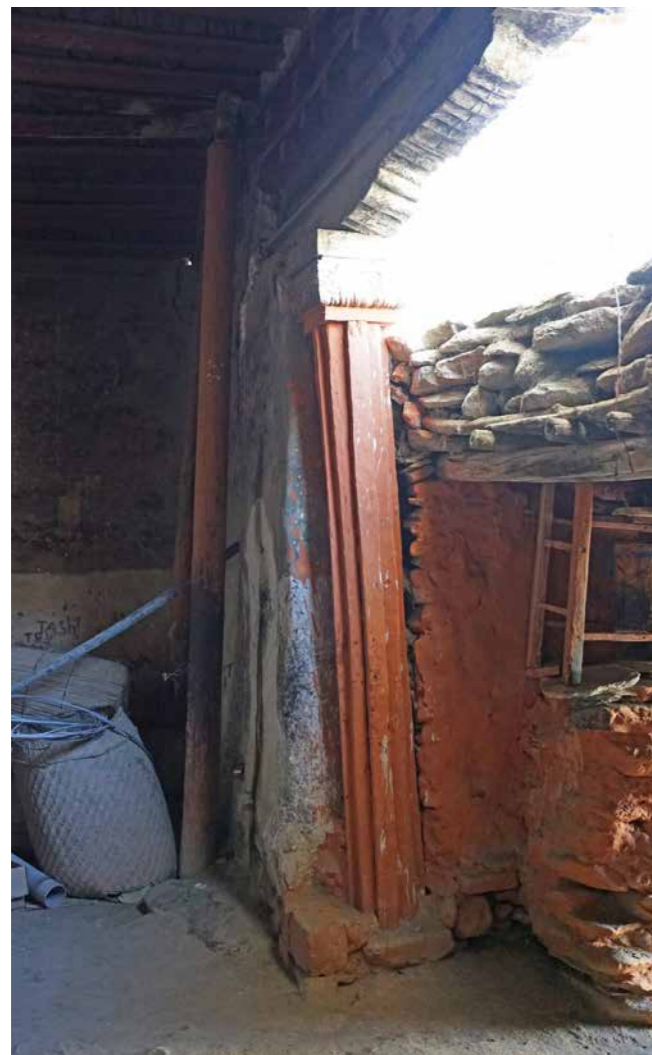
**CROSS BEAM AND TEMPORARY SUPPORTS**  
The badly damaged column is not original to the buildings. It leans to the left whereas the capital has tilted in the opposite direction. The base stone was obviously only temporarily

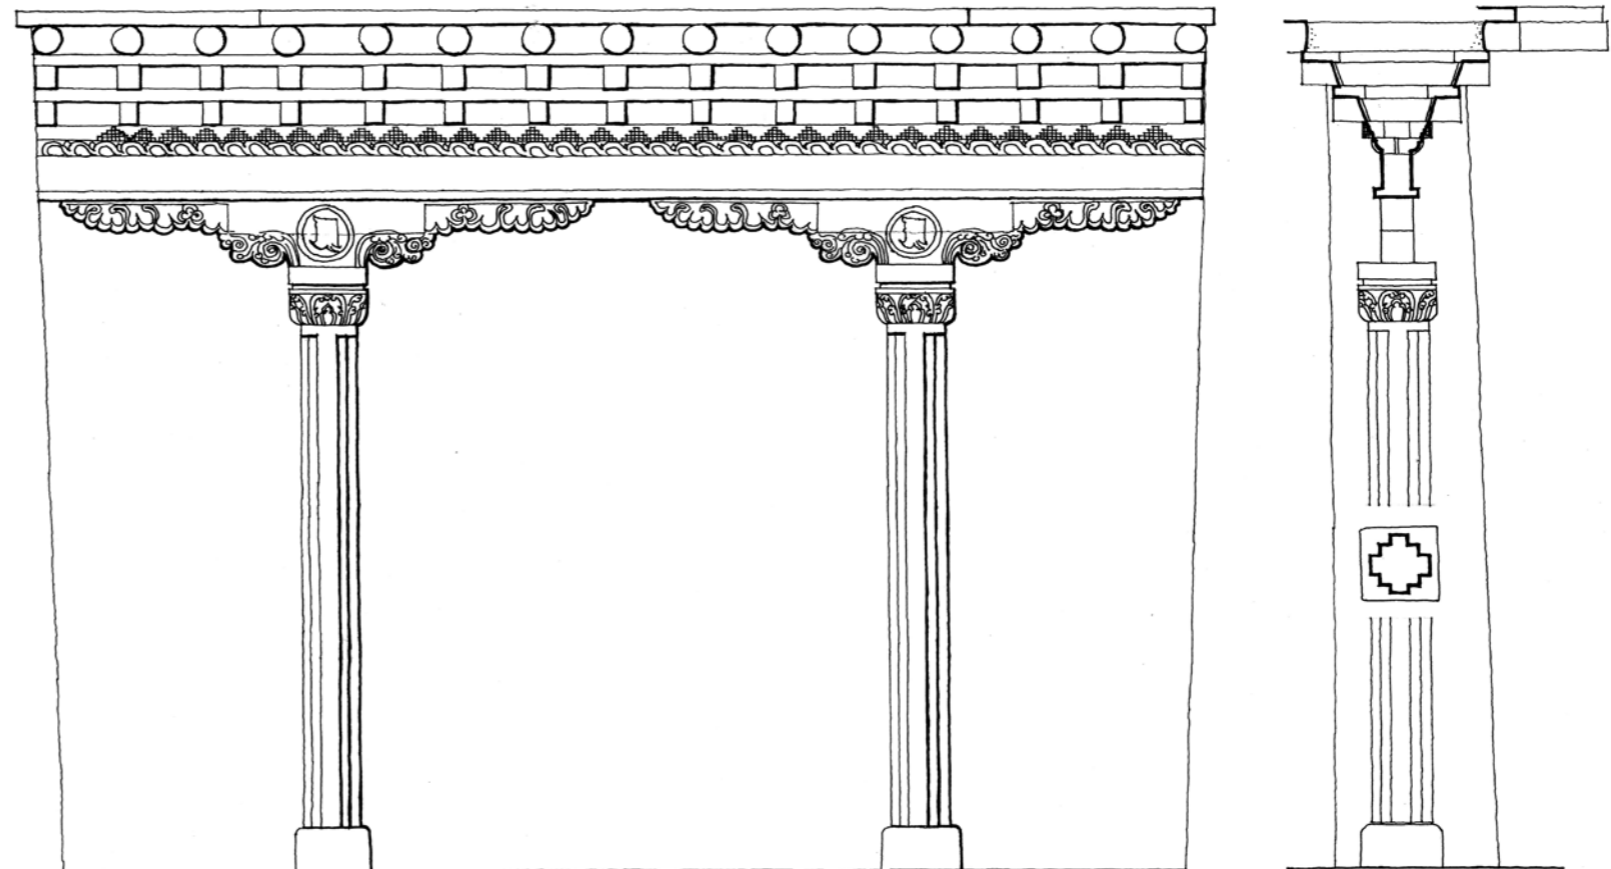
placed there. The entire assembly is in need of complete reconstruction including a new foundation for the pillar to support the weight of the balcony and roof above.

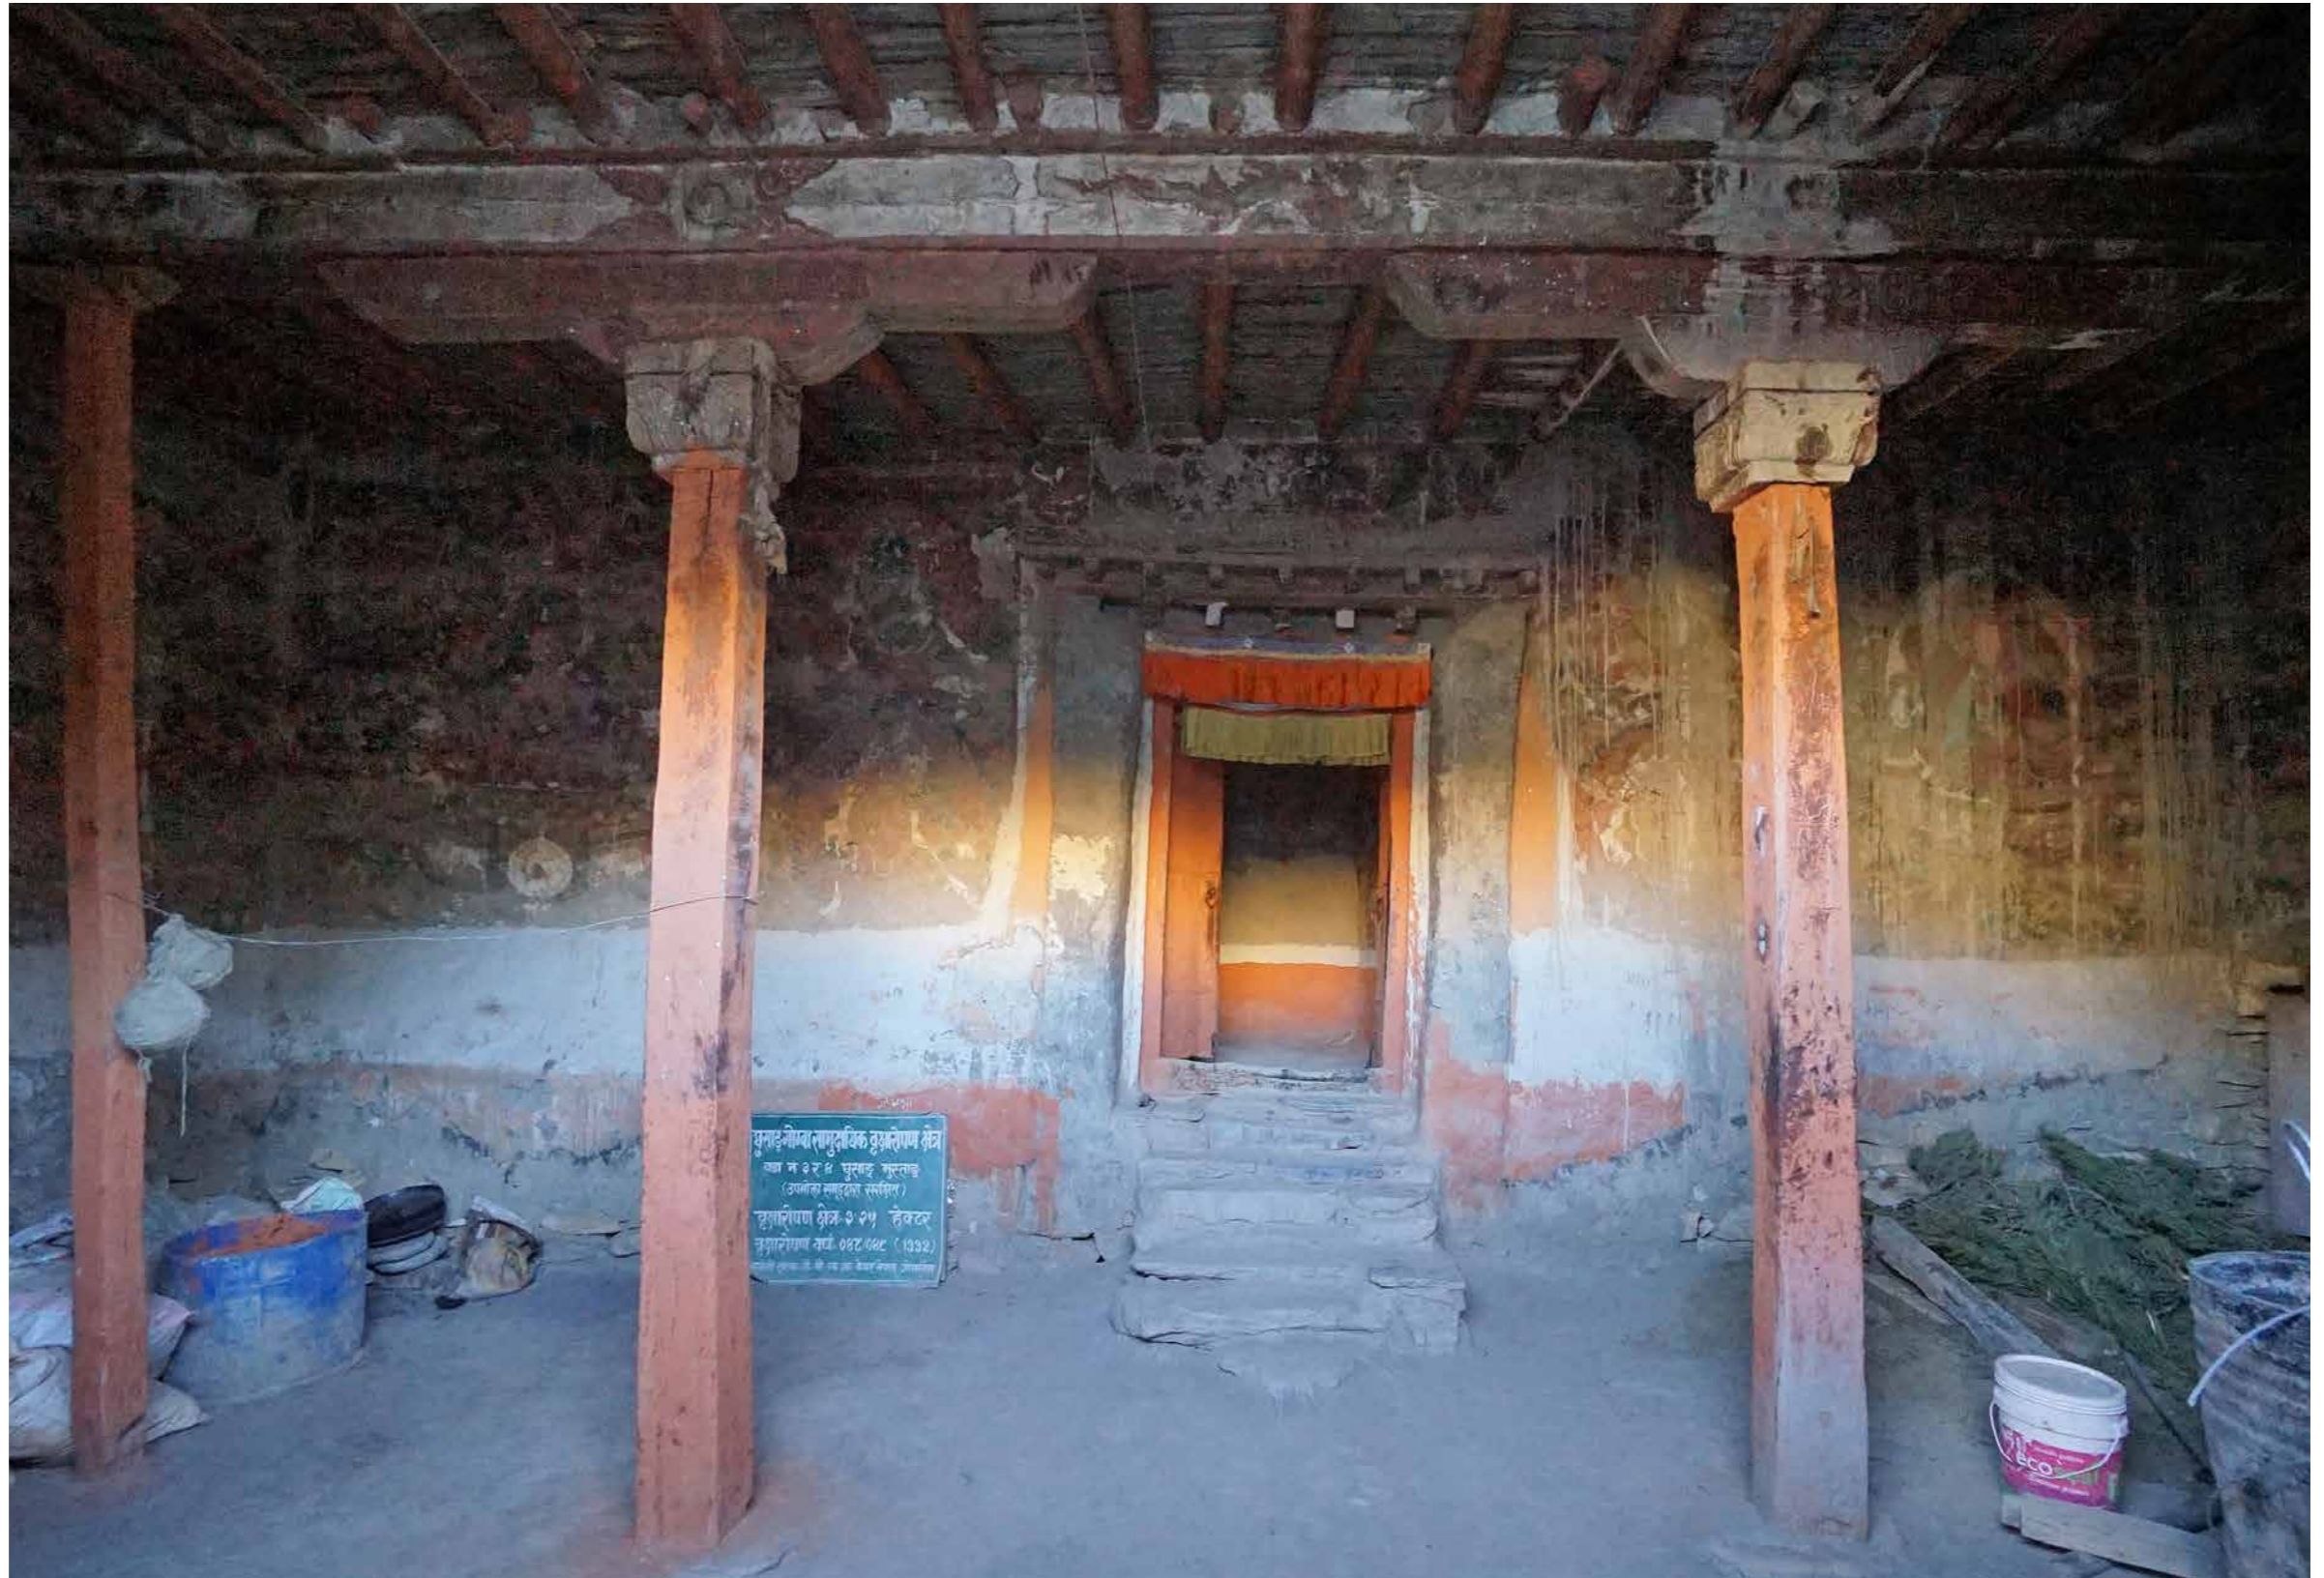
#### CENTRAL PILLARS AND CROSS BEAMS

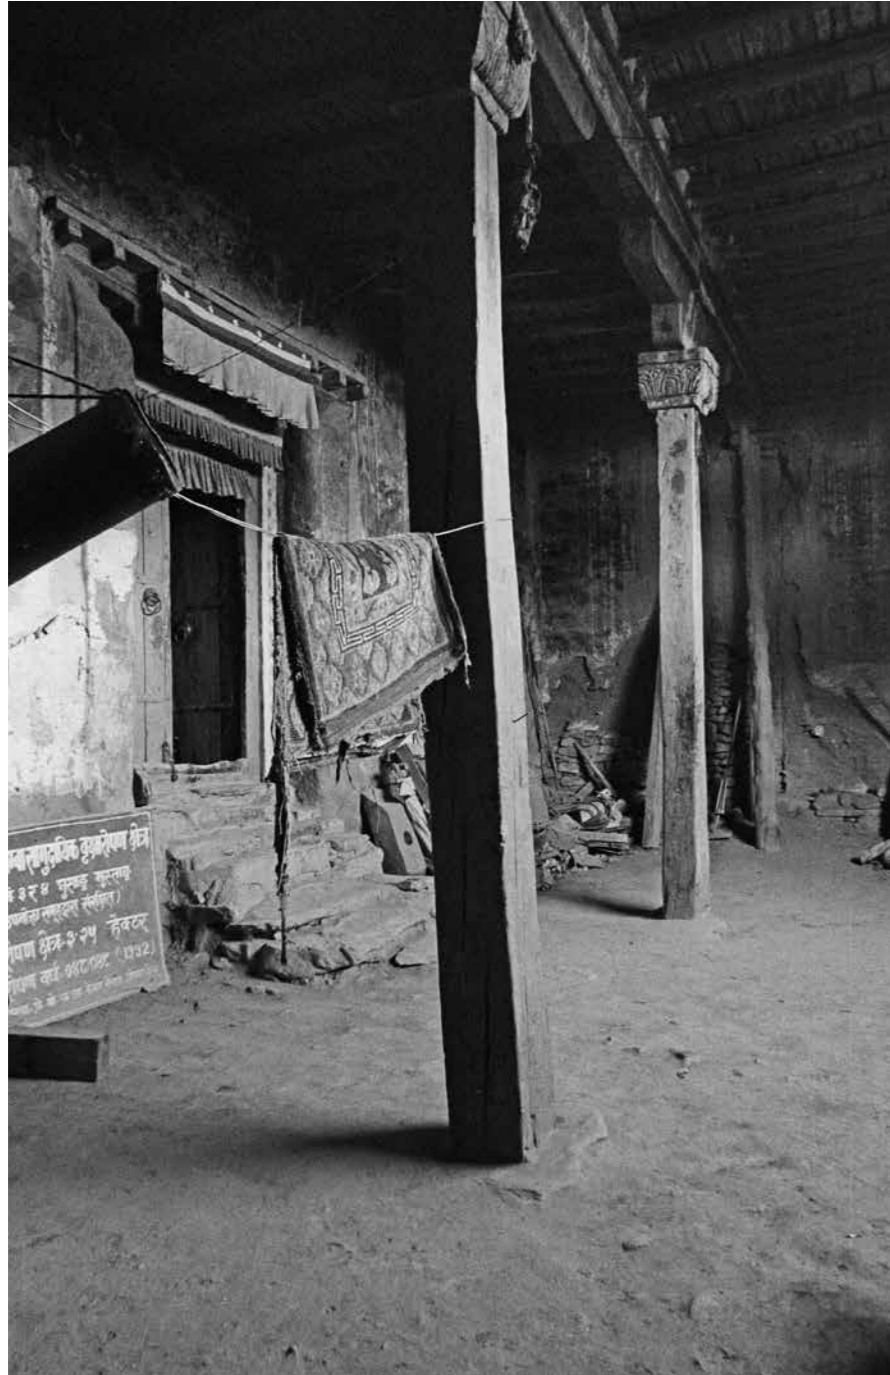
**VIEW FROM SOUTH**  
 Photo by John Harrison, 2005  
 As can be seen in this photo, the severe damage and erosion of the rammed earth walls dates back more than 20 years.

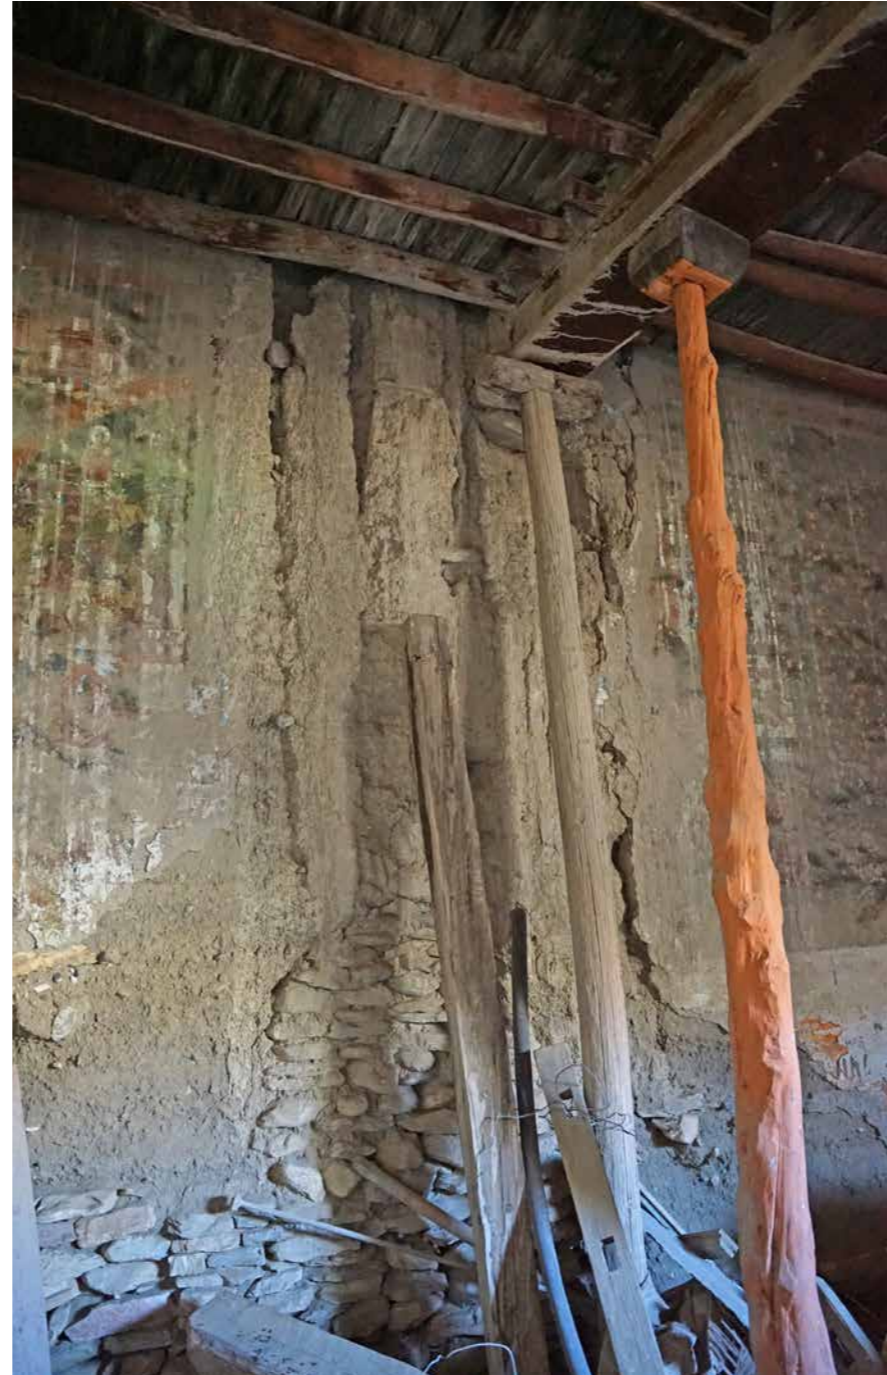
**DAMAGE UNDER THE MAIN BEAM**  
 Many years of leaks from a damaged water spout two floors above have severely eroded the wall and completely destroyed the wall paintings. The rammed earth wall was partly filled in with rocks and the main beam supported by makeshift supports.

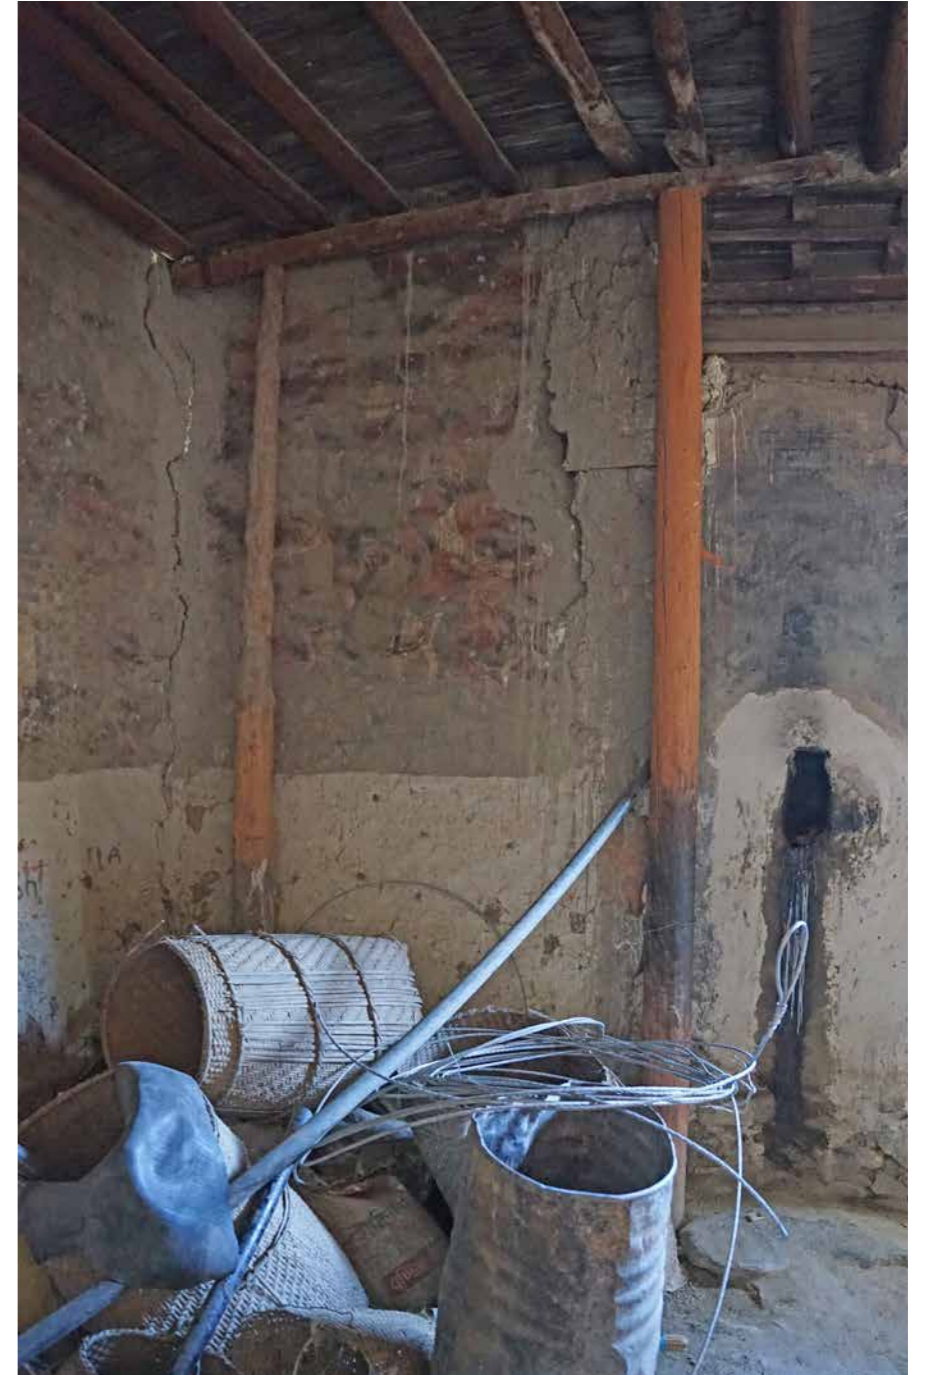
**SEPARATED WALLS**  
 Light can be seen through the vertical crack indicating outward movement of the south wall. The round joists are damaged by wet rot and have been shored up.
