## **SEISMIC STRENGTHENING AND RESTORATION OF GONPA GANG**

DAMAGE ASSESSMENT AND RESTORATION CONCEPT

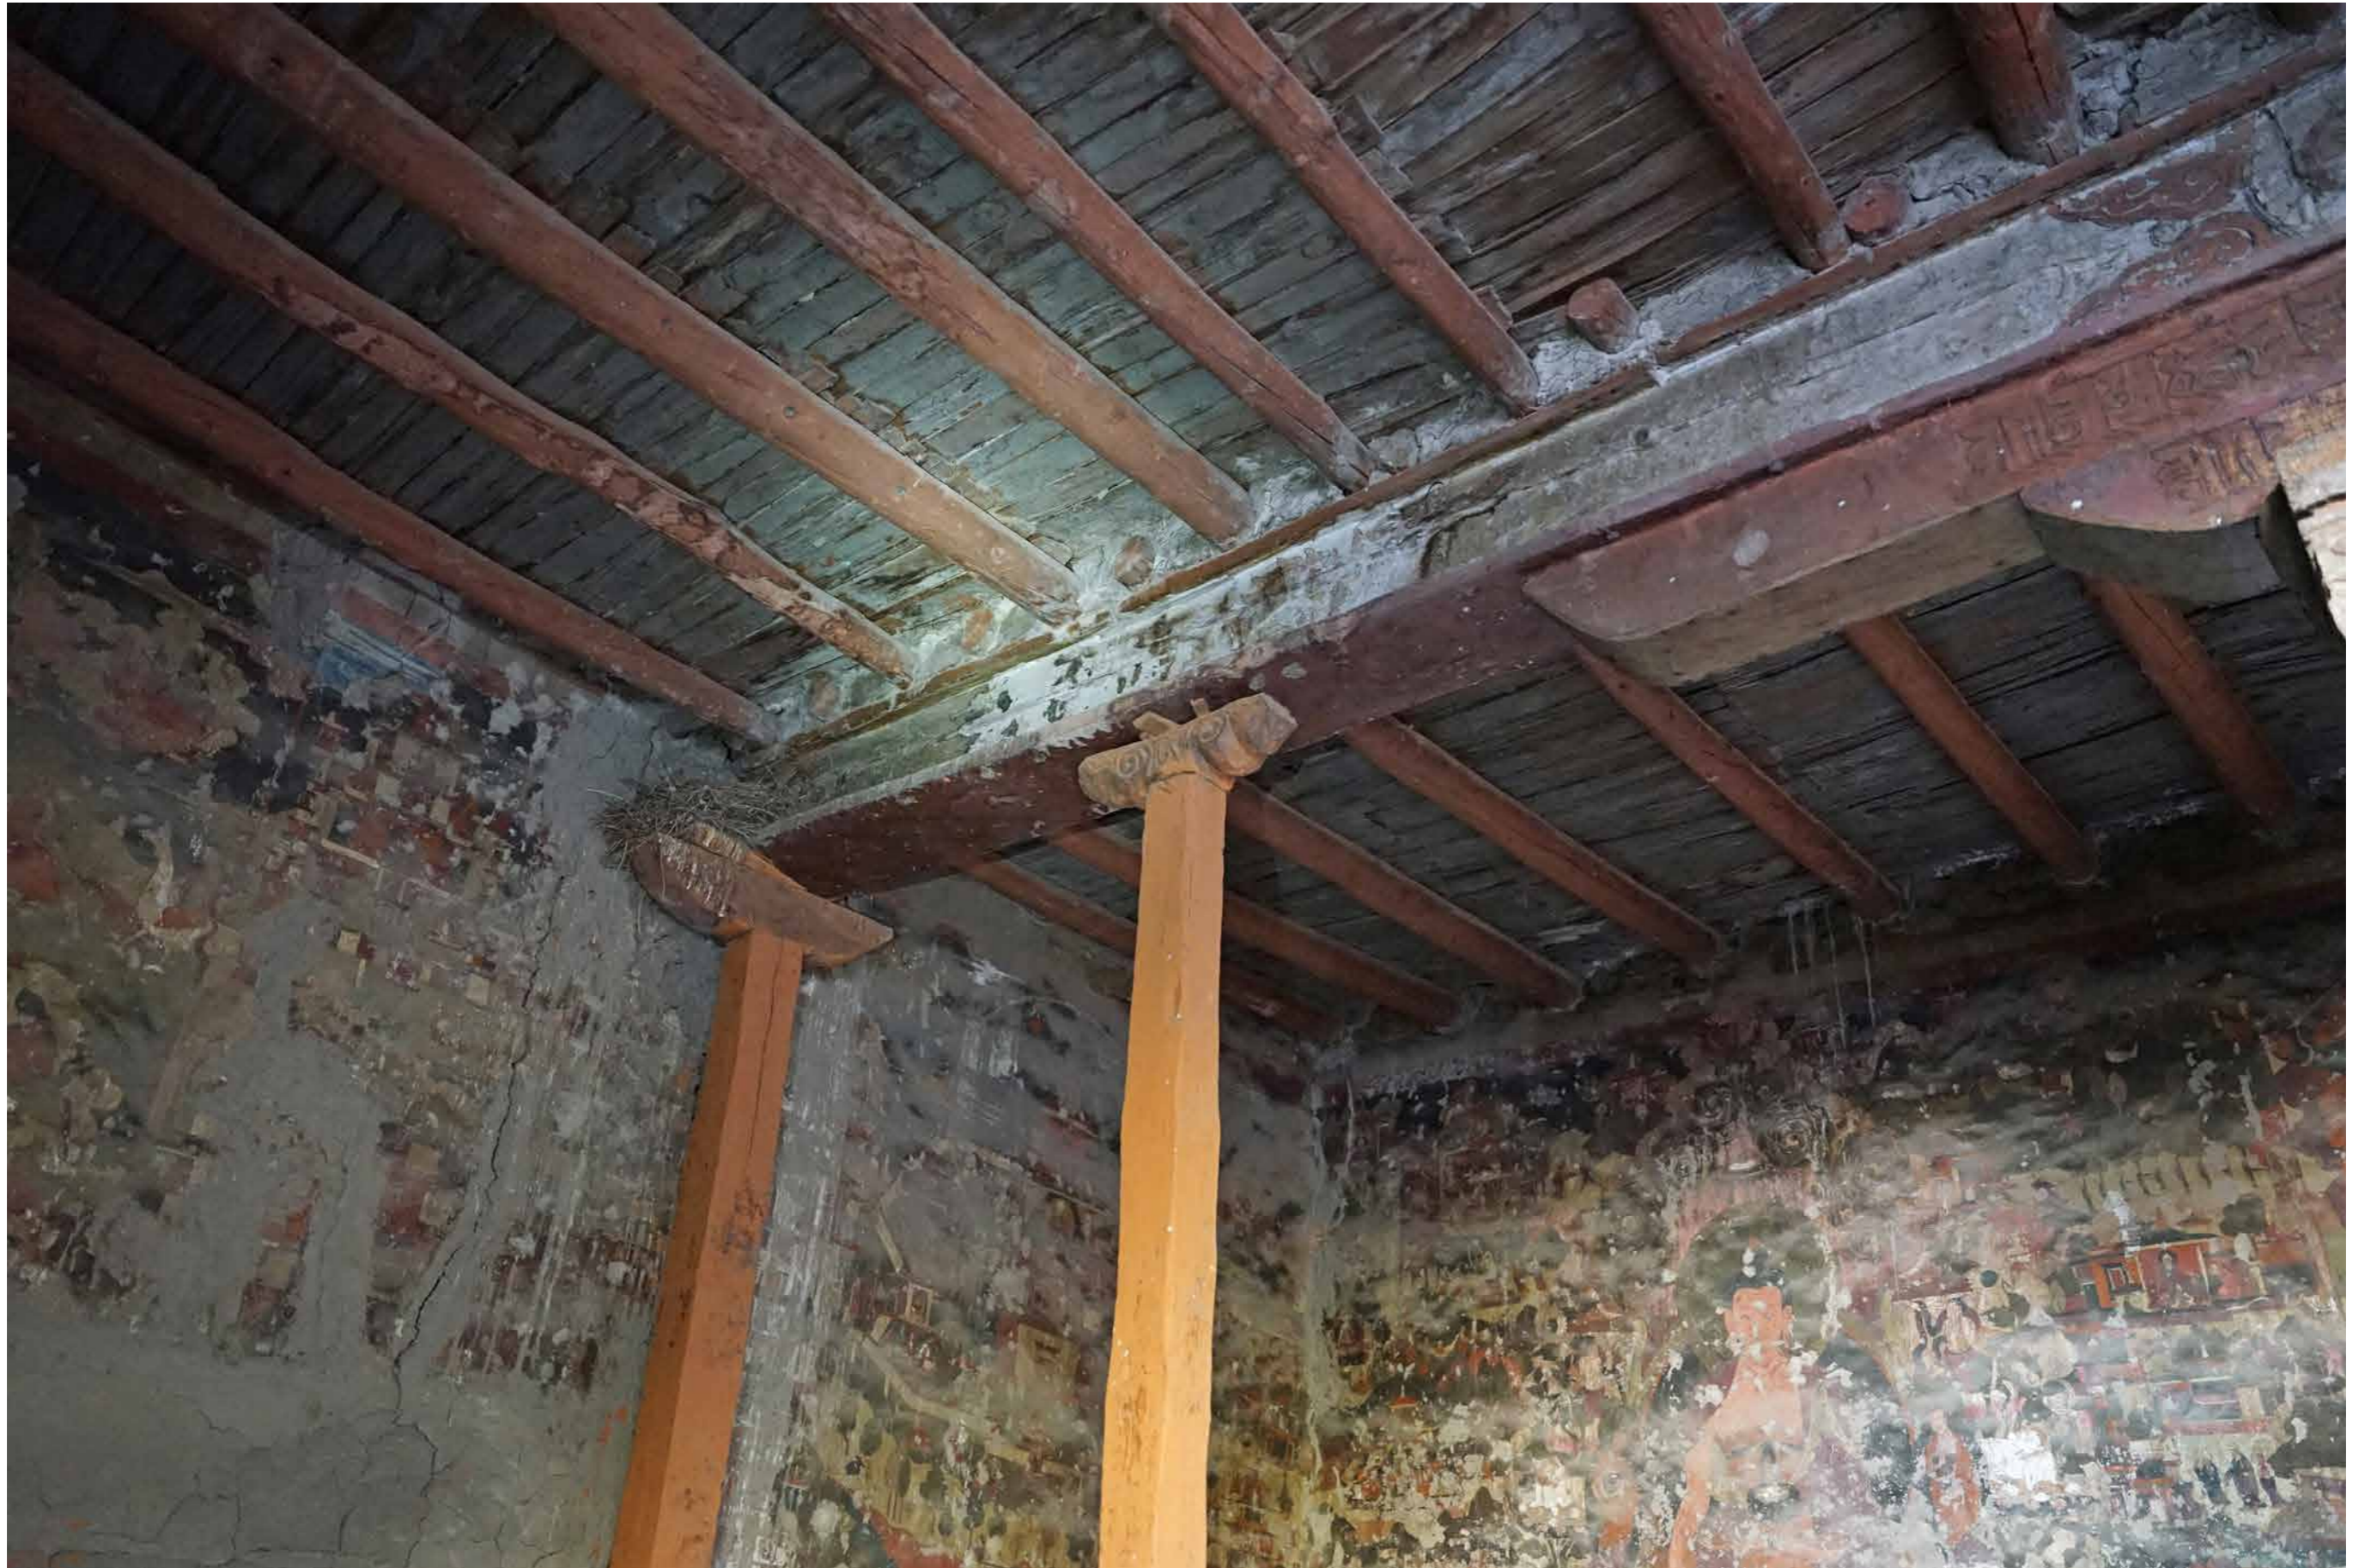
**SEPARATED WALLS**  
 Light can be seen through the vertical crack indicating outward movement of the south wall. The round joists are damaged by wet rot and have been shored up.

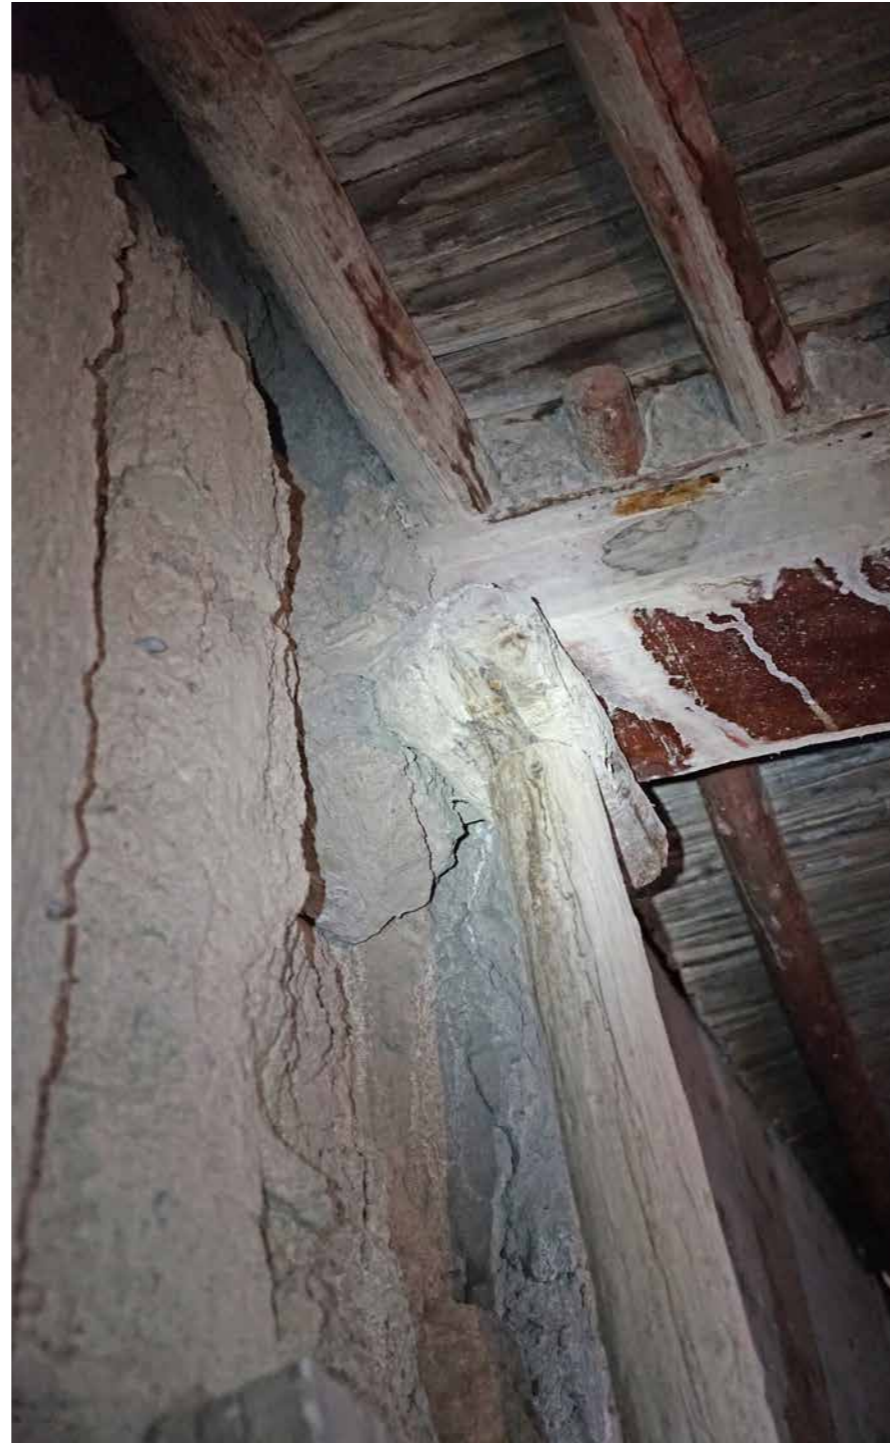
**DETAIL OF THE NORTH WALL AND BEAM**  
The wall has been eroded to a point that is can't provide sufficient bearing for the cross beam. The beam is currently held up by a temporary prop.

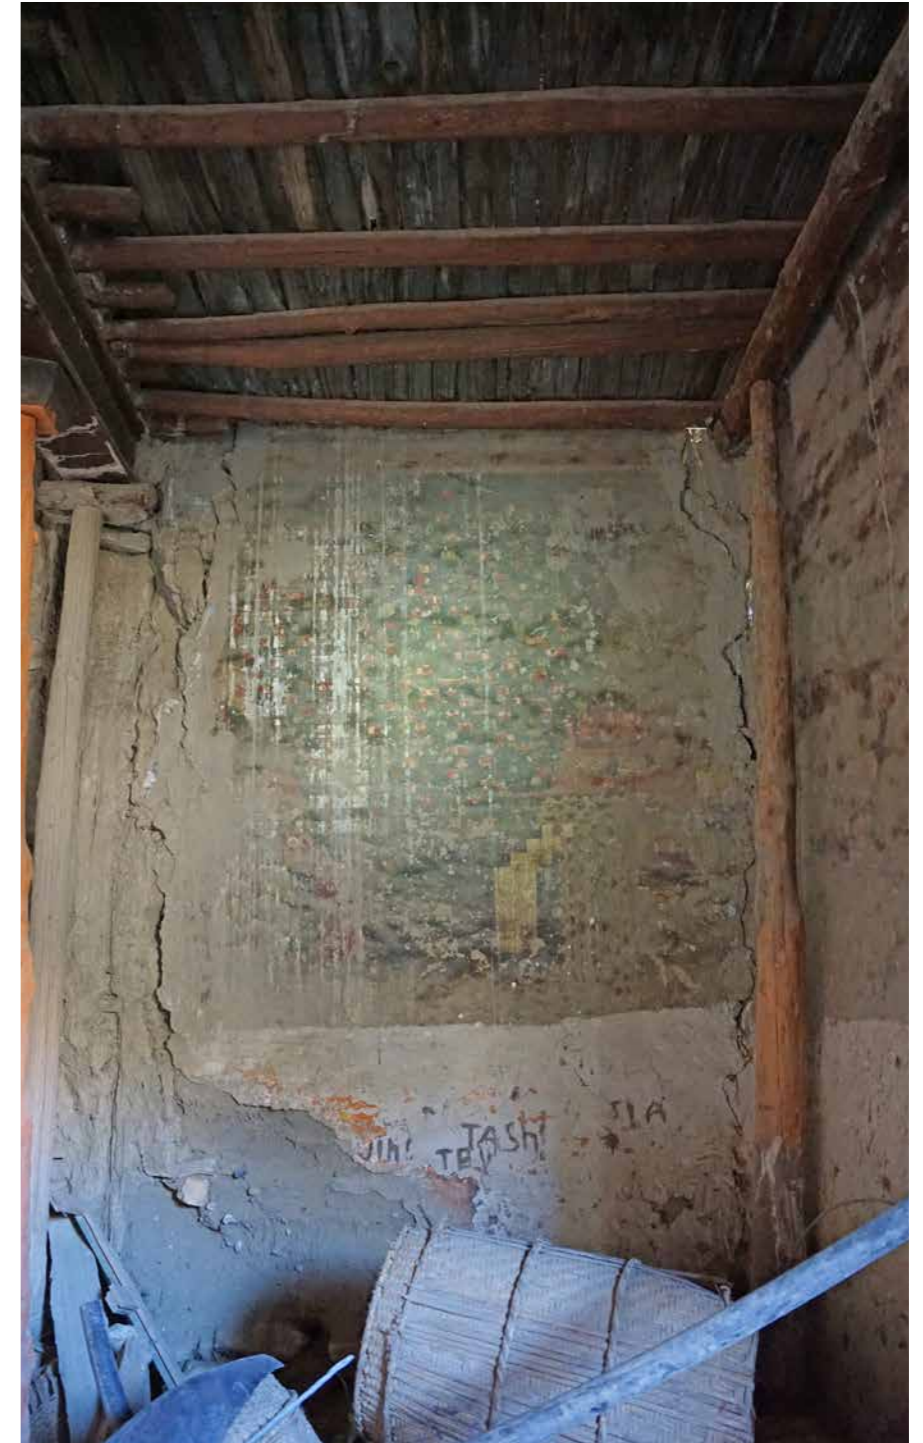
**NORTH-EAST CORNER OF THE PORTAL**  
Severe water infiltration has damaged the main beam and round joists beyond repair. Similar to the situation in the south of the room, here the beam is also temporarily supported by two

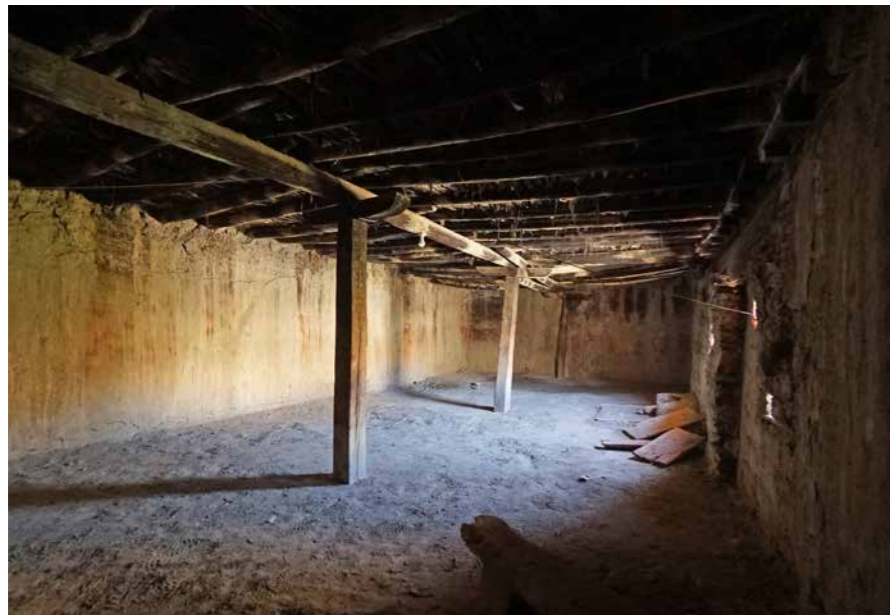
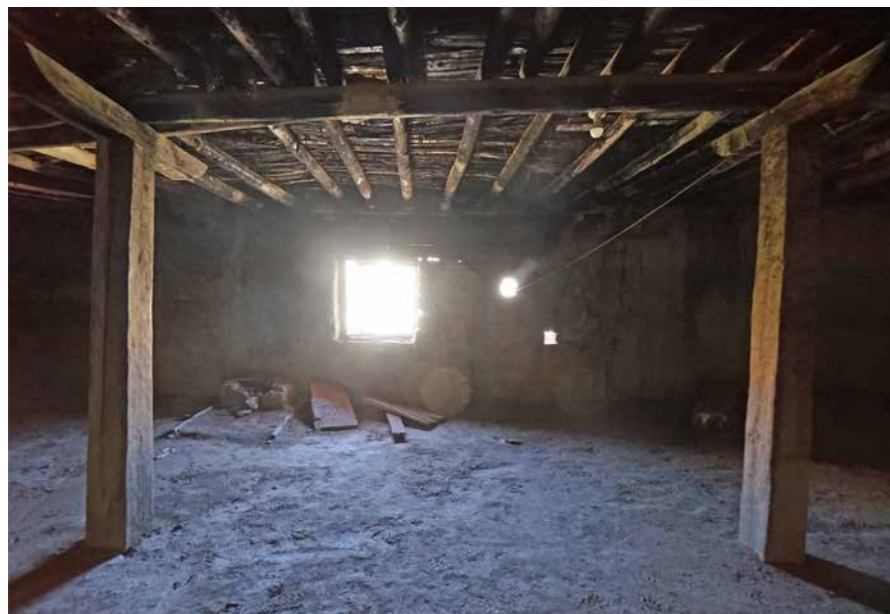
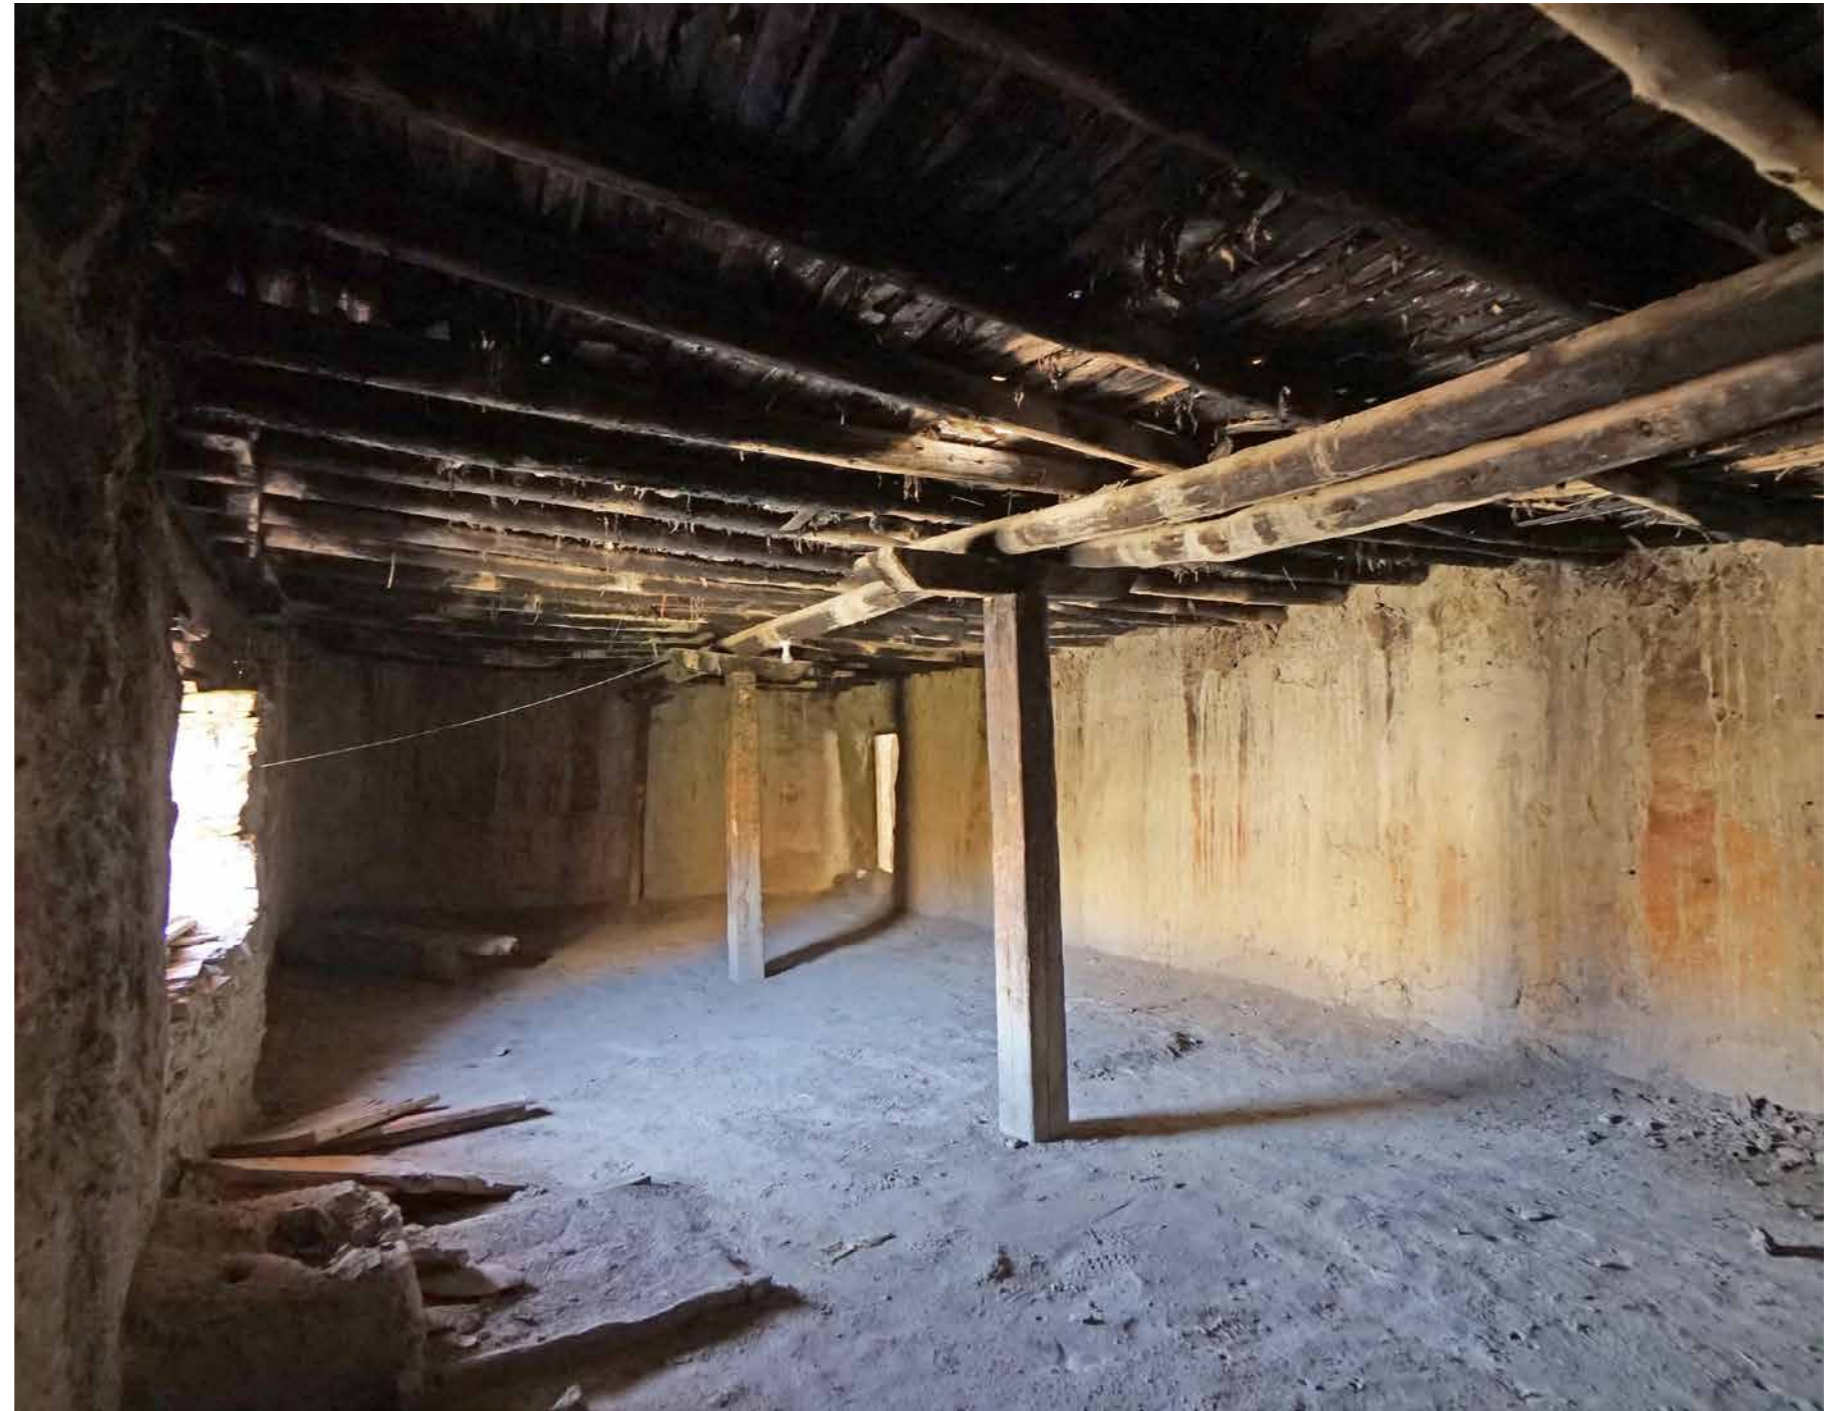
**FORMER RECEPTION ROOM**  
This empty room has not been used for a long time. It is planned to restore it with a new timber structure and a large opening to the balcony protected by 4 doors with glass panes.

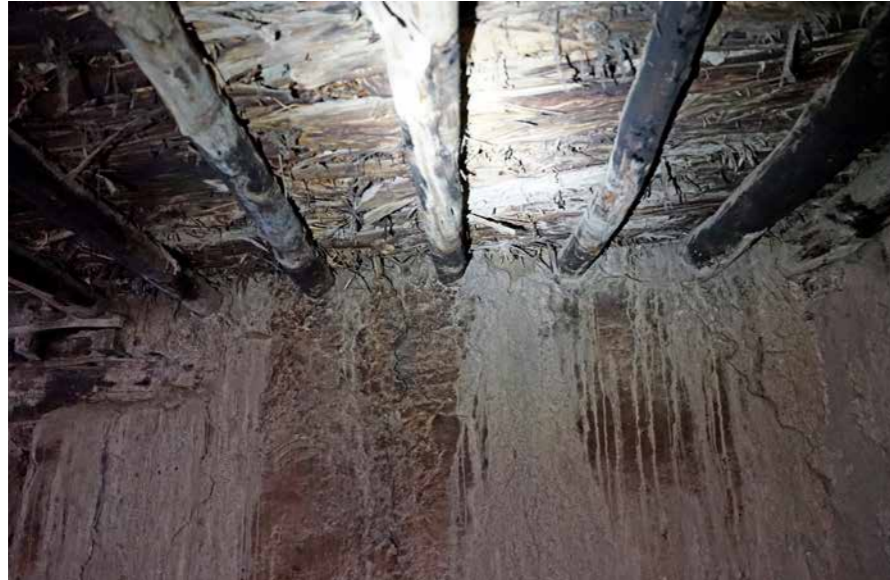
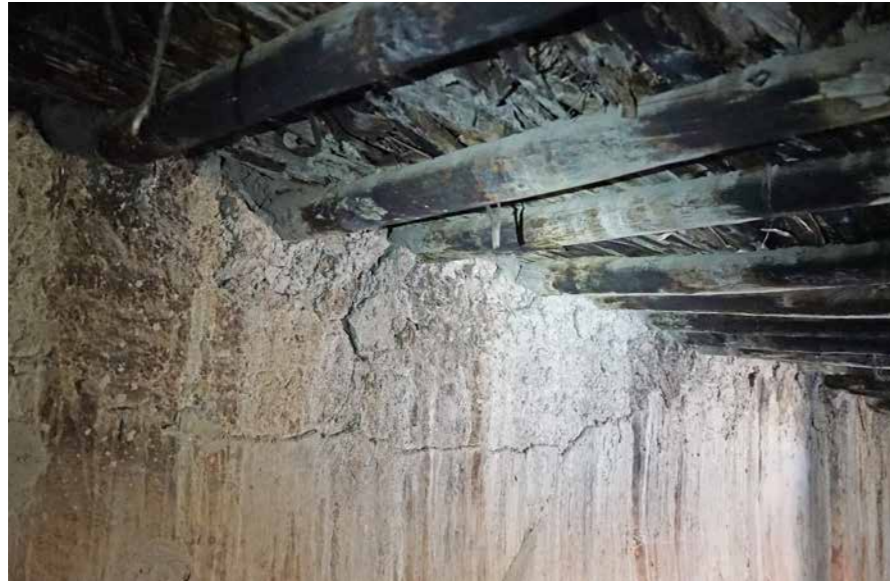
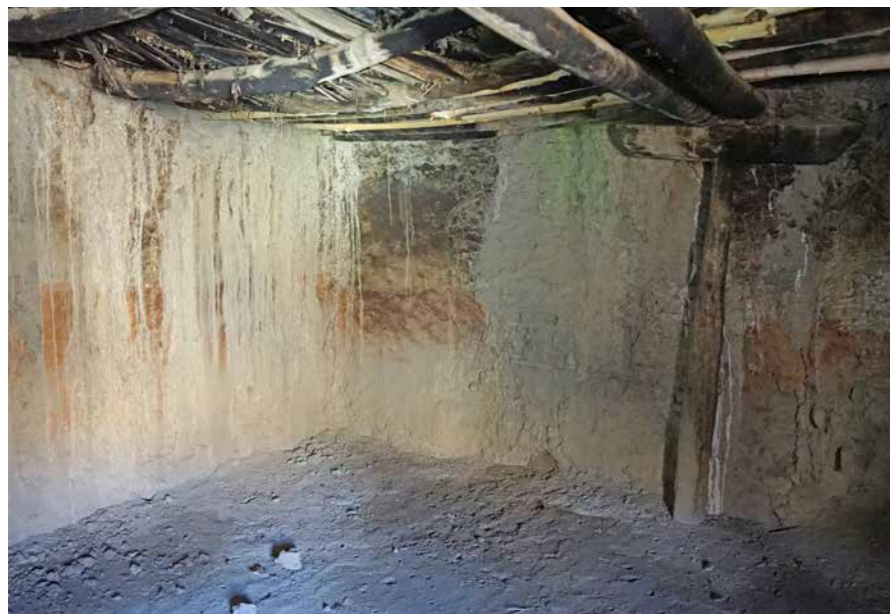
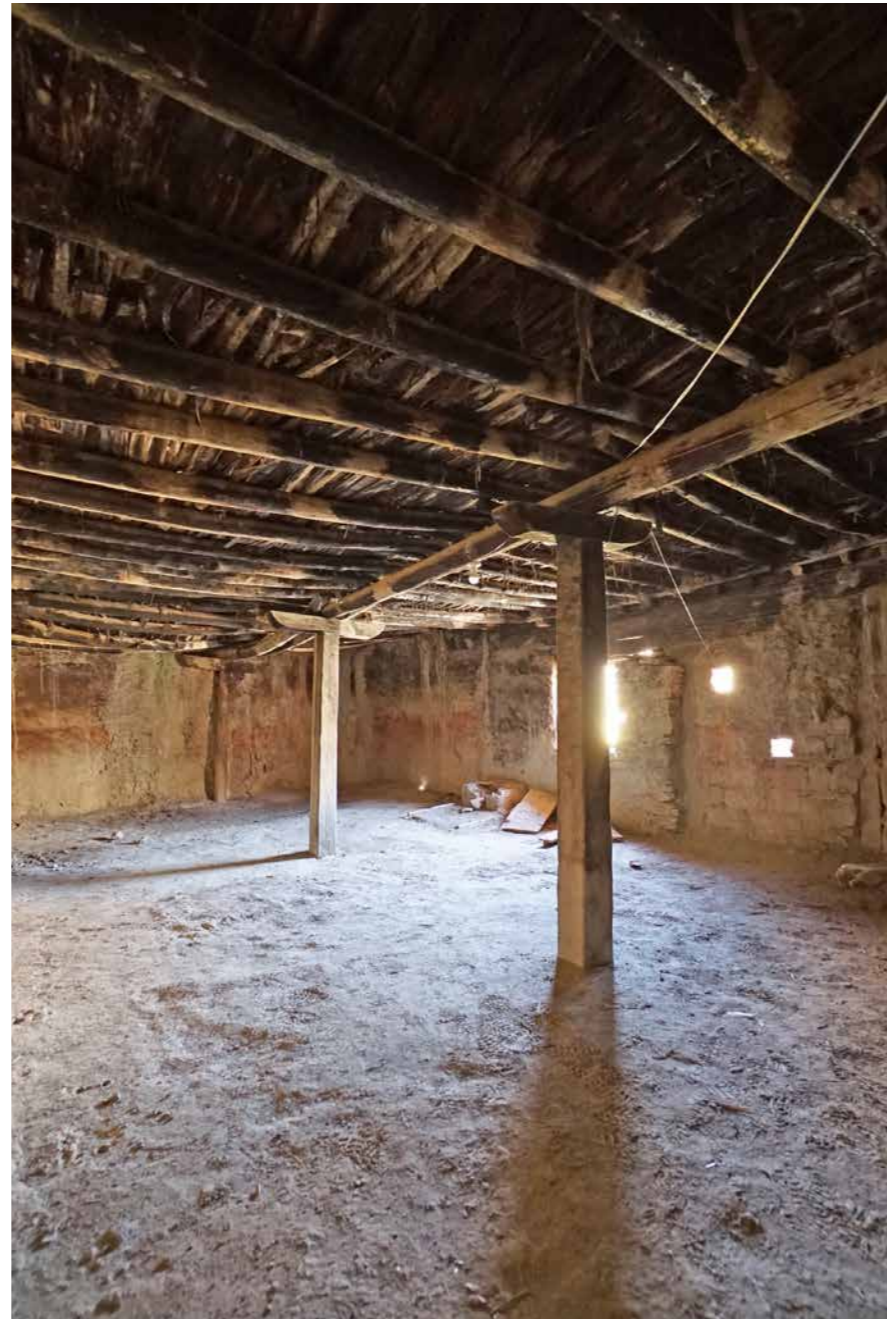
**VIEW TOWARDS NORTH-EAST**  
 This room certainly was rebuilt at some time with recycled materials. The capitals are too small, don't match the design used in the dhukhang and are installed perpendicular to the beam. The original cross beam would have certainly been of a rectangular cross-section.

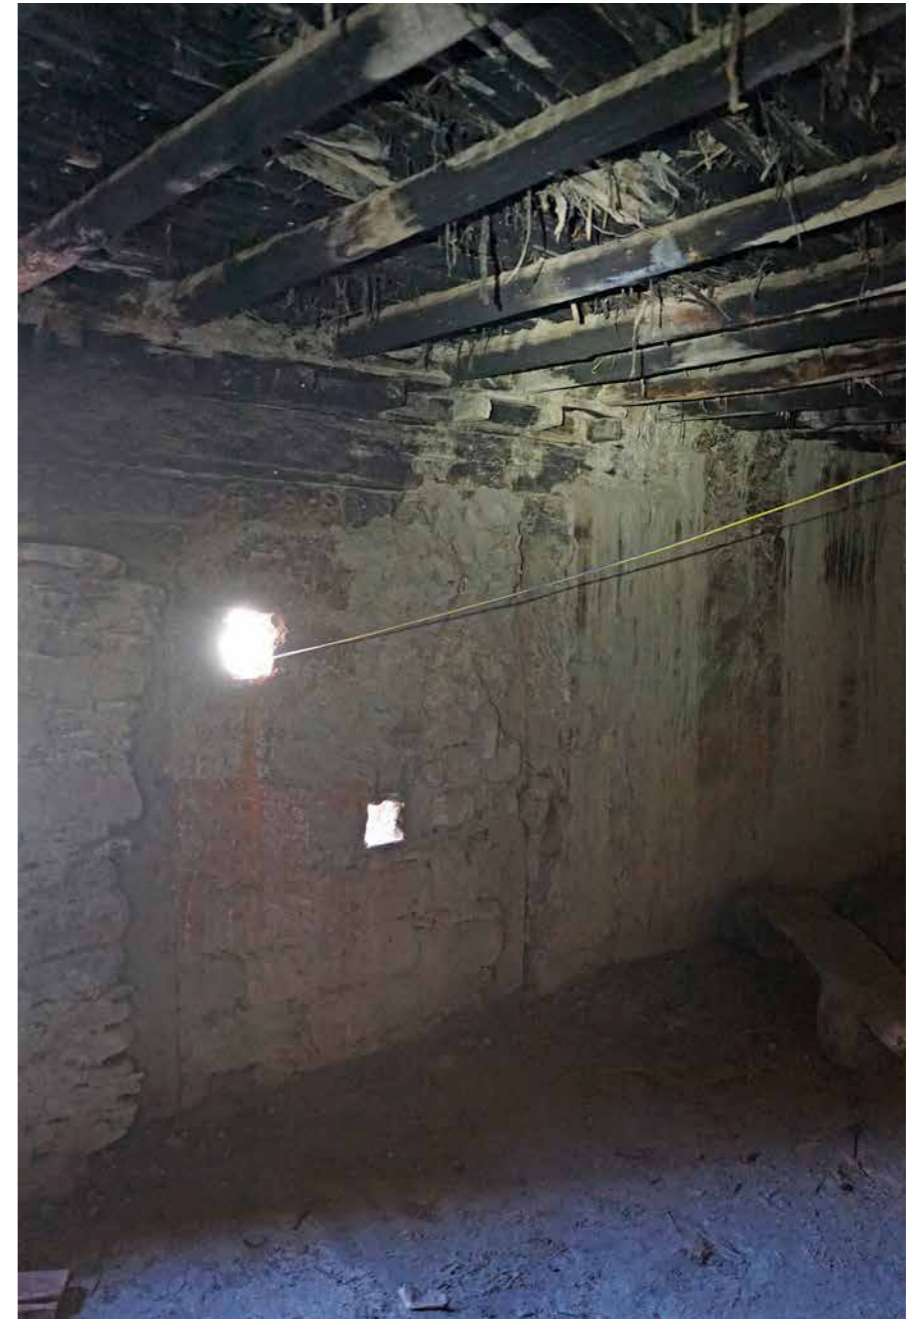
**VIEW TOWARDS THE EAST**  
 The opening to the balcony was closed off with mud brick leaving only two small holes in the wall. Most of the two columns and cross beam are encased with mud. The leaking roof has taken its toll on the ceiling structure and walls.

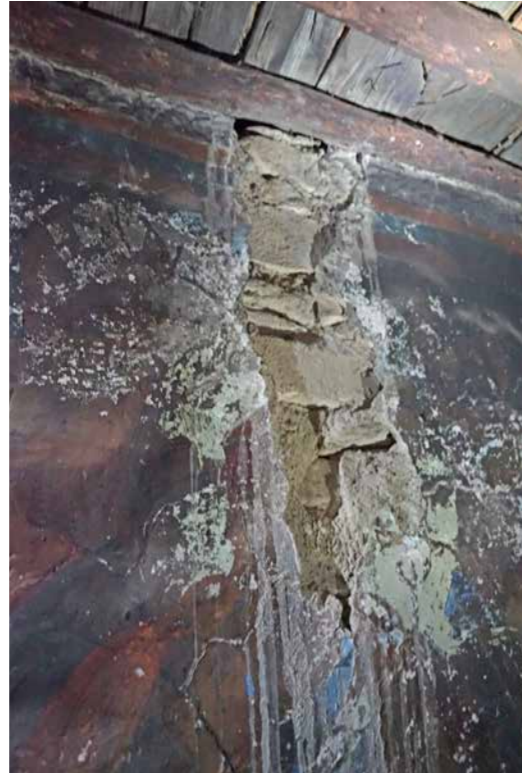
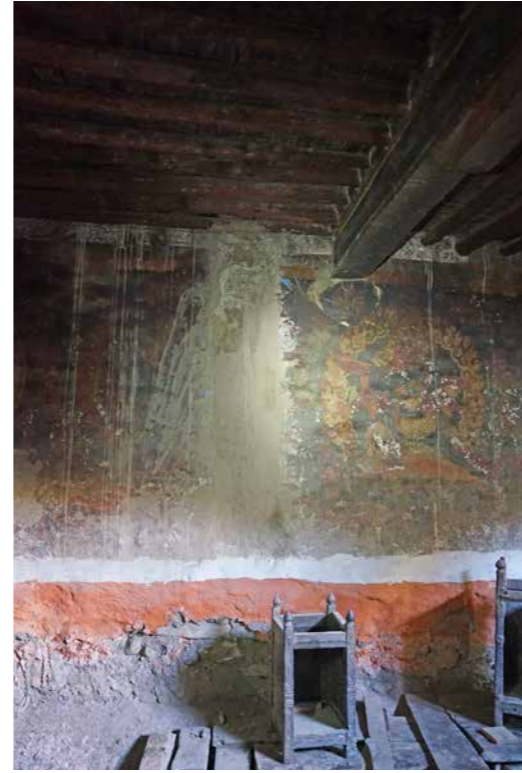
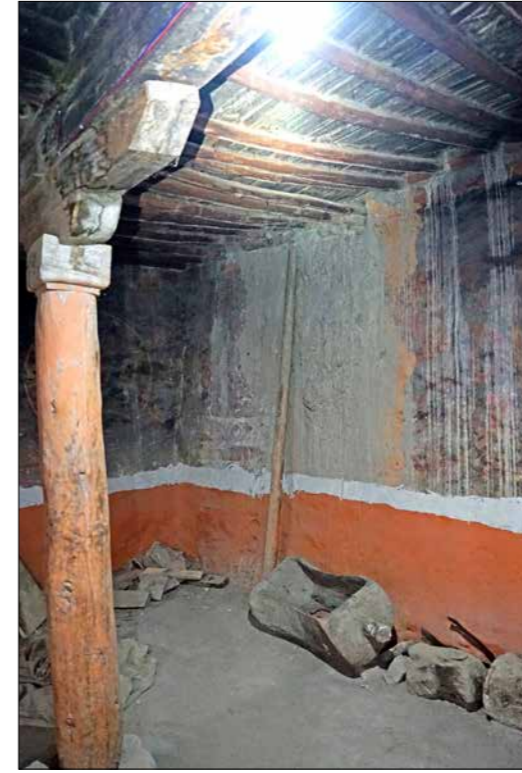
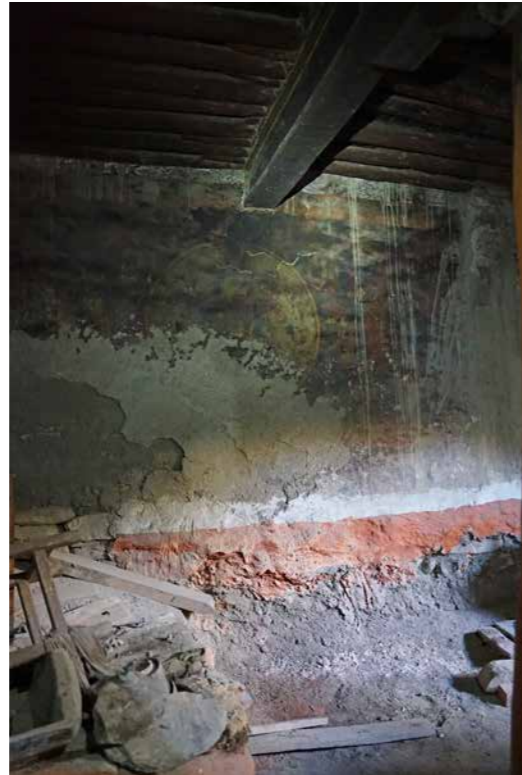
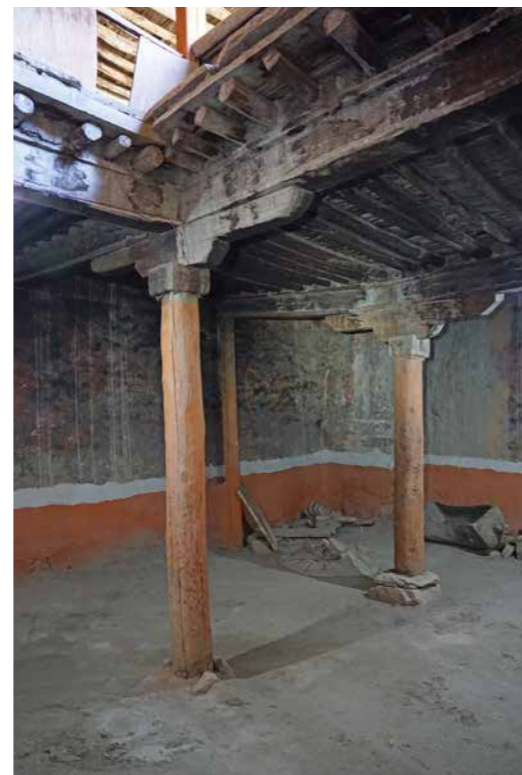
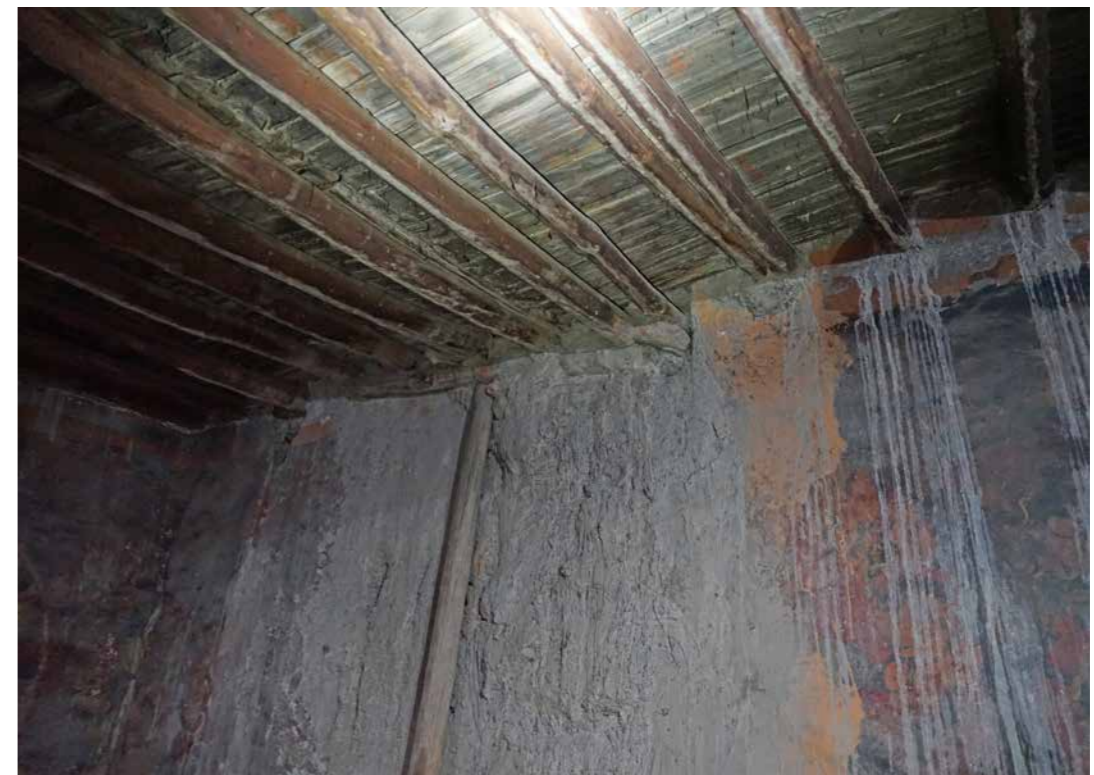
**RISING DAMP AND WATER LEAKS**  
Rising damp and water infiltration from above have eroded large areas of wall plaster and paintings.

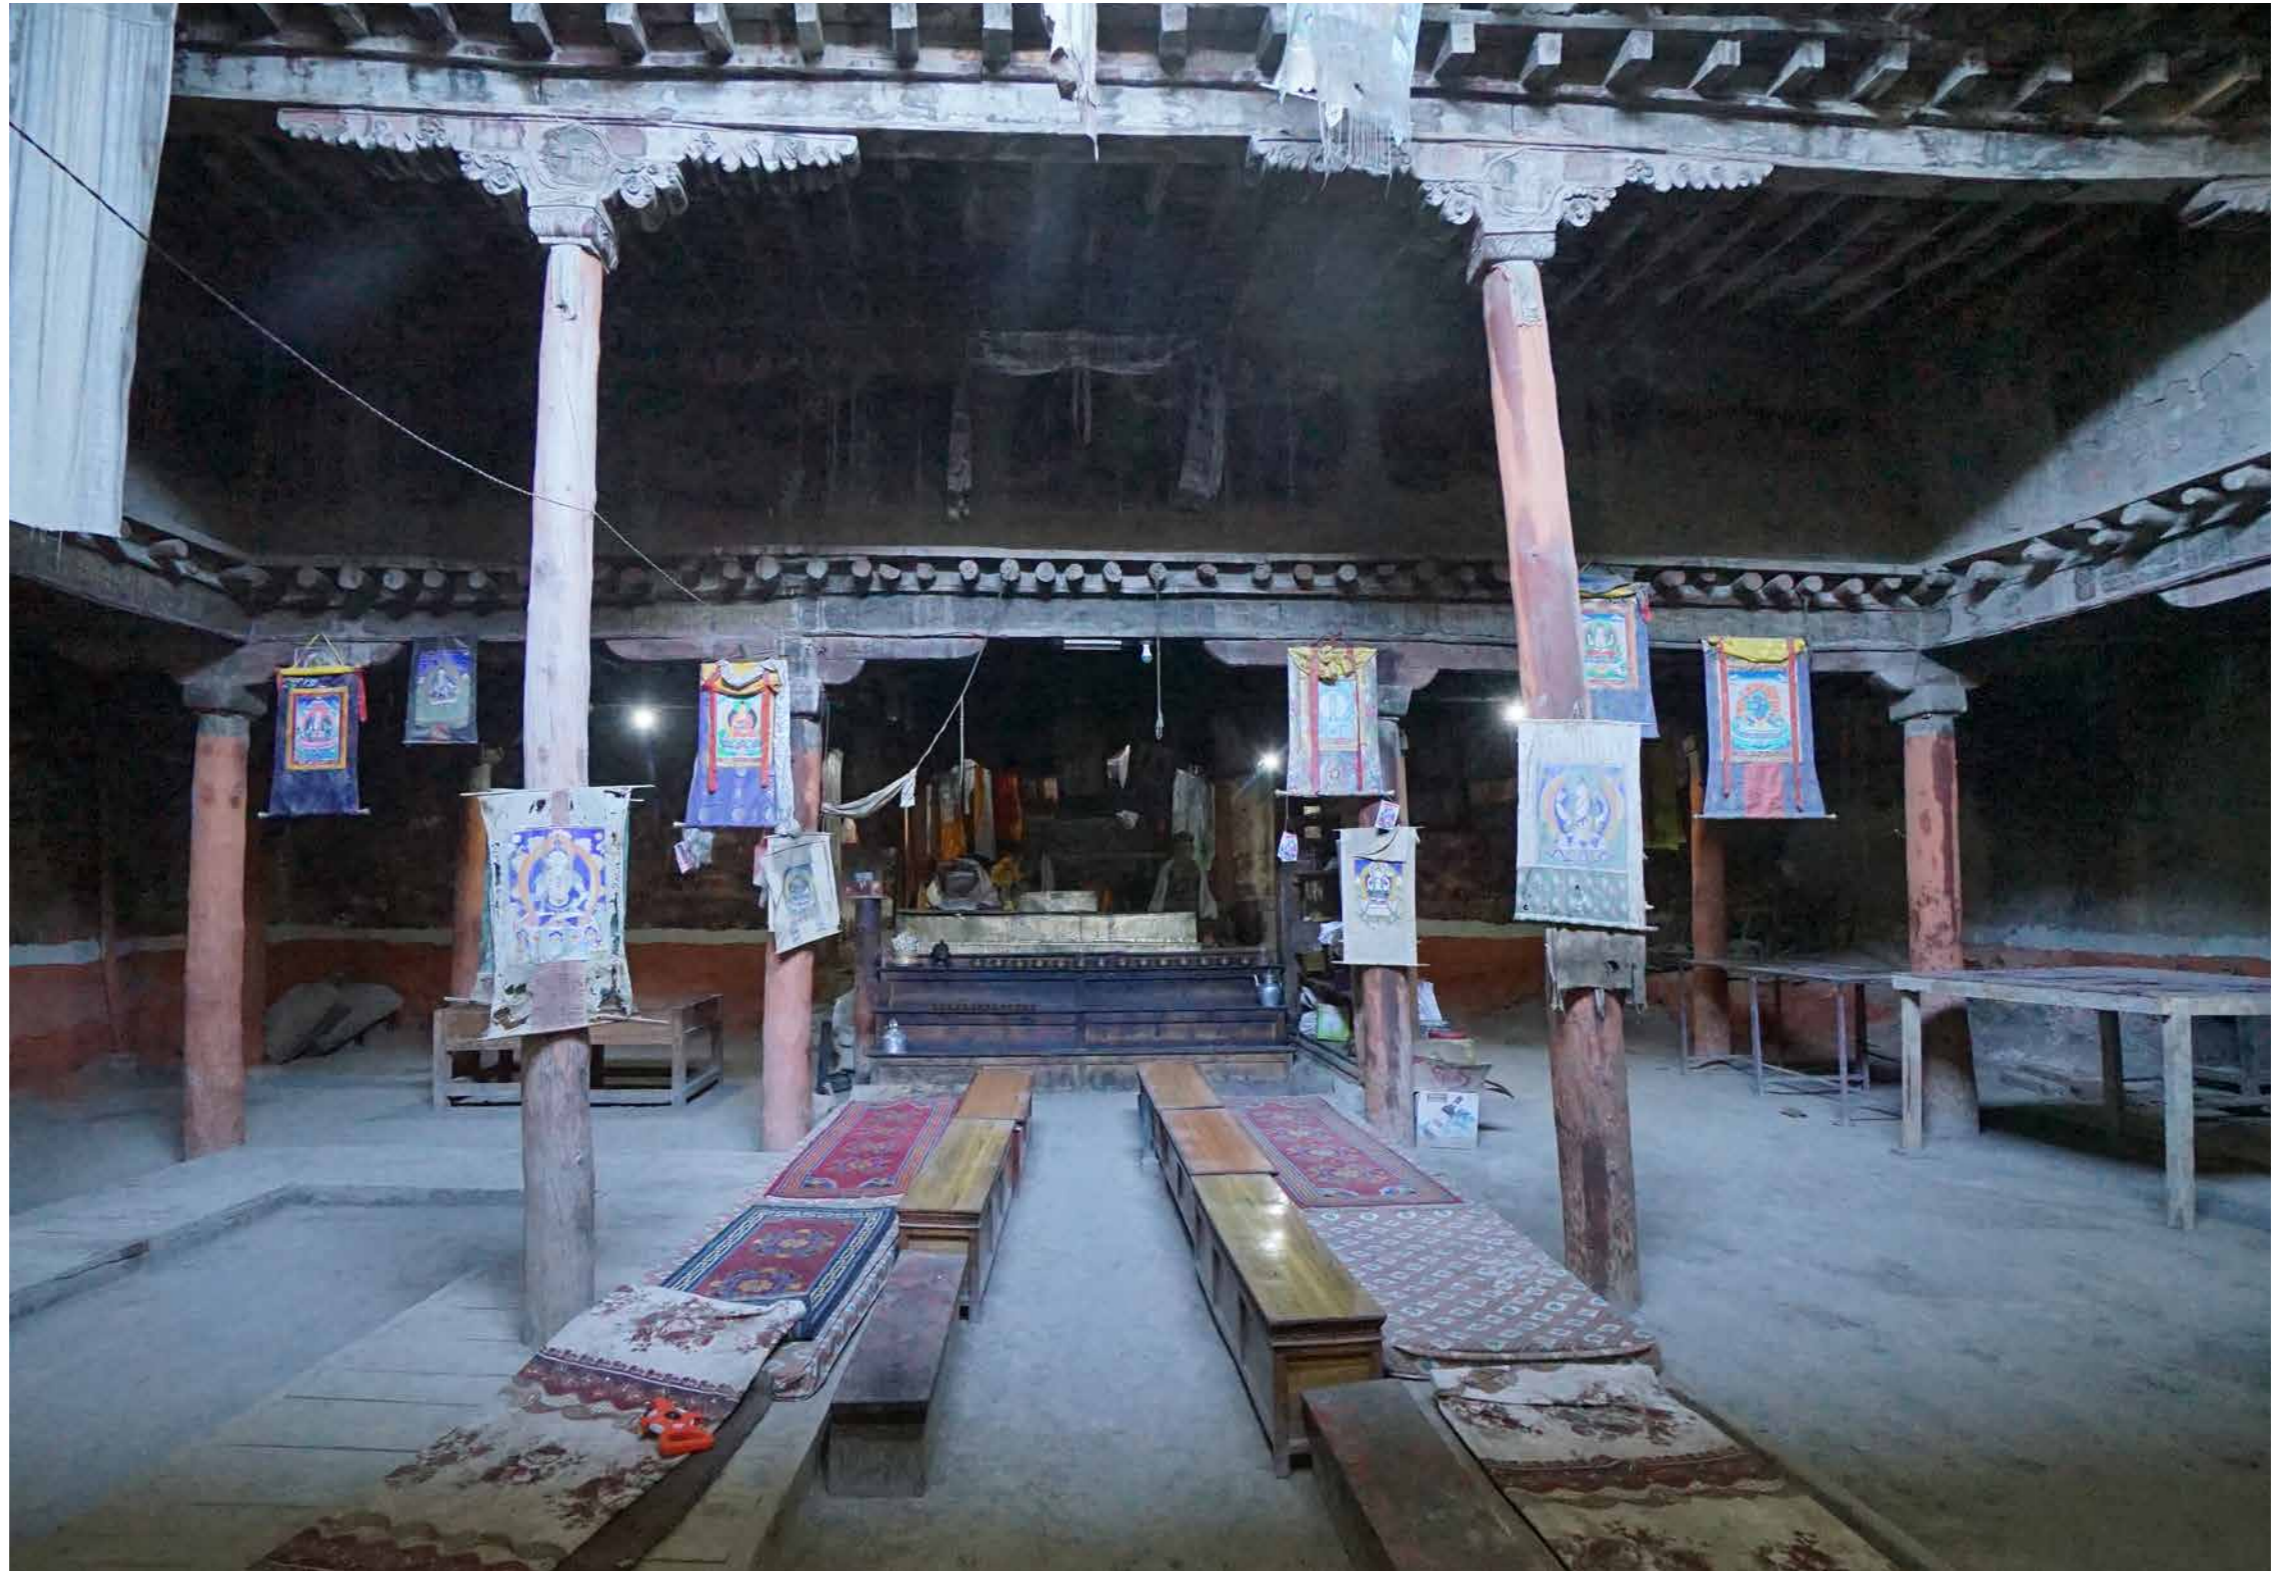
**MAIN HALL, VIEW TOWARDS THE WEST**  
Gaps between capitals and beams indicate the settlements of the bearing structure. The columns in front are leaning which likely is a result of earthquake damage. The right cross beam sags which is probably caused by wet rot. Water damage is evident throughout the building.
