## **SEISMIC STRENGTHENING AND RESTORATION OF GONPA GANG**

DAMAGE ASSESSMENT AND RESTORATION CONCEPT

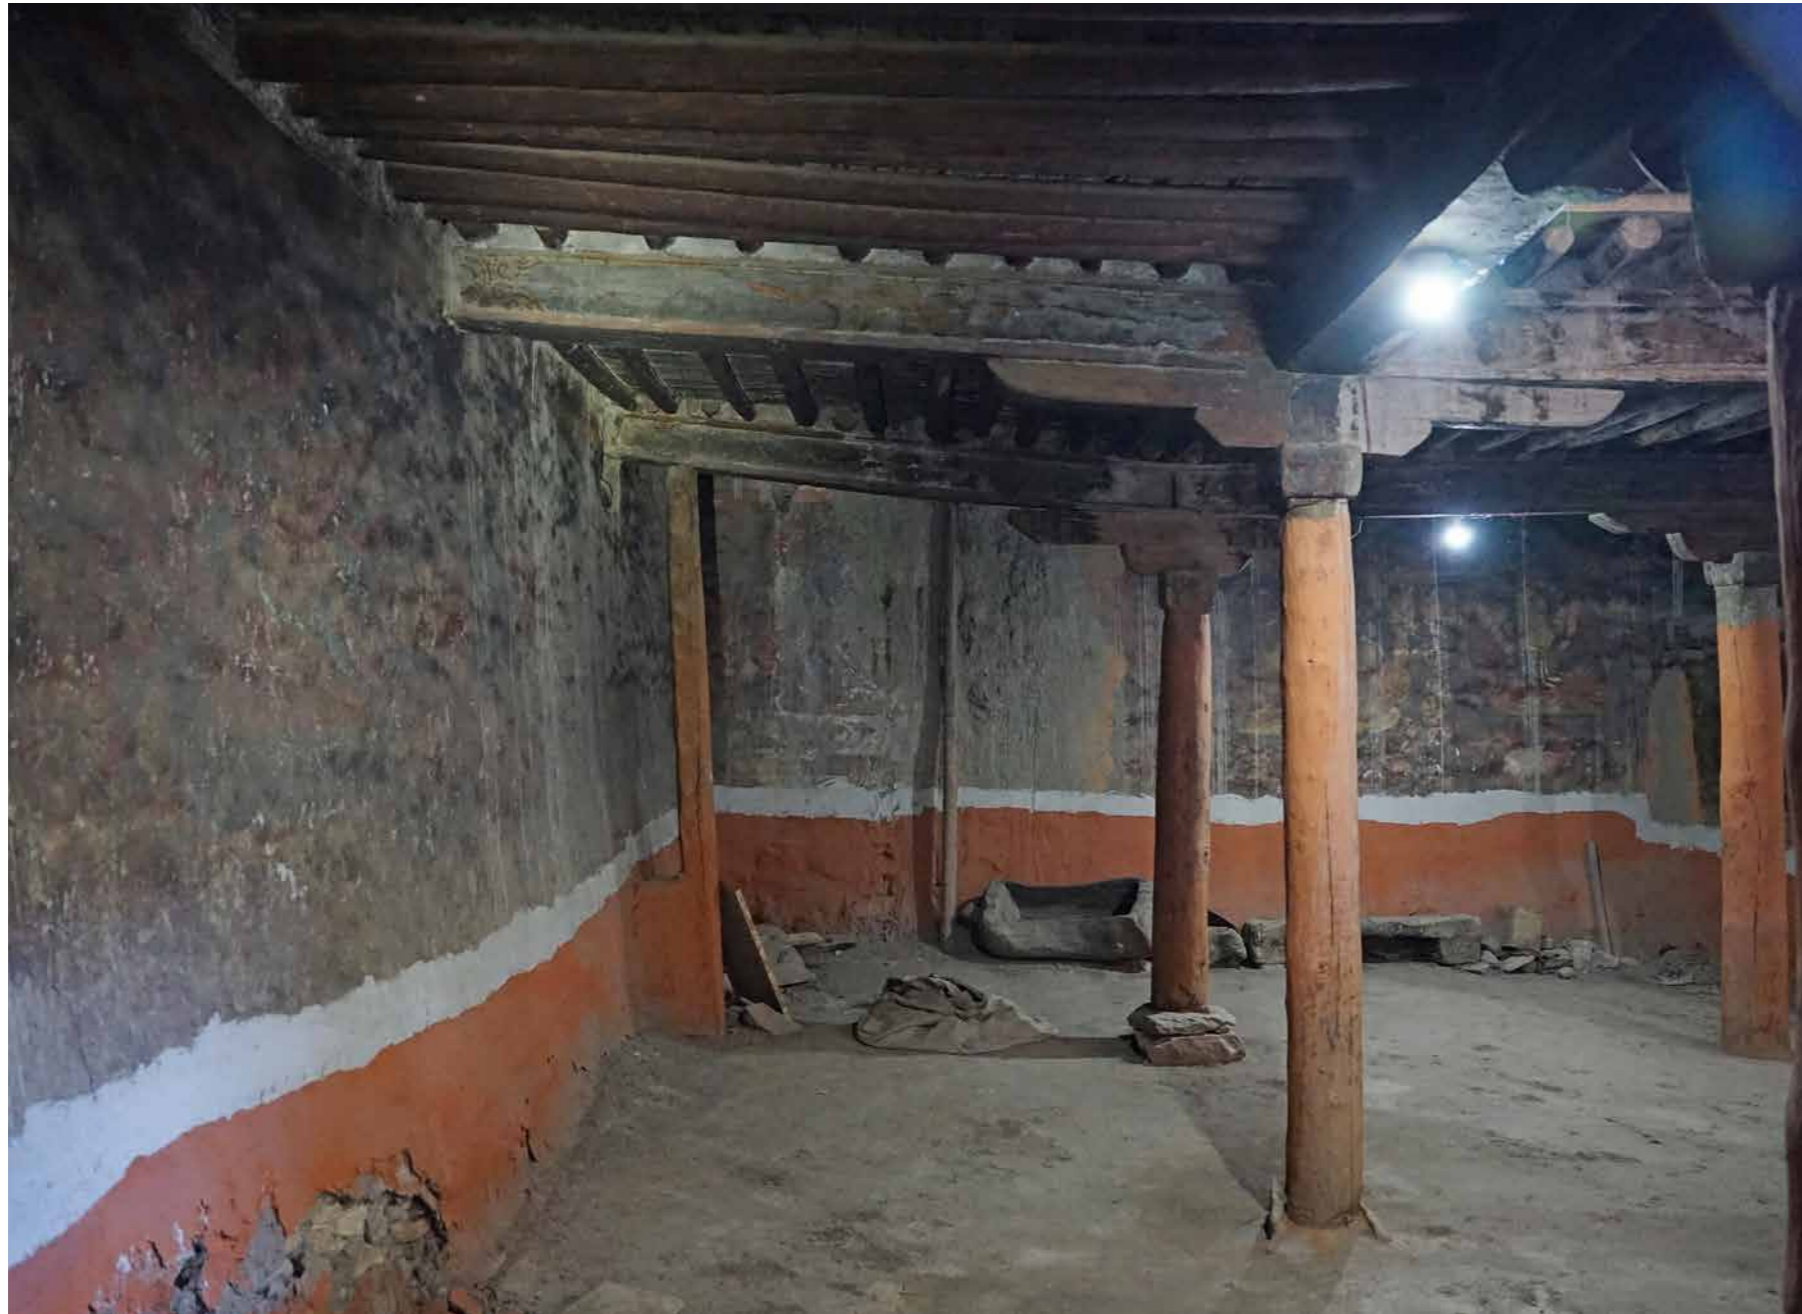
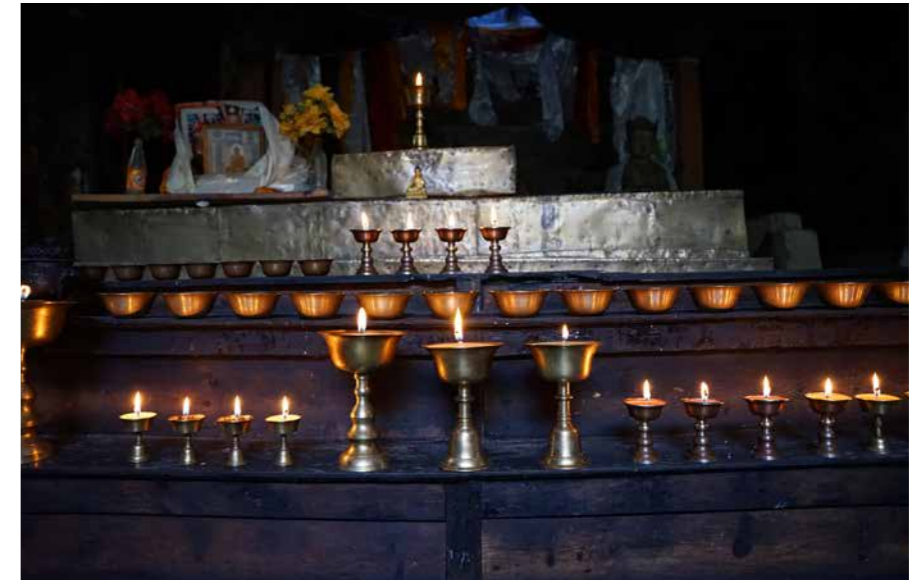
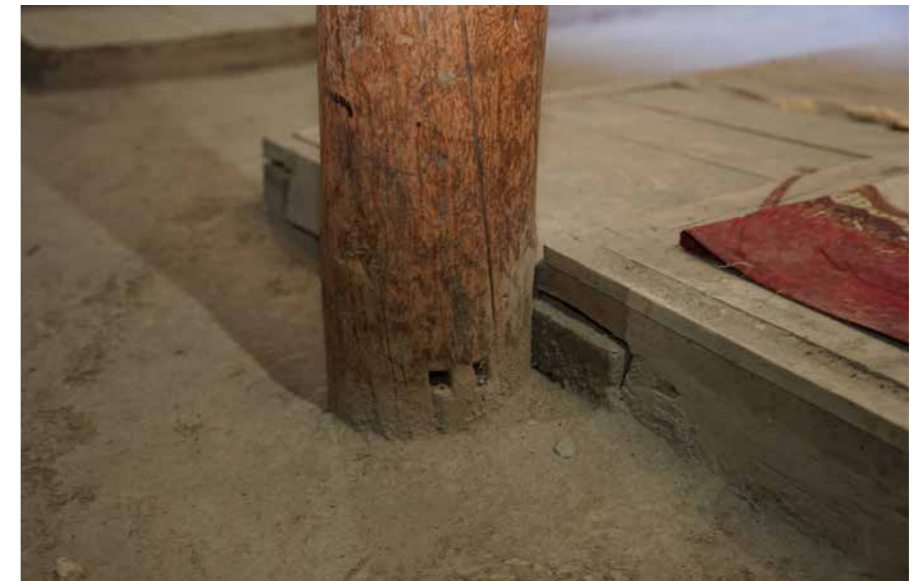
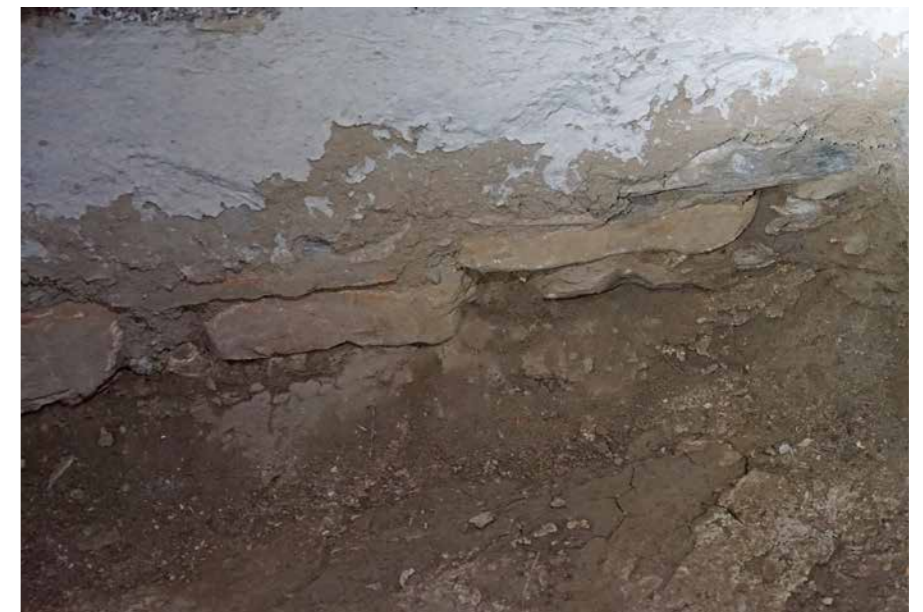
**VIEW TO THE EAST**  
 Wall paintings on the east wall were almost completely destroyed by water leaks from above. Peeling mud plaster in the left foreground indicates rising damp. The cross beam in the background is propped up by a post. Note the round pillar that is supported by two stones. In that area the ceiling has sagged by more than 6 inches and will require complete reconstruction.

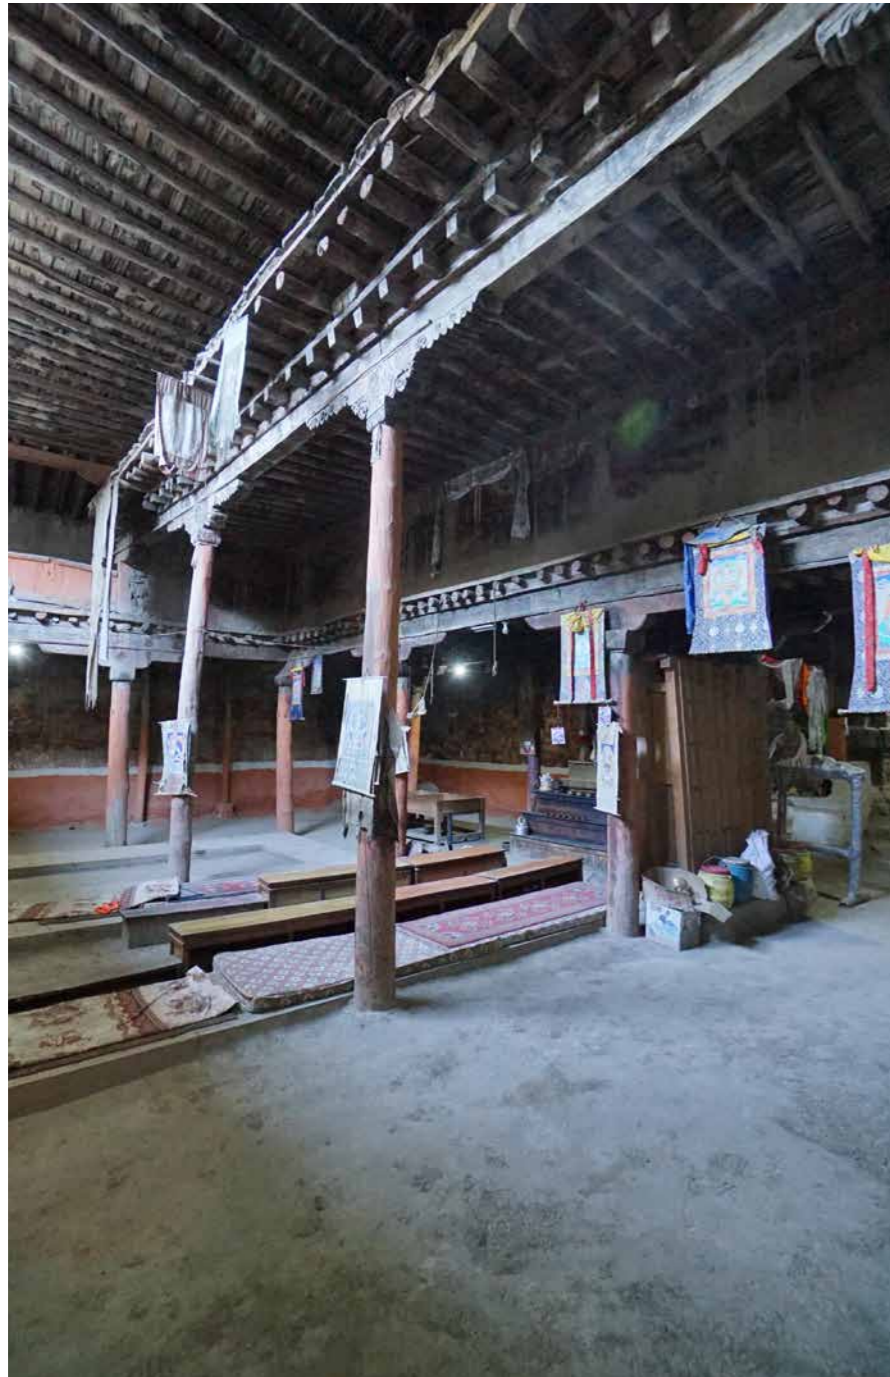
**VIEW TO THE SOUTH-WEST**  
 The two tall round pillars are leaning. They will be reinstalled on new point foundations.

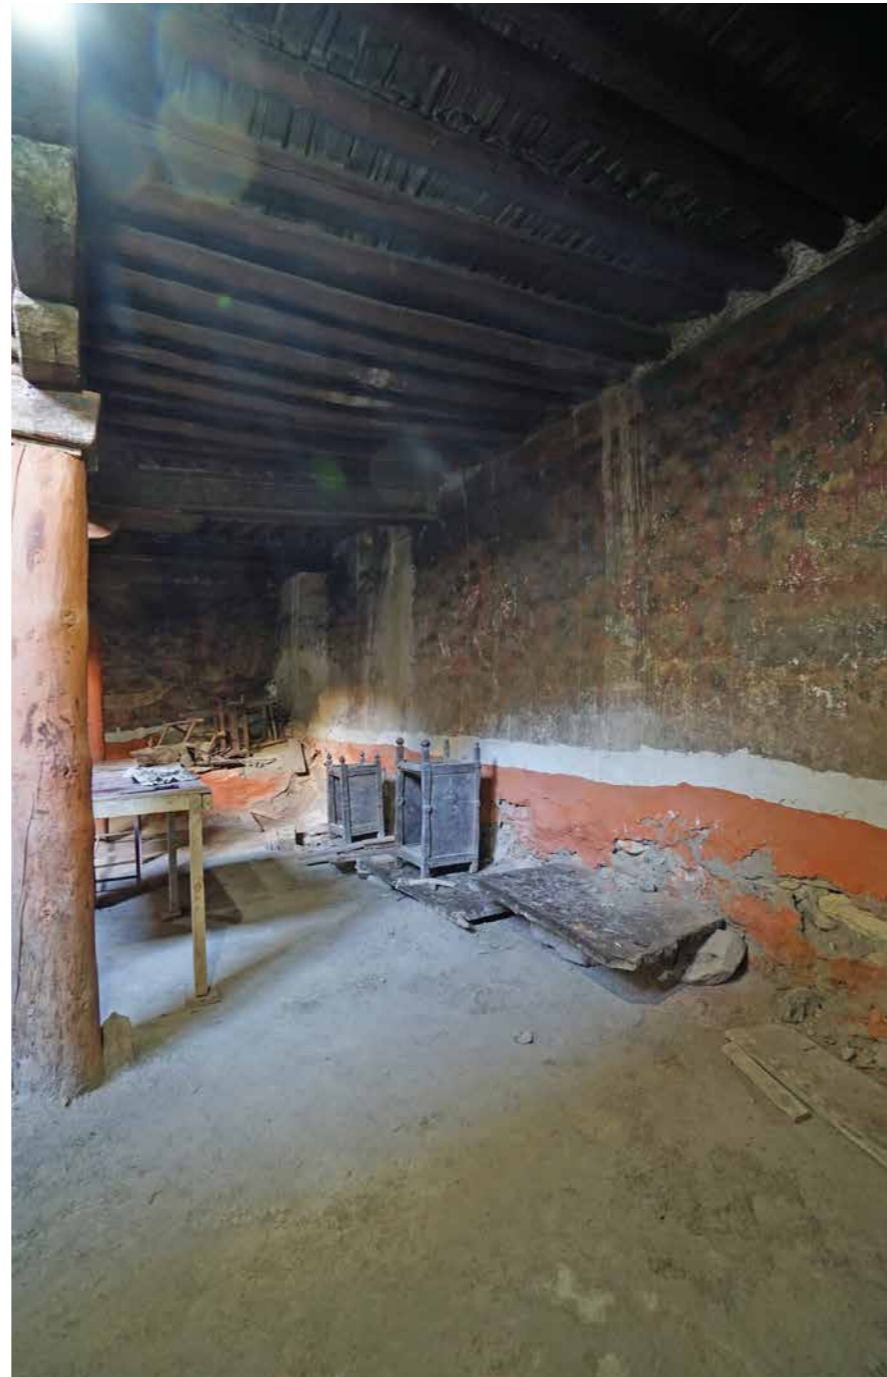
**VIEW TO THE NORTHWEST**  
 The north-west corner of the dhukhang is most affected by rising damp. The new improved drainage system will lessen the impact on the buildings foundations.

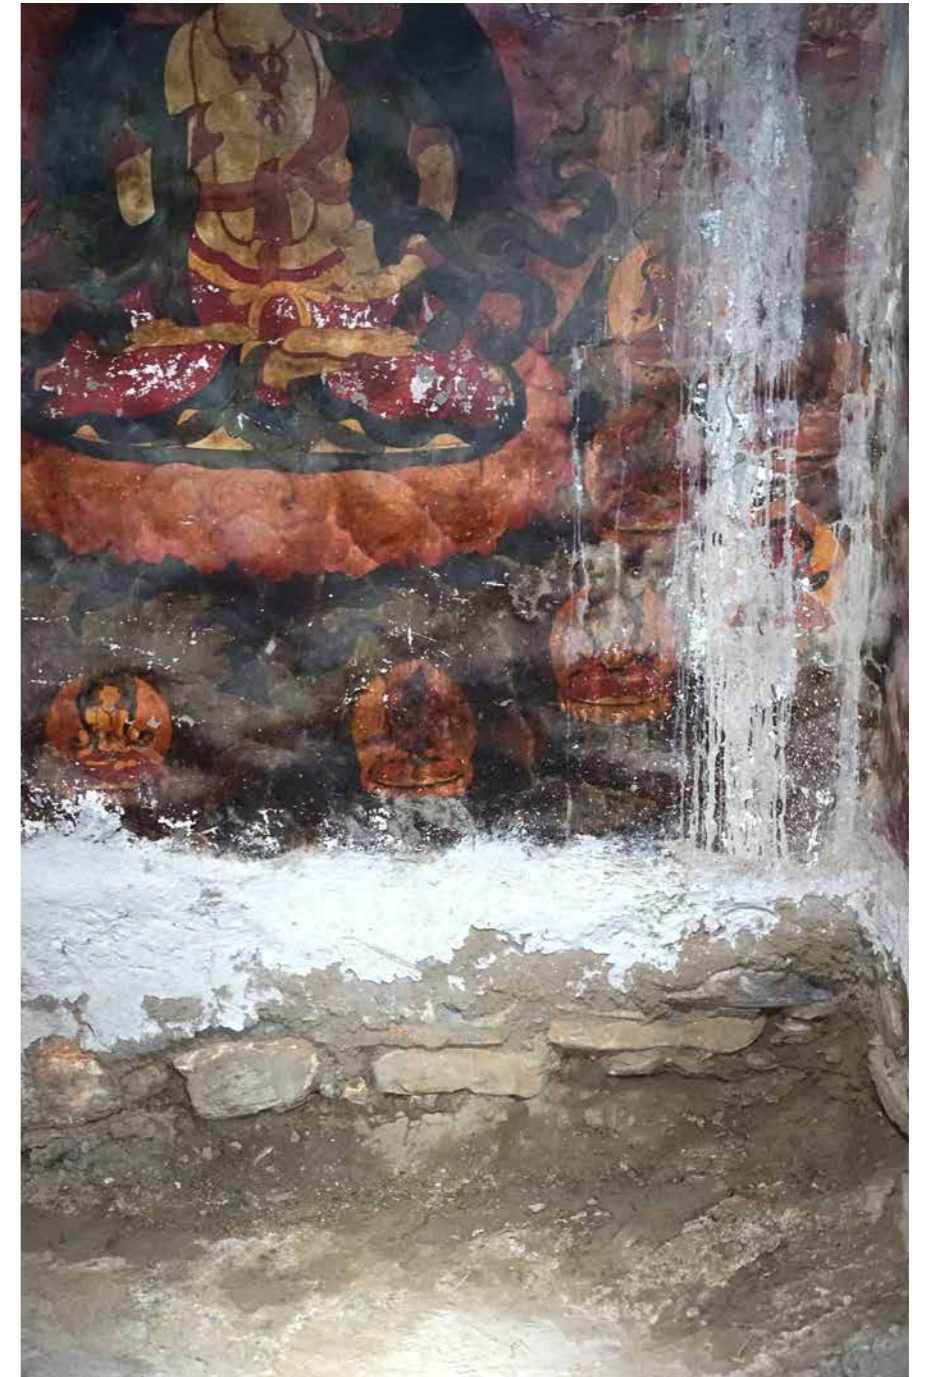
**DAMAGE TO WALL PAINTINGS**

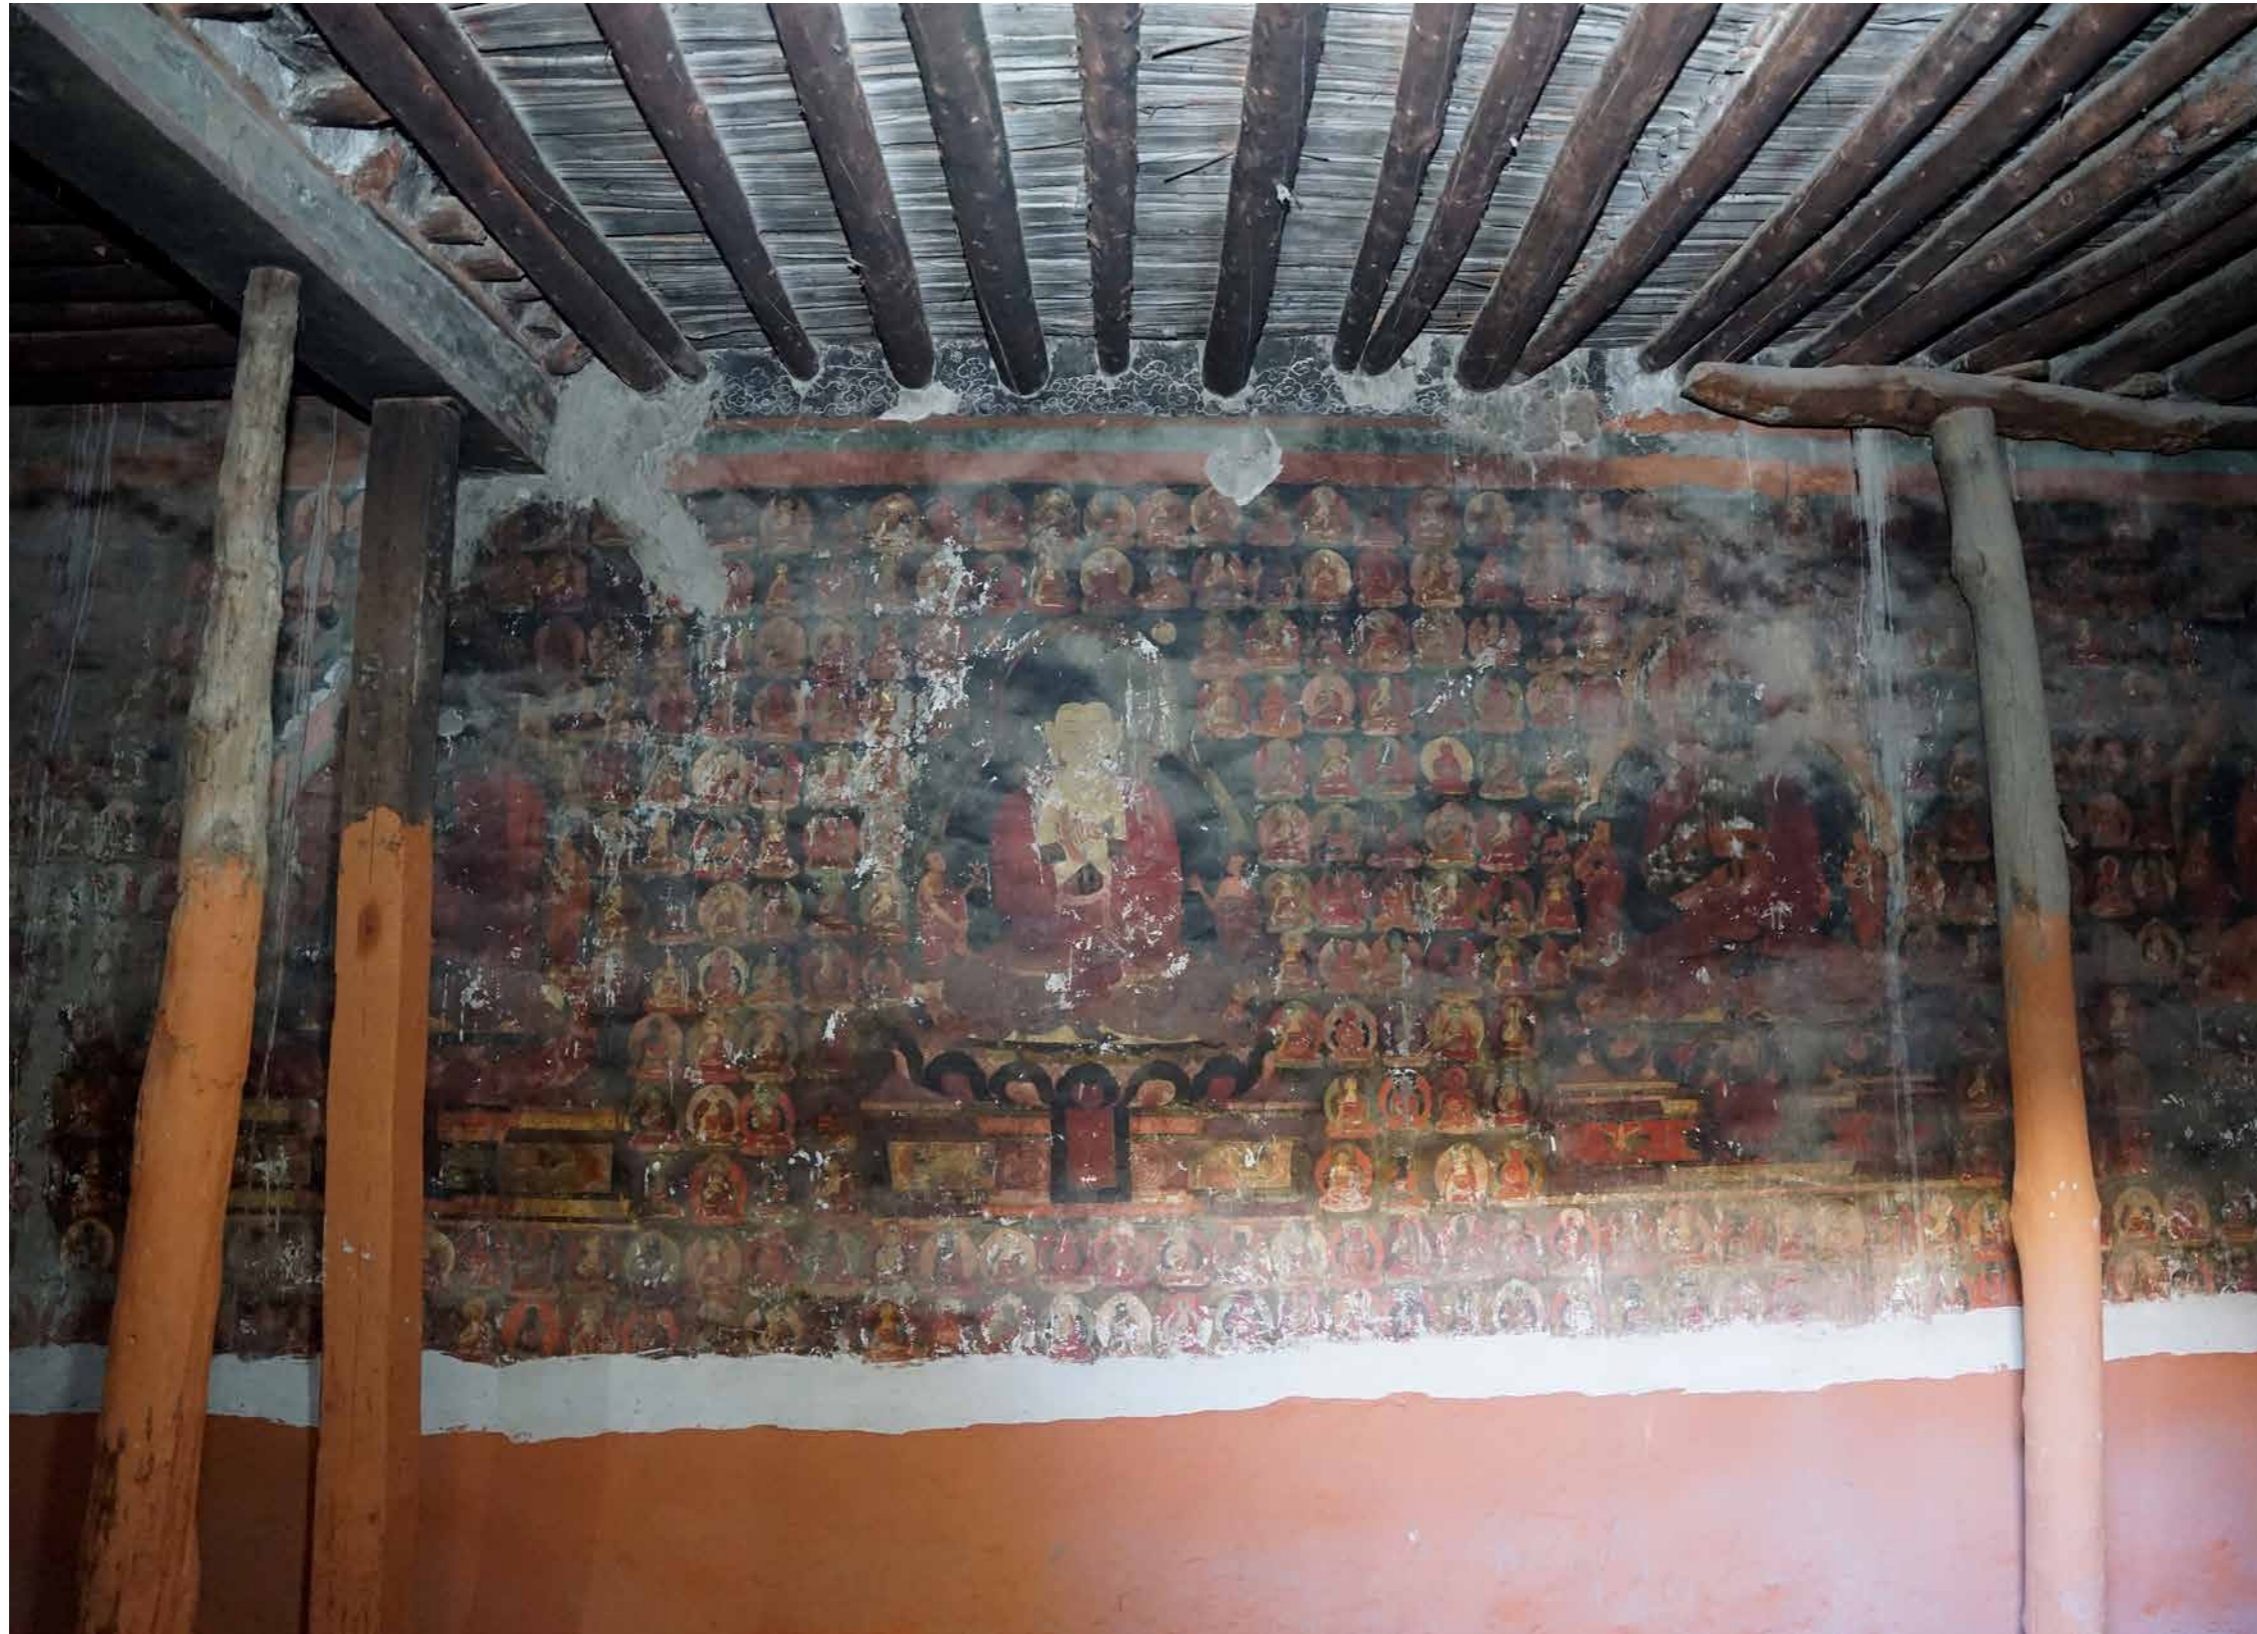
**MAIN HALL, VIEW TOWARDS THE SOUTH**

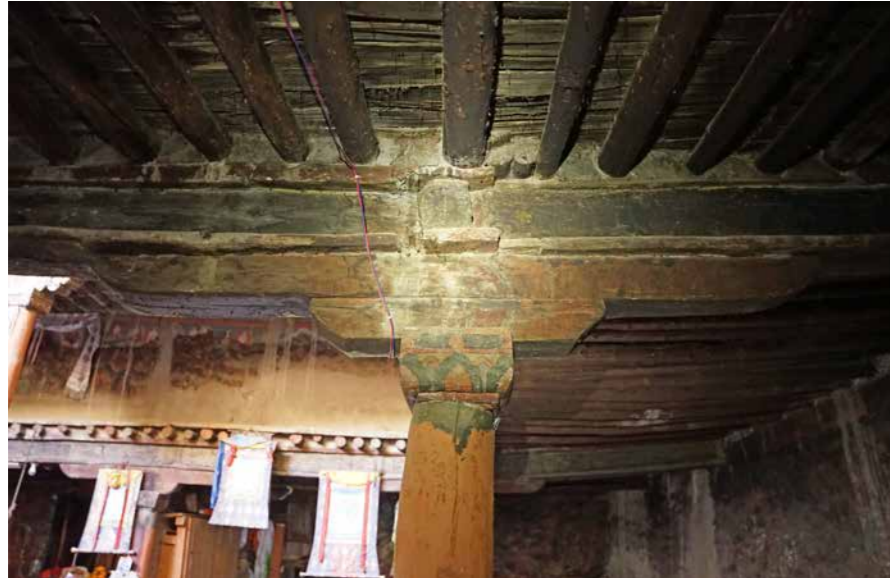
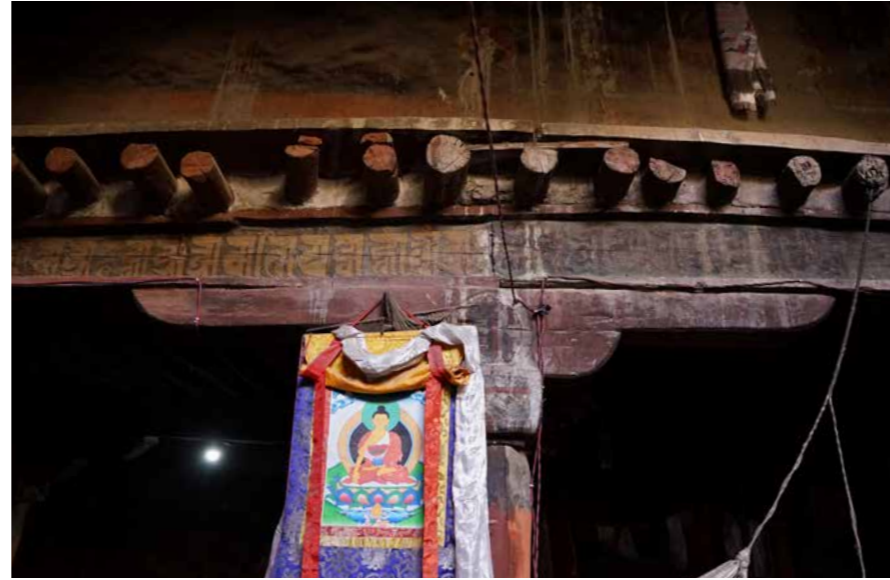
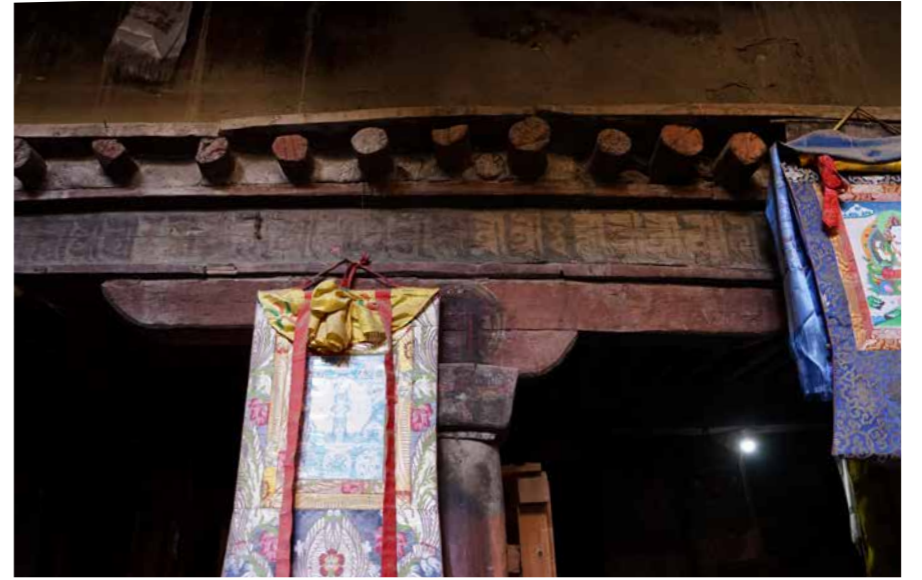
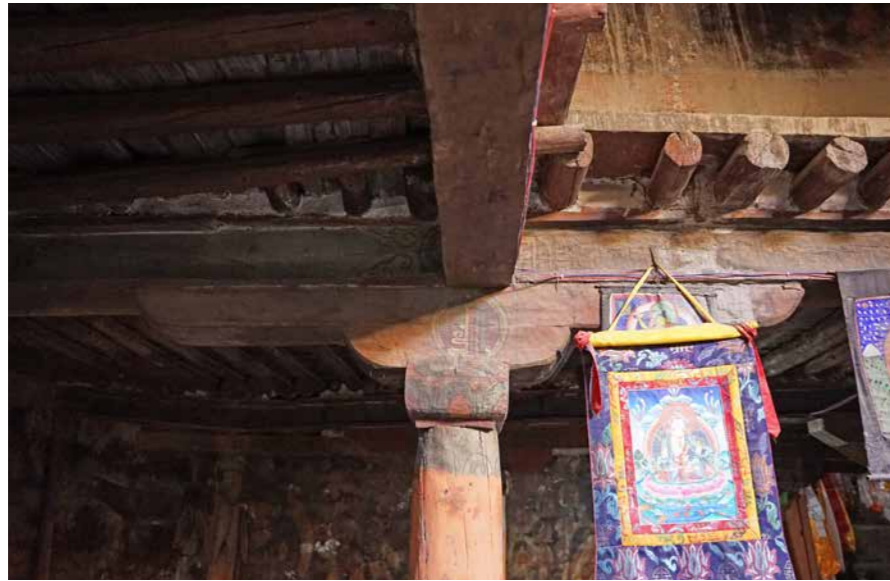
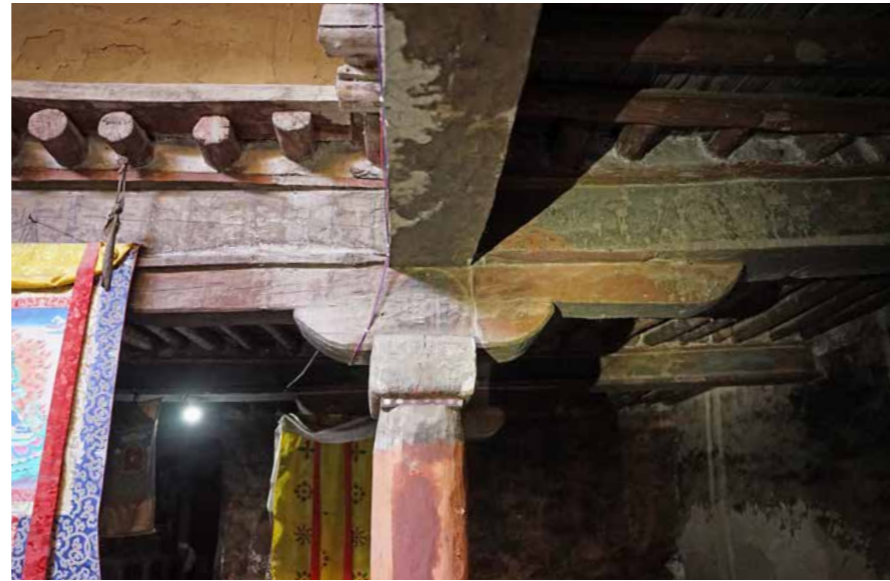
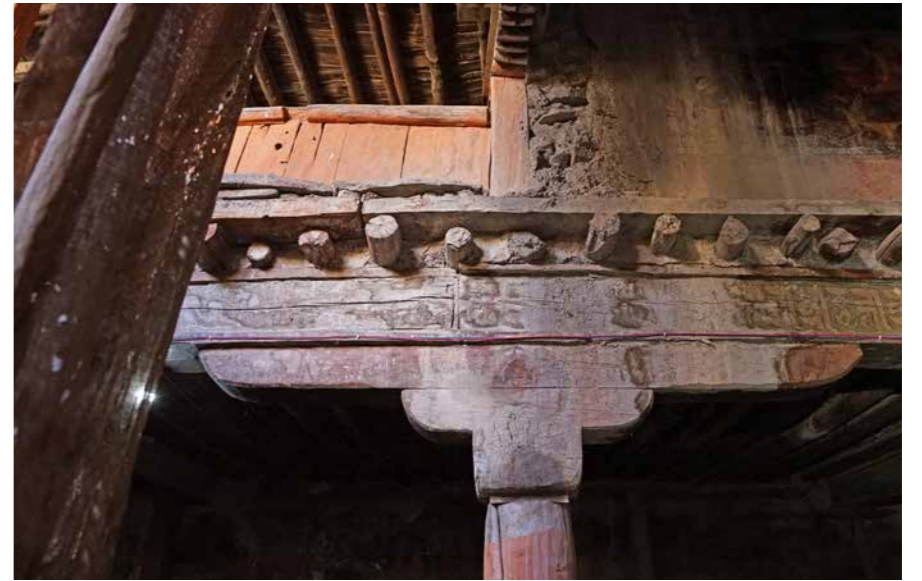
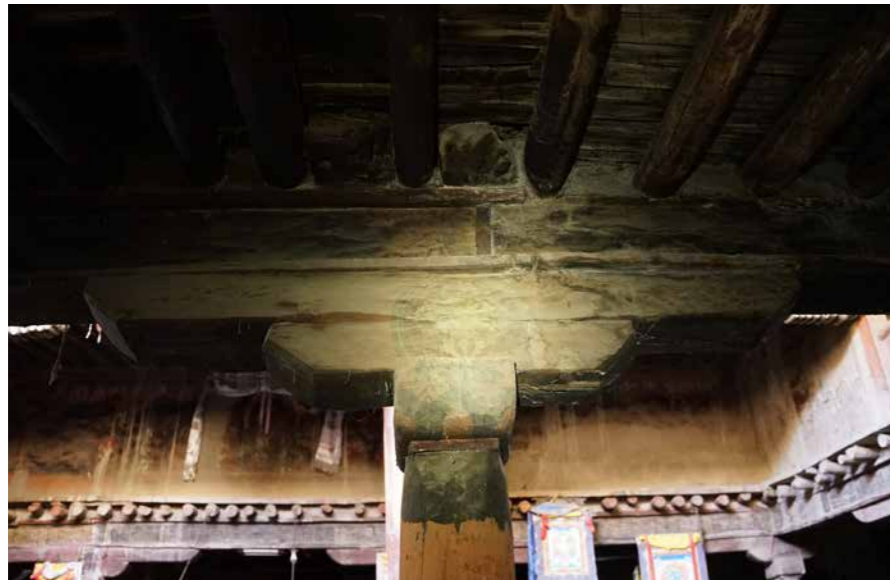
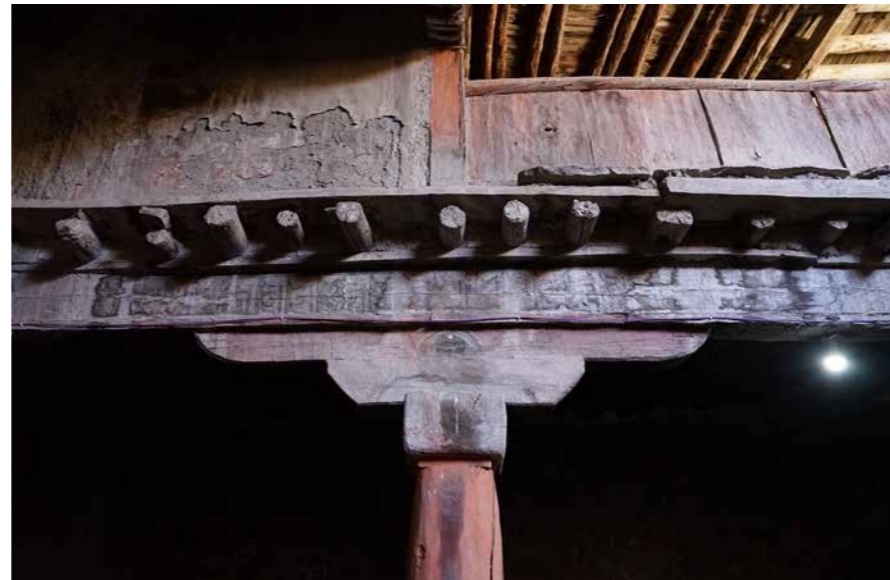
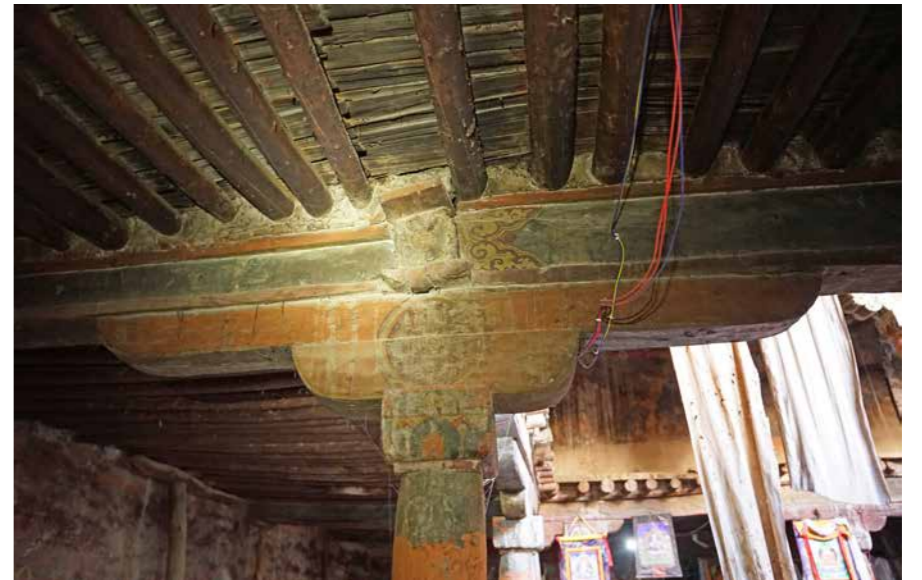
All areas display signs of water leakage which consequently caused rot and structural damage.

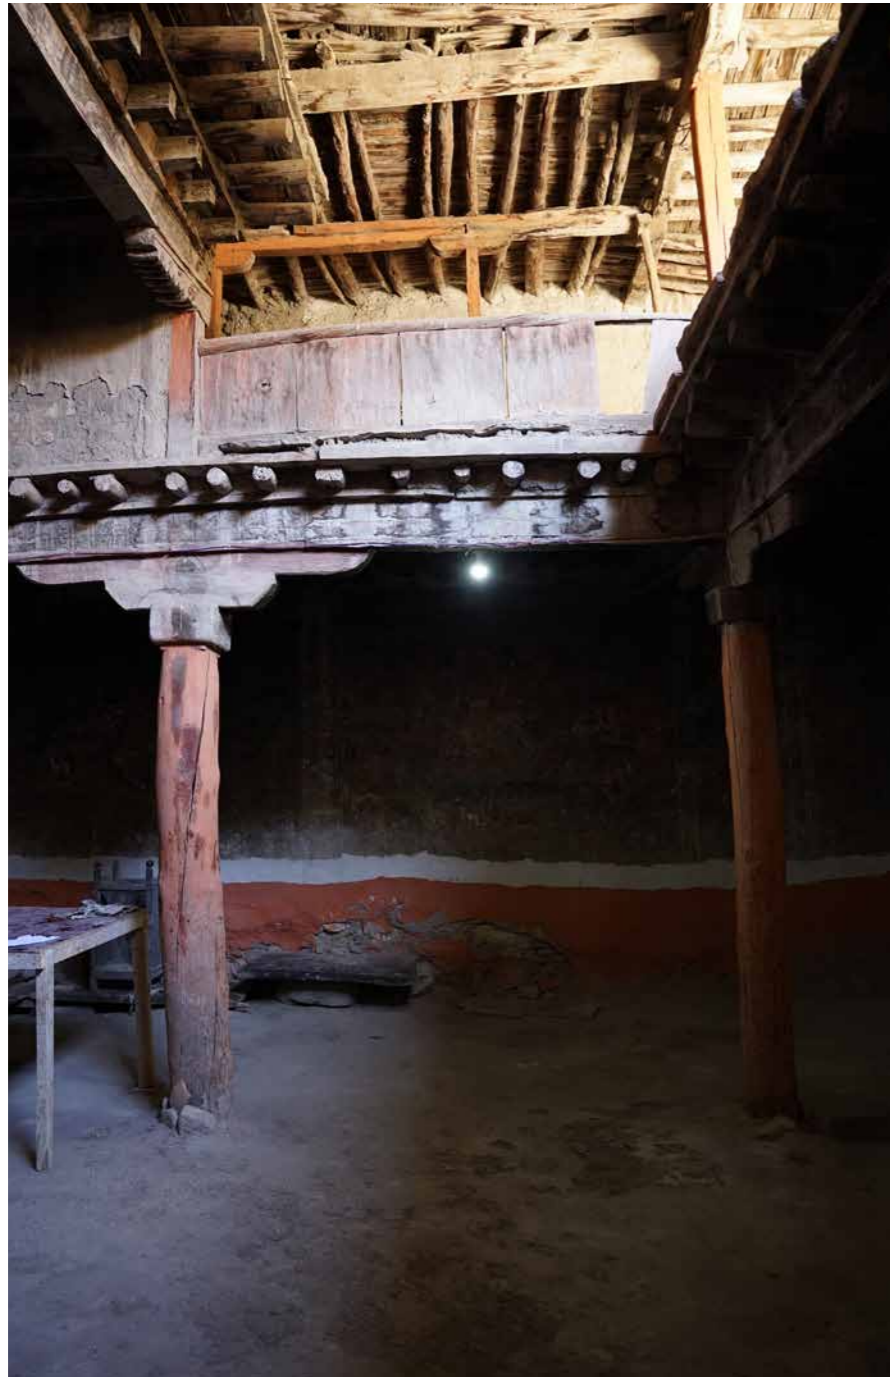
**VIEWS OF THE DAMAGED CEILING STRUCTURE**  
The main beam and round poplar joists are held up by temporary supports. Cracks below the beam were poorly patched up with mud mortar.

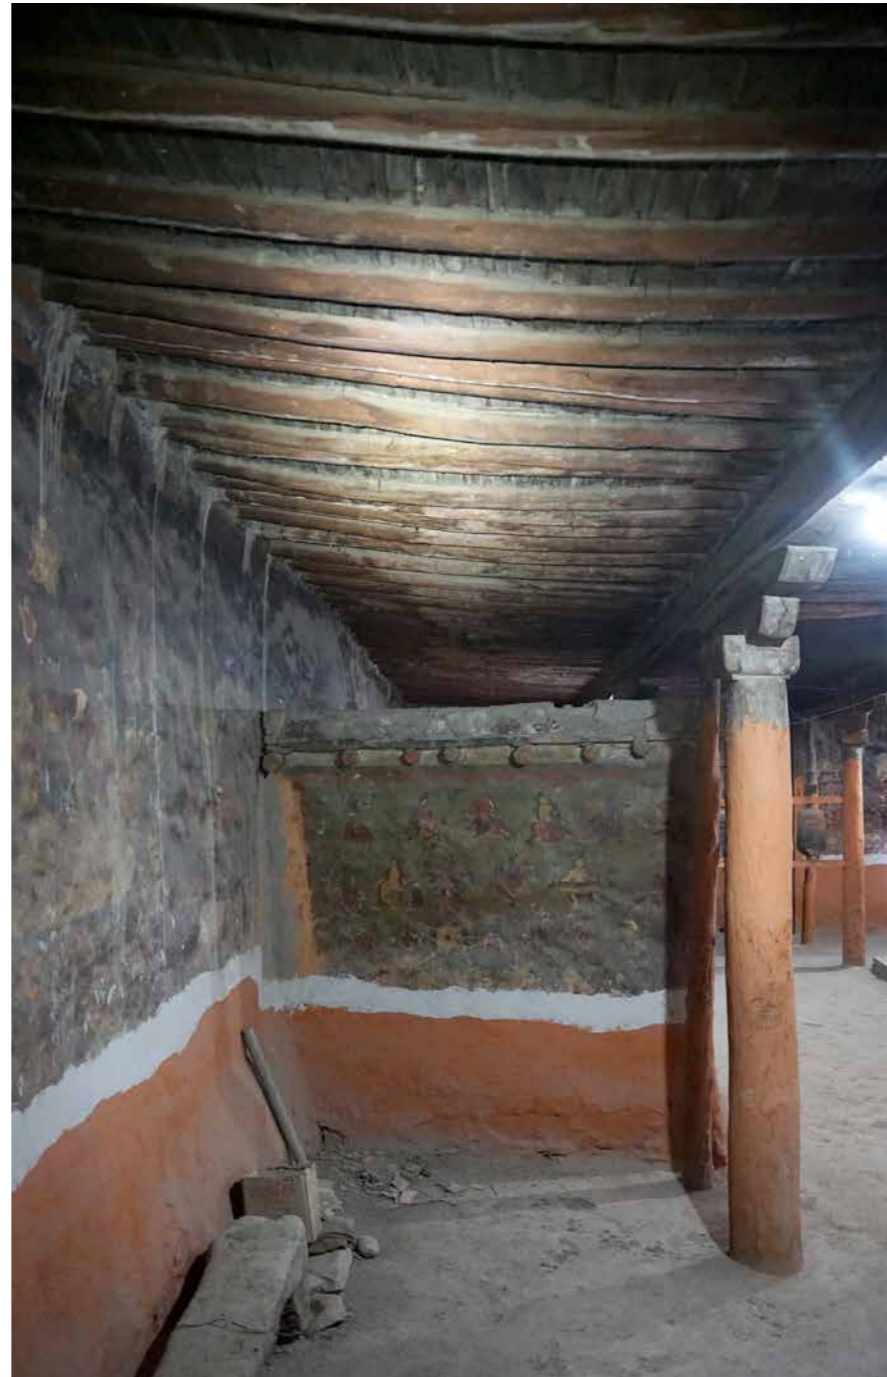
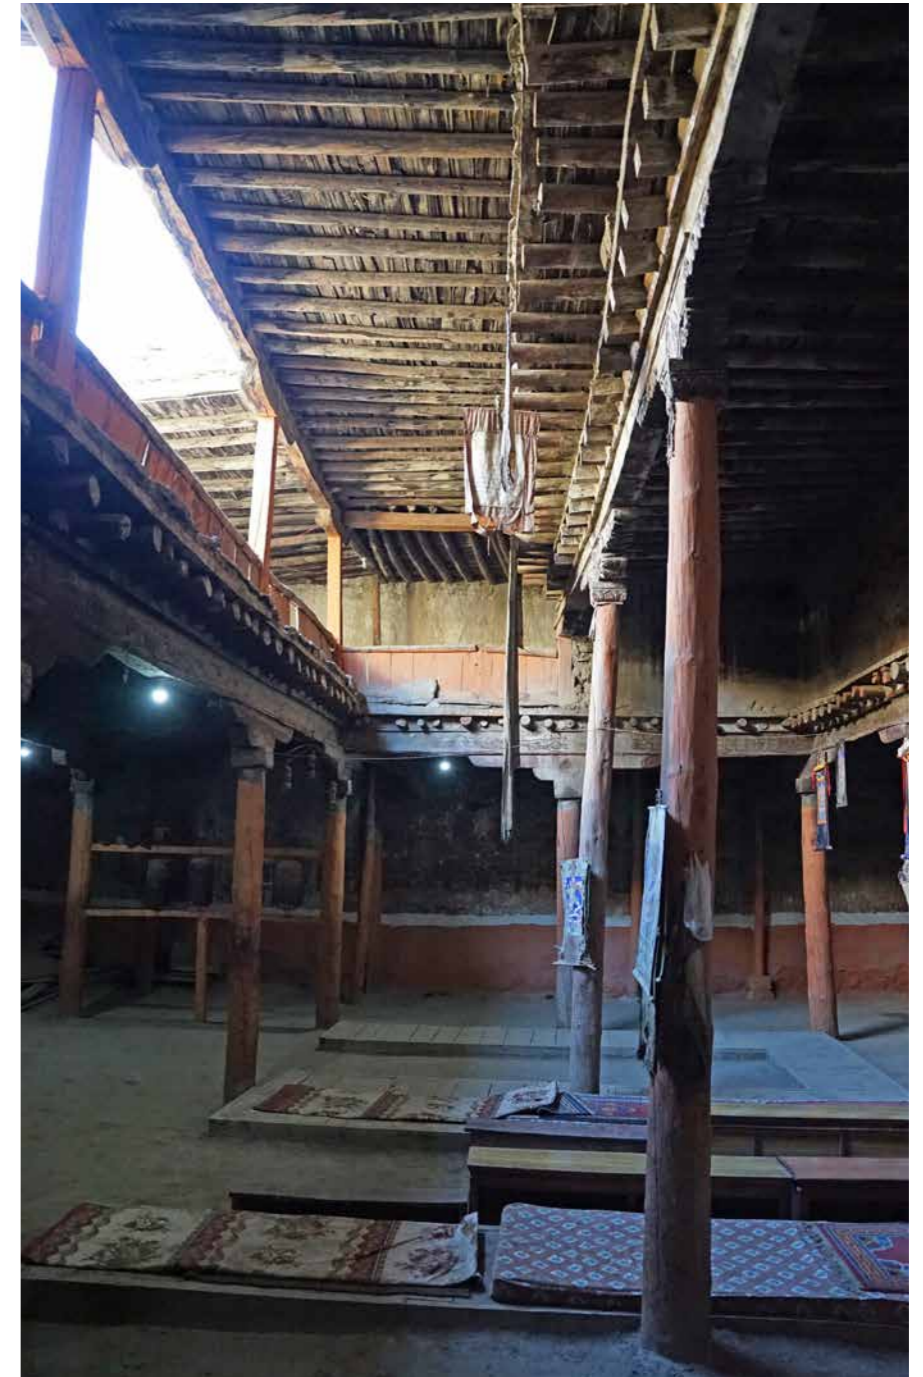
**VIEW TO THE SOUTH**  
Note the leaning pillar in the center.

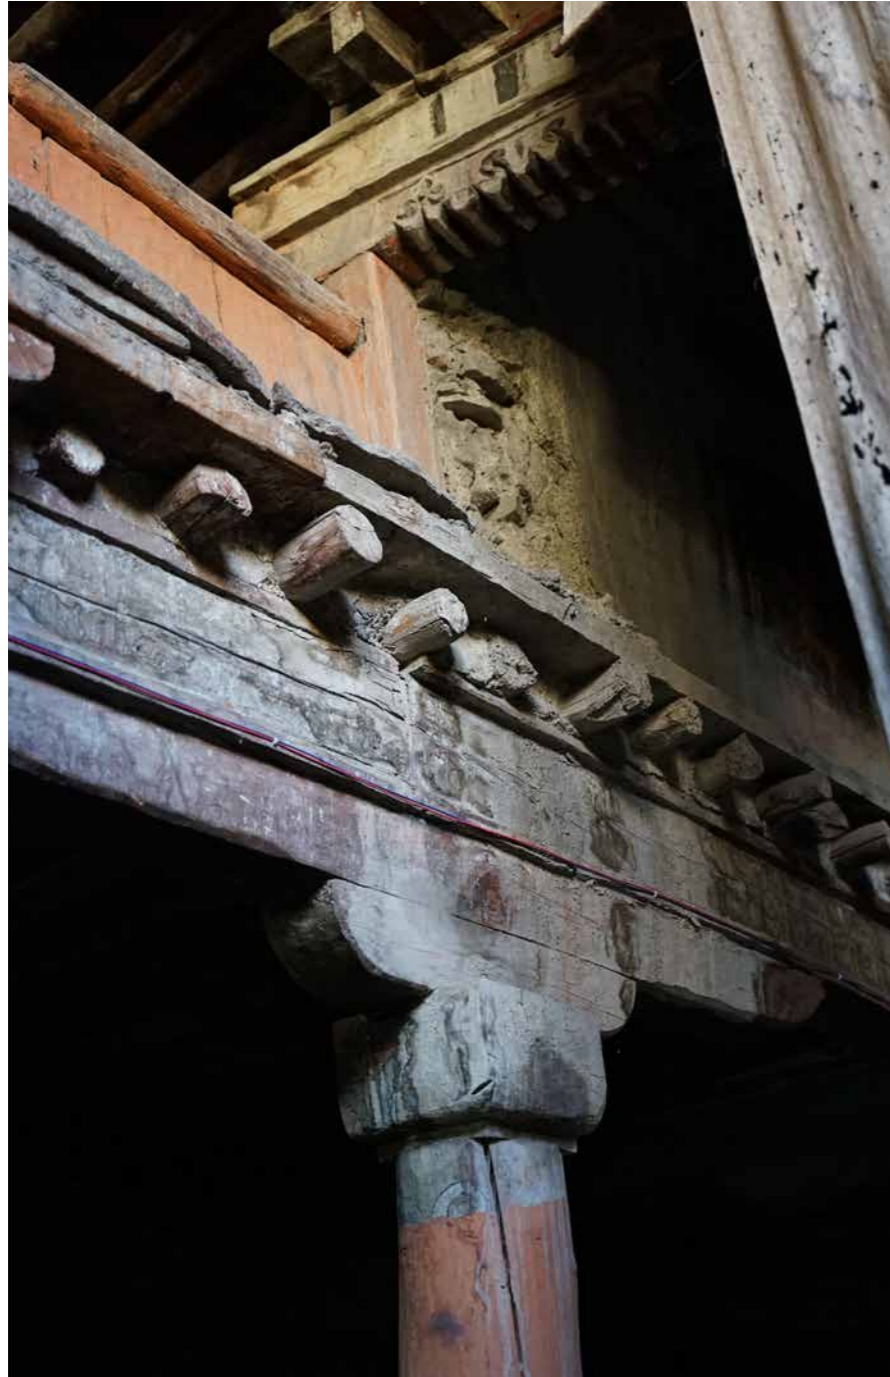
WATER DAMAGE  
Note the leaning pillar in the center.
