## **SEISMIC STRENGTHENING AND RESTORATION OF GONPA GANG**

DAMAGE ASSESSMENT AND RESTORATION CONCEPT

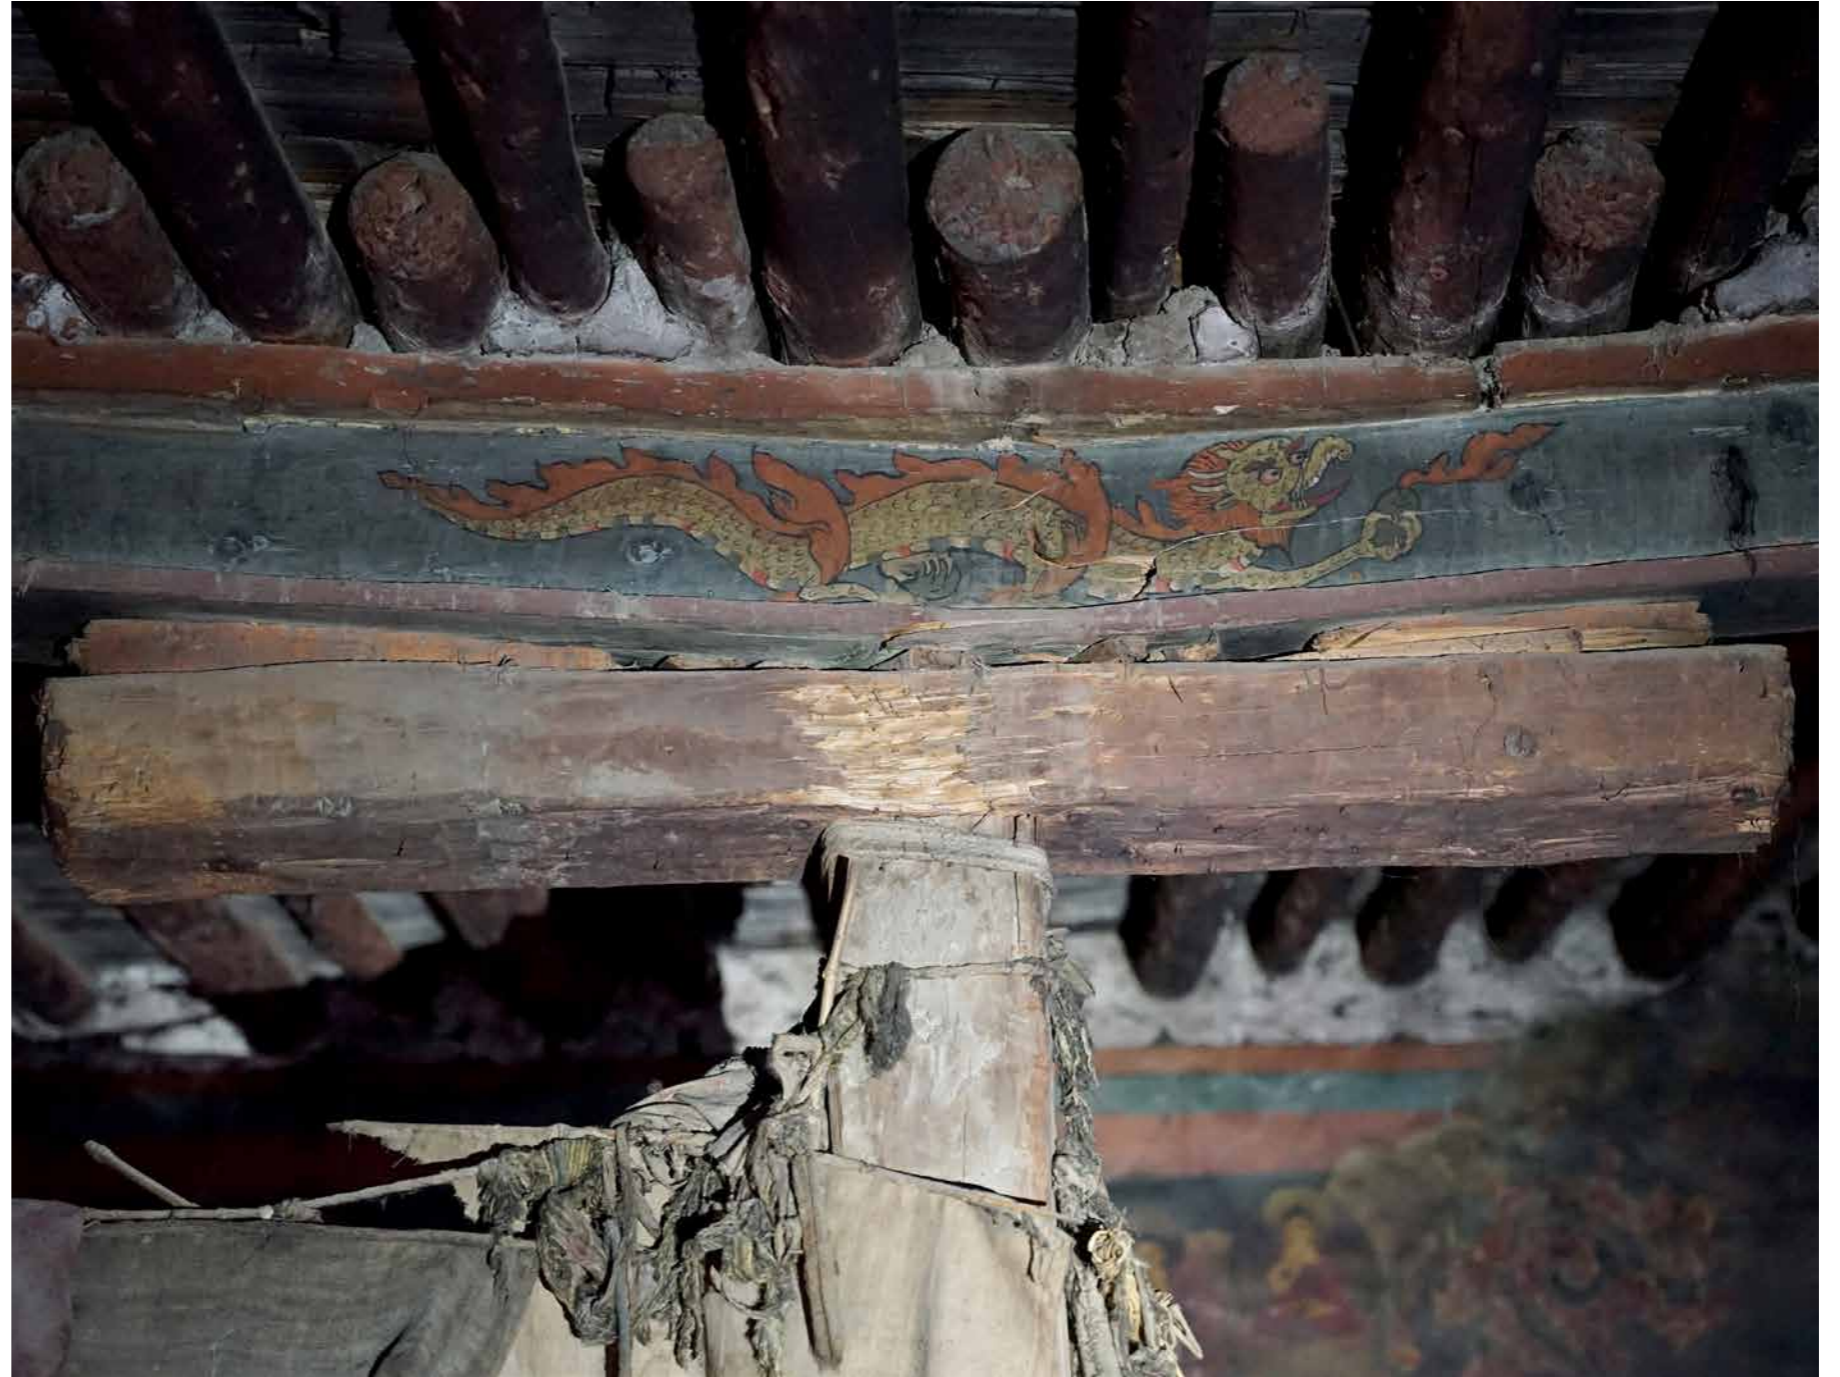
DAMAGE BEYOND REPAIR

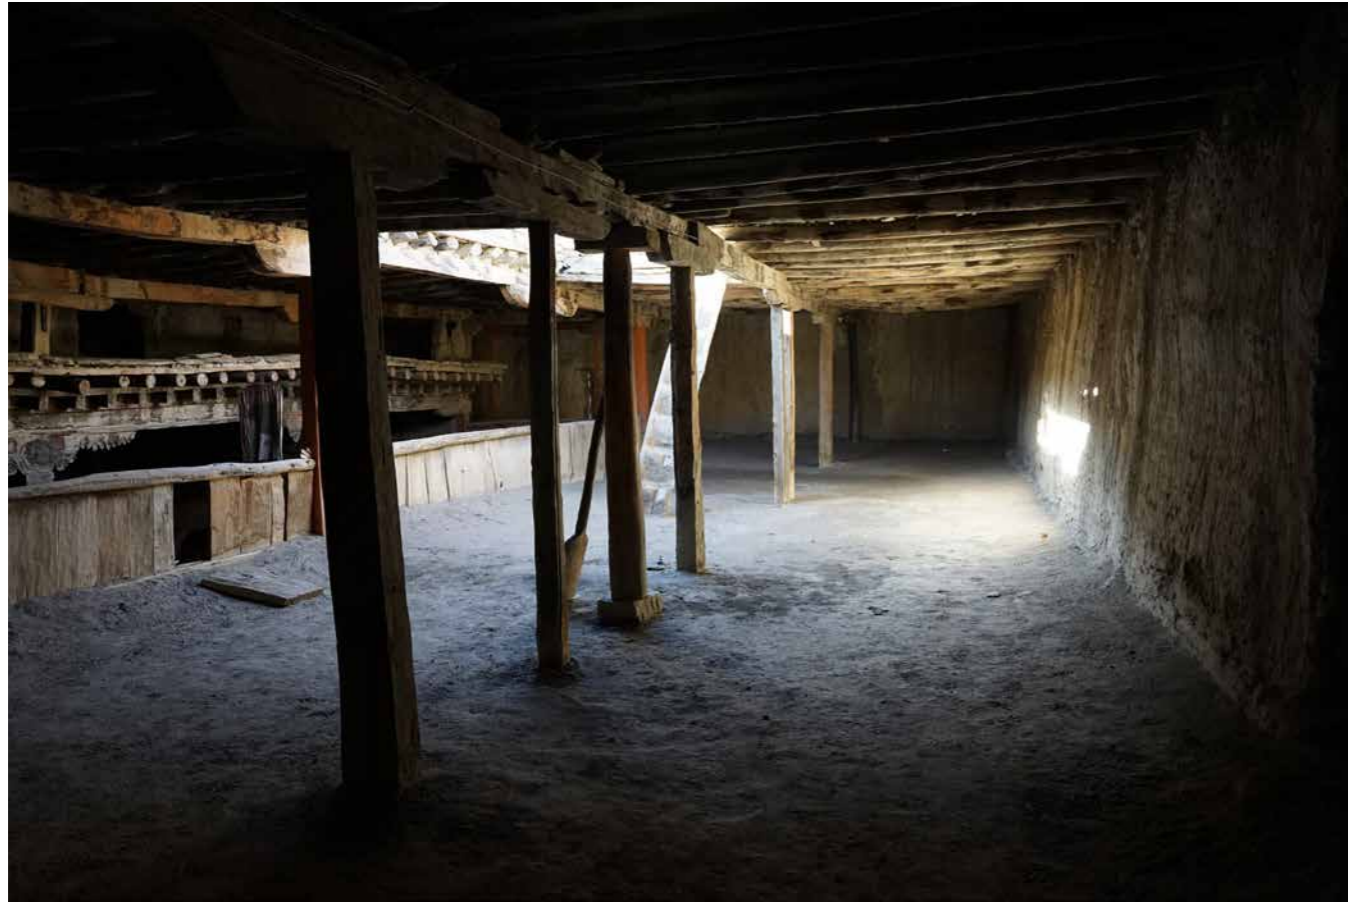
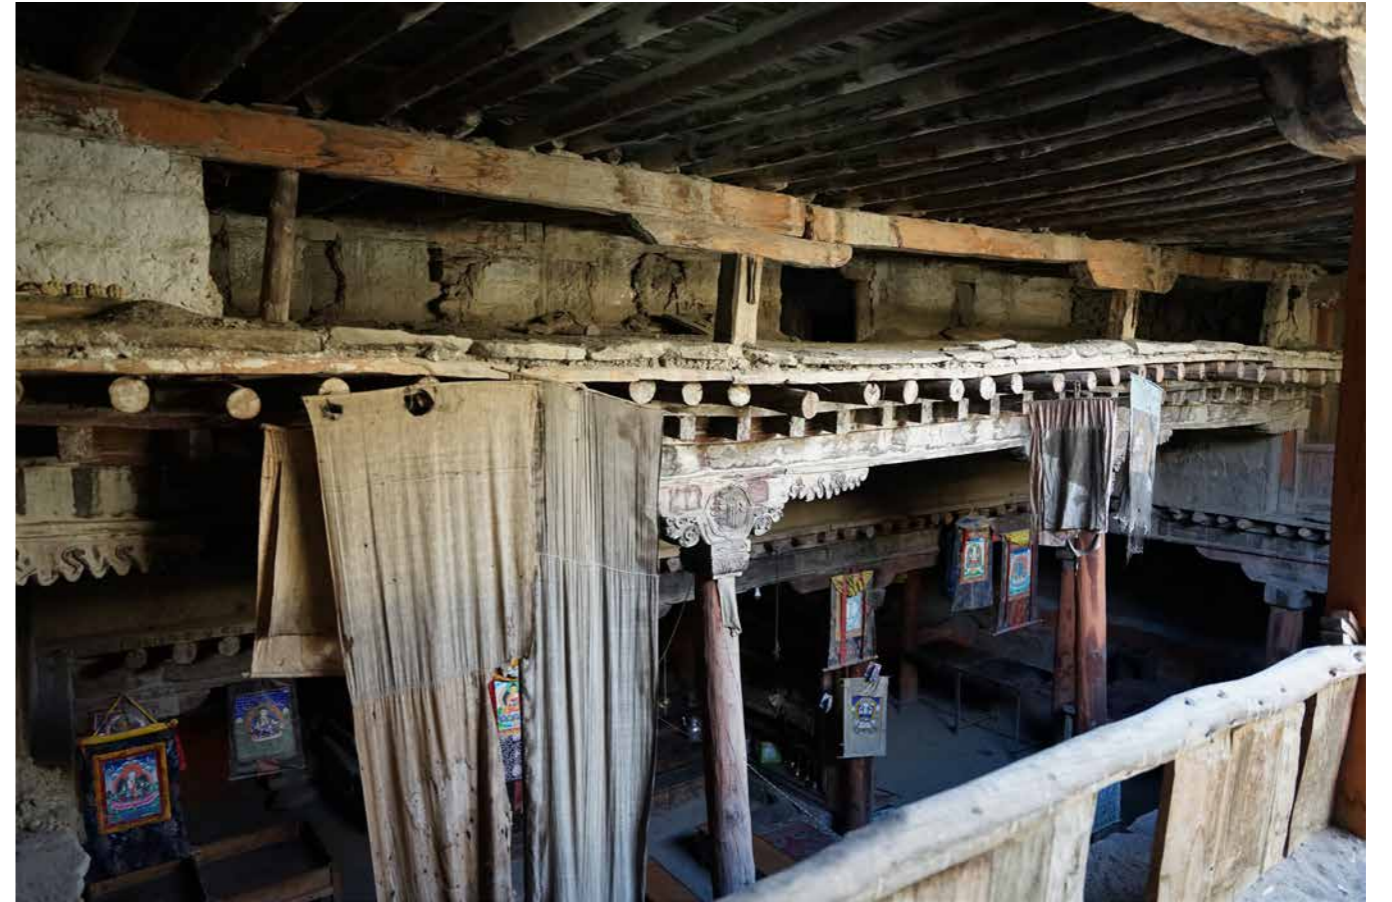
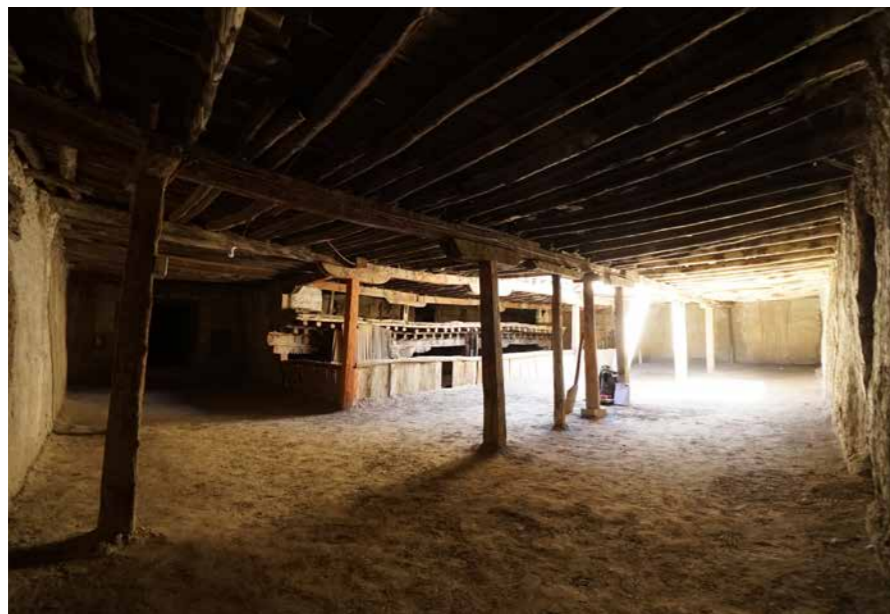
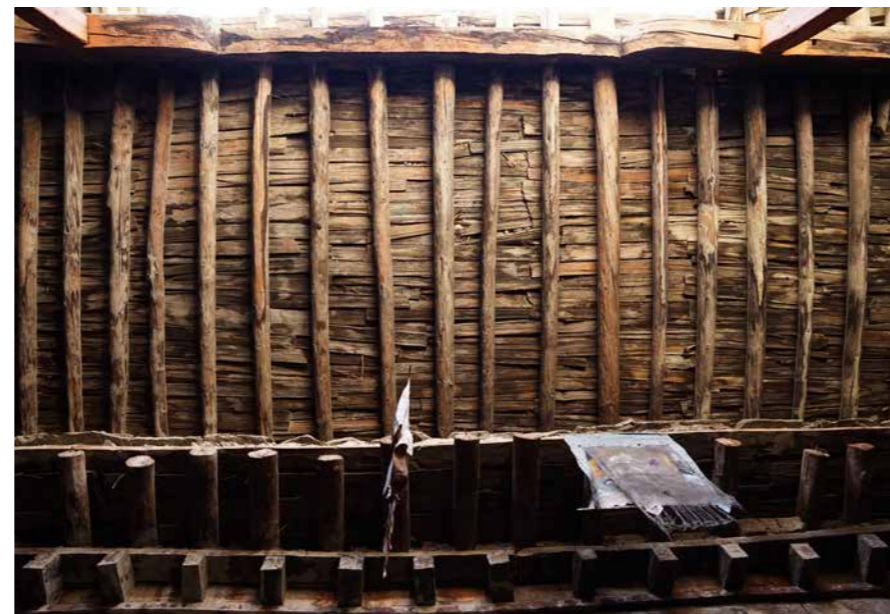
DHUKHANG GALLERY  
UPPER FLOOR – U04

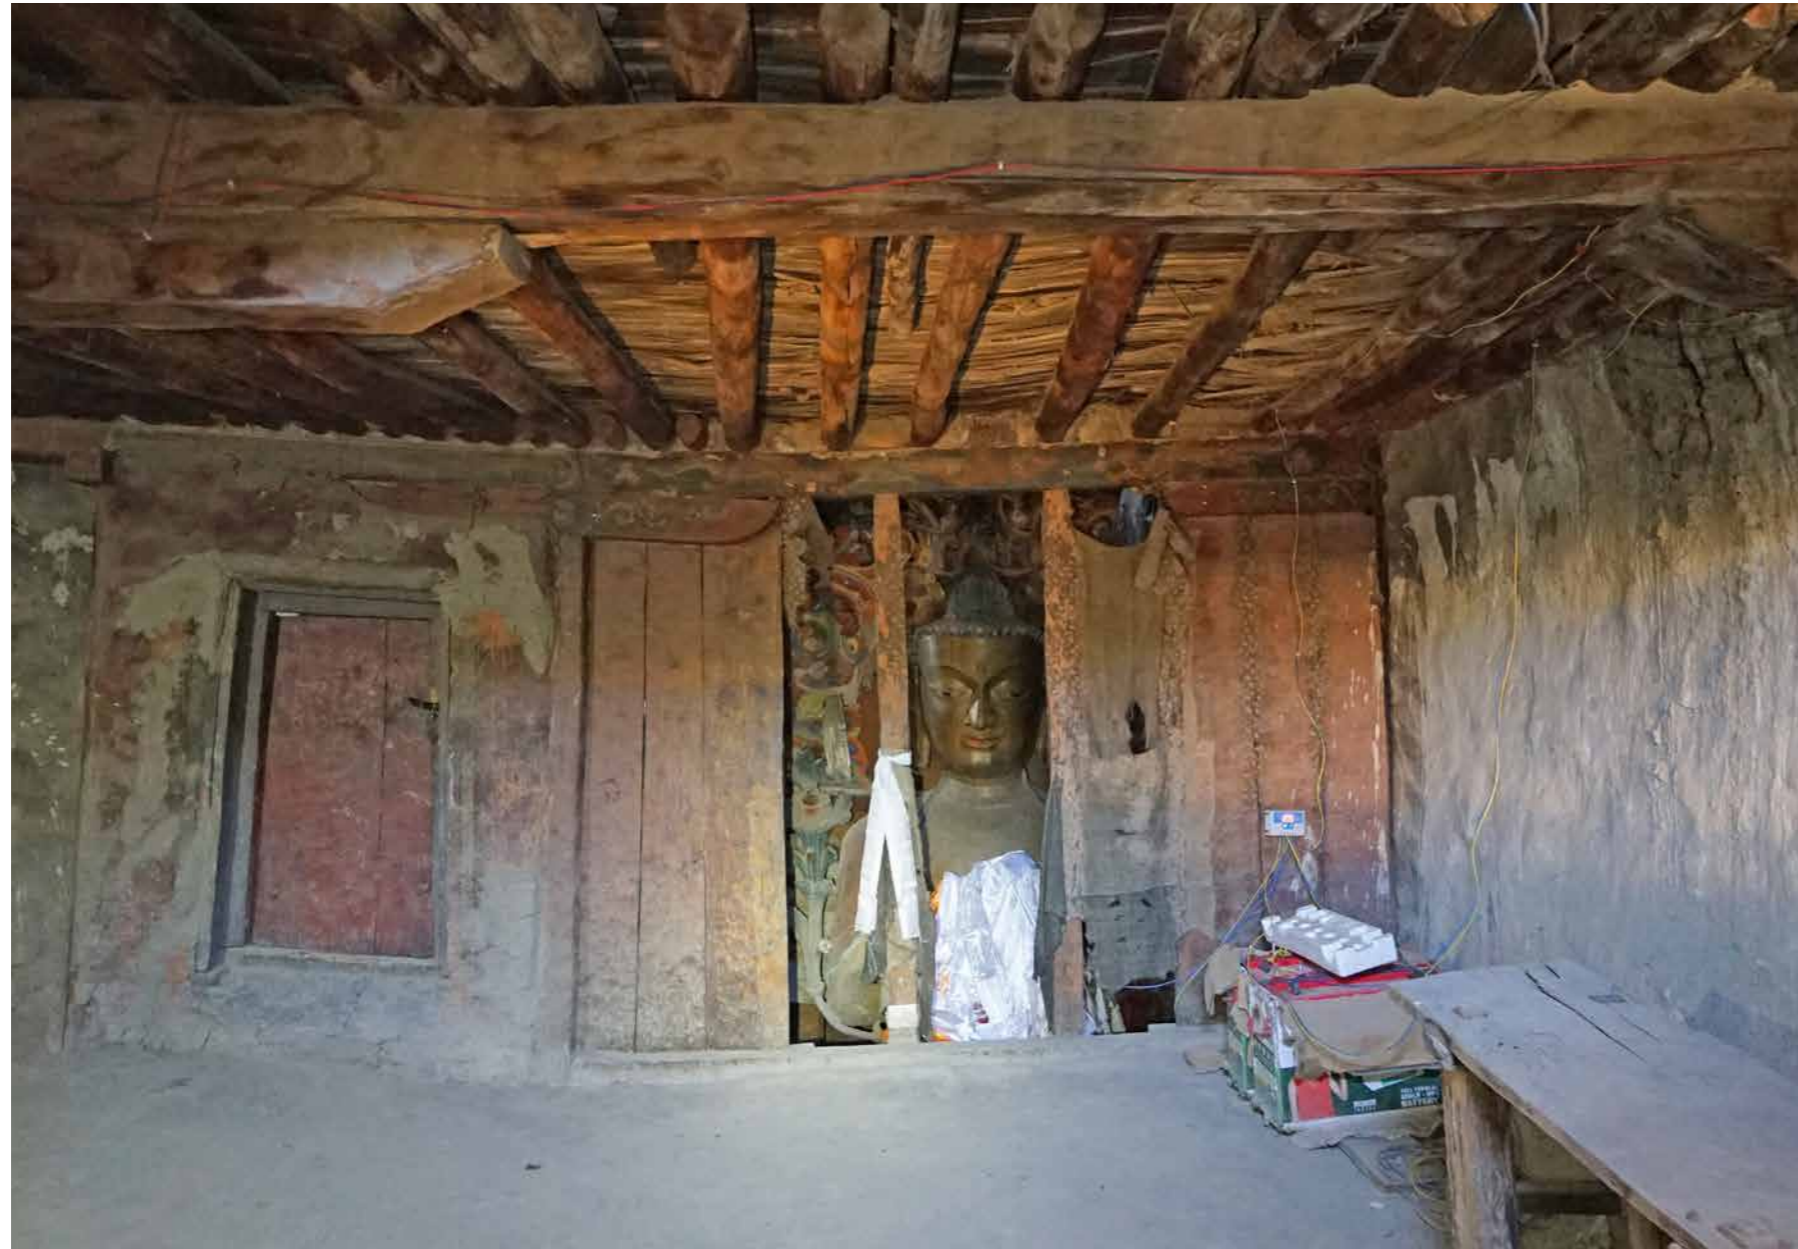
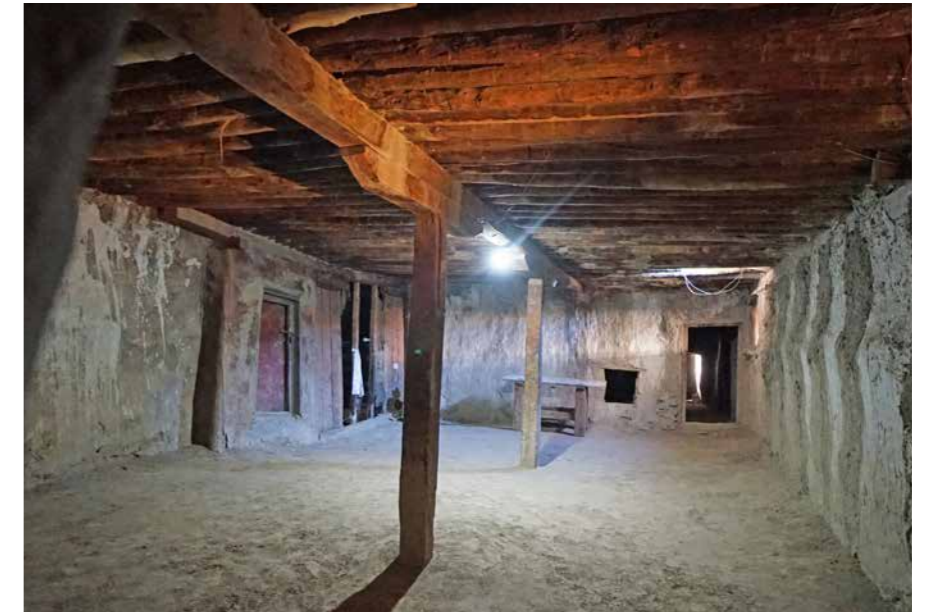
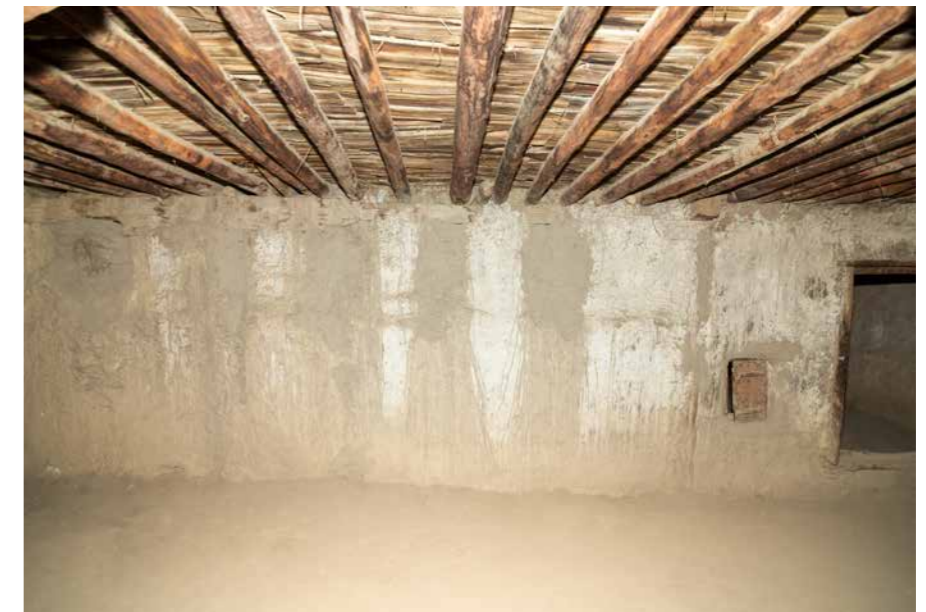
**UPPER ROOMS**  
The northern two bays above the dhukhang are divided into two rooms. One opens to the sanctum and faces Maitreya on eye level. The other room remains unused. Two wooden doors lead to the balcony that allows circumambulation of Maitreya, however, the doors were locked during the field visit to Gonpa Gang.

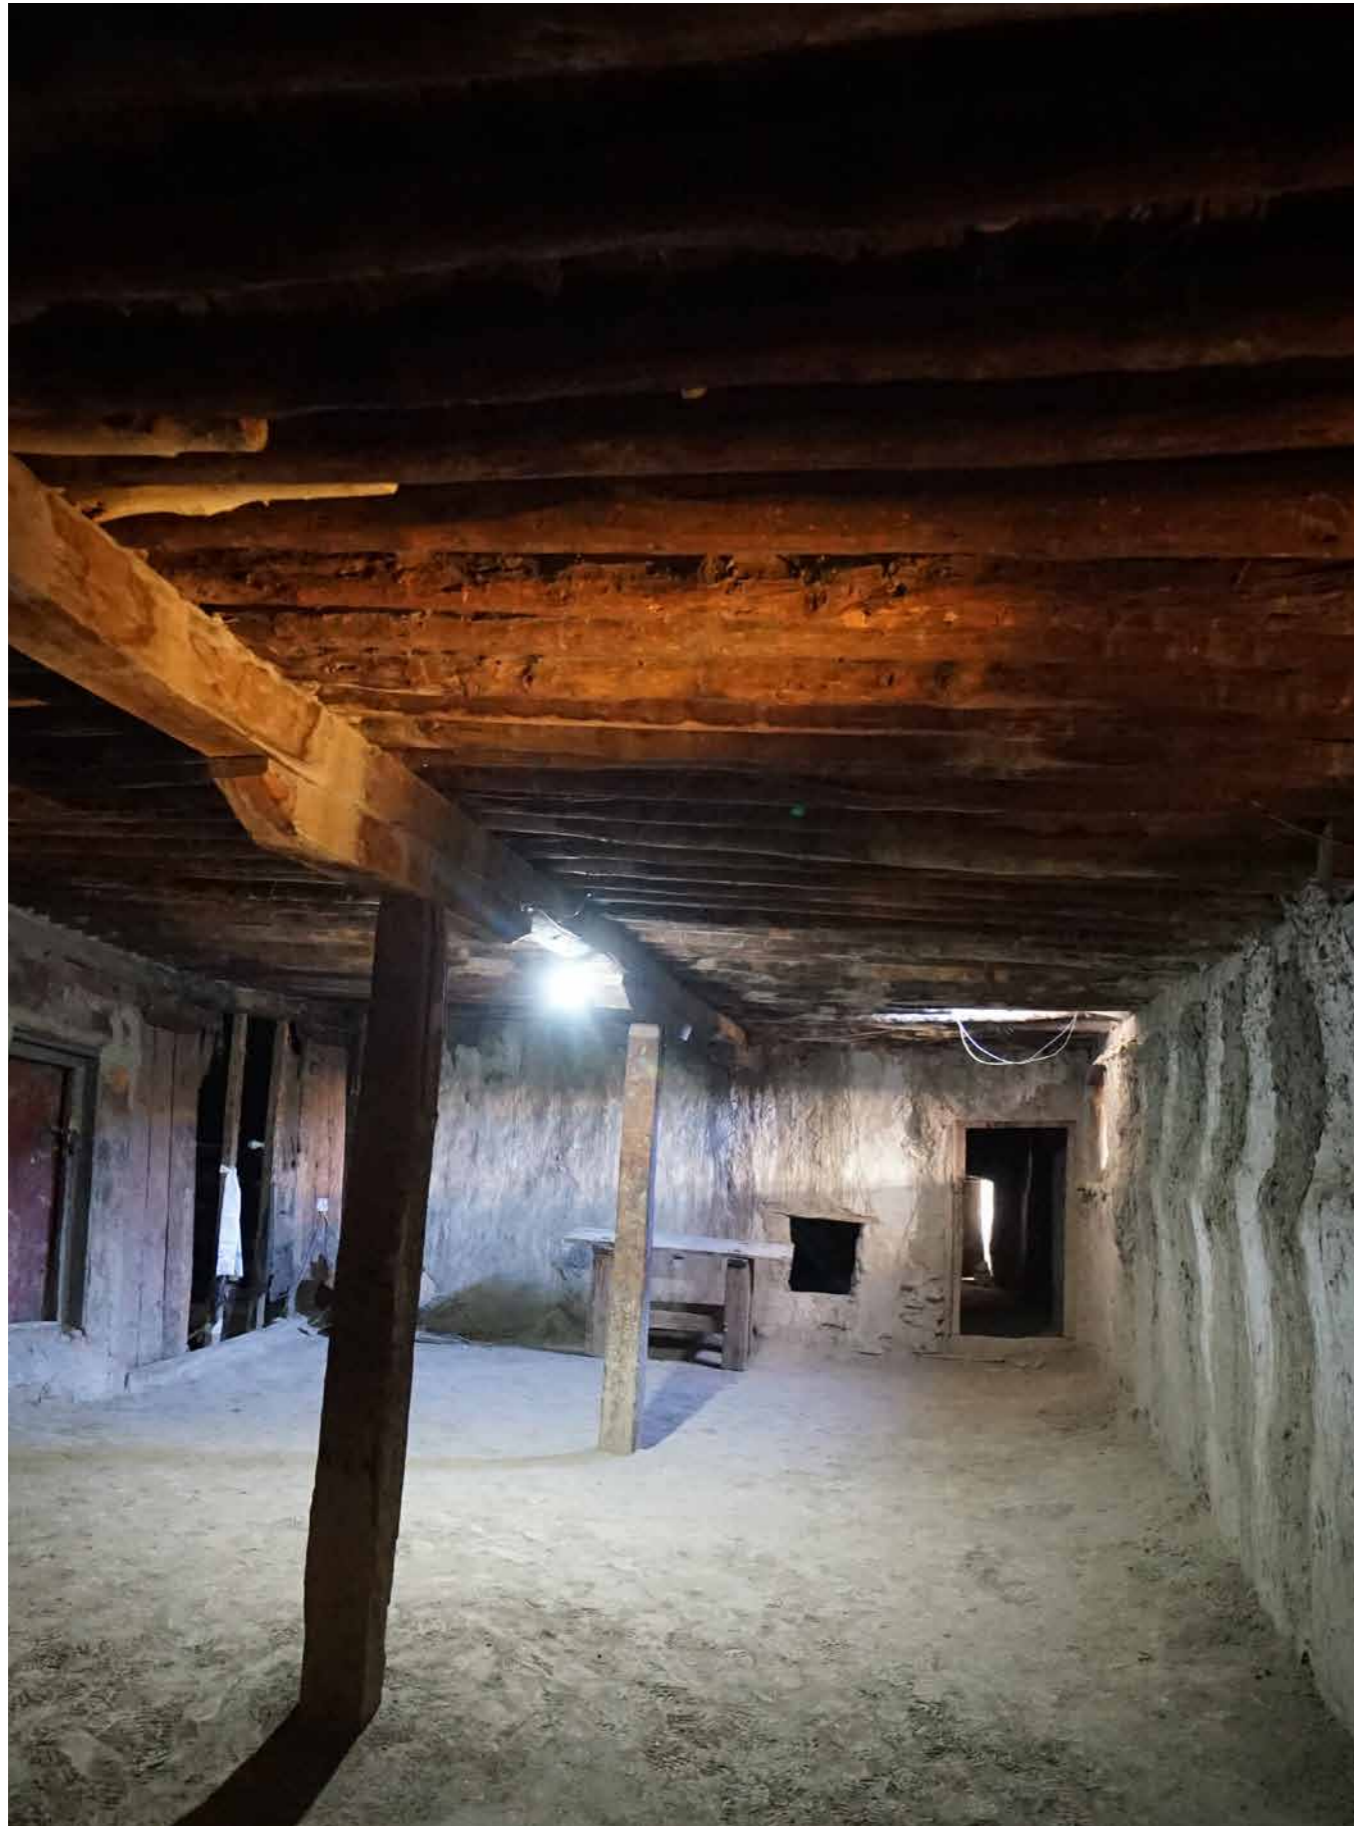
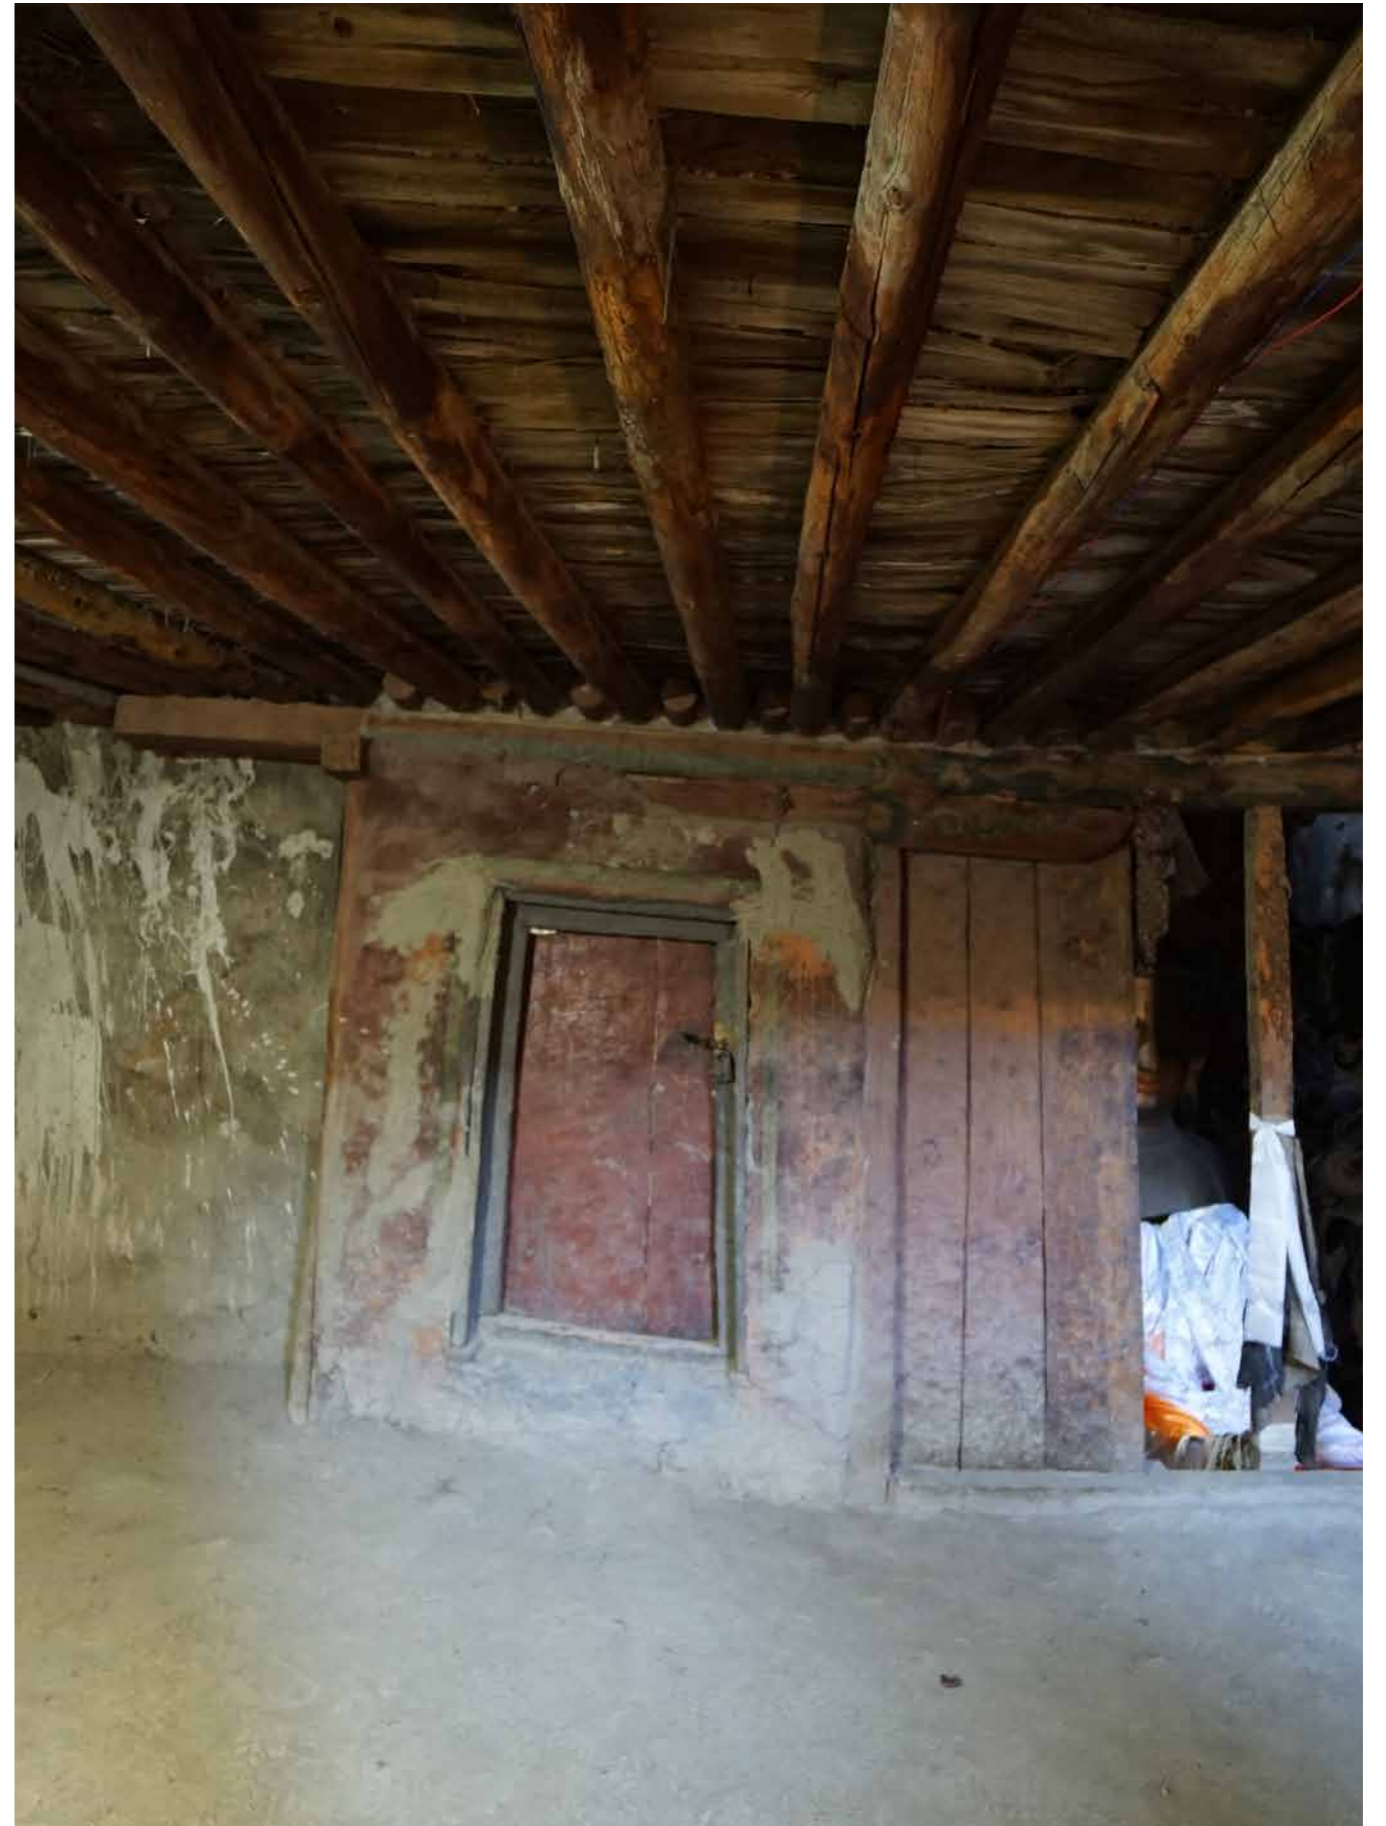
## SANCTUM – MAITREYA GROUND FLOOR – L01

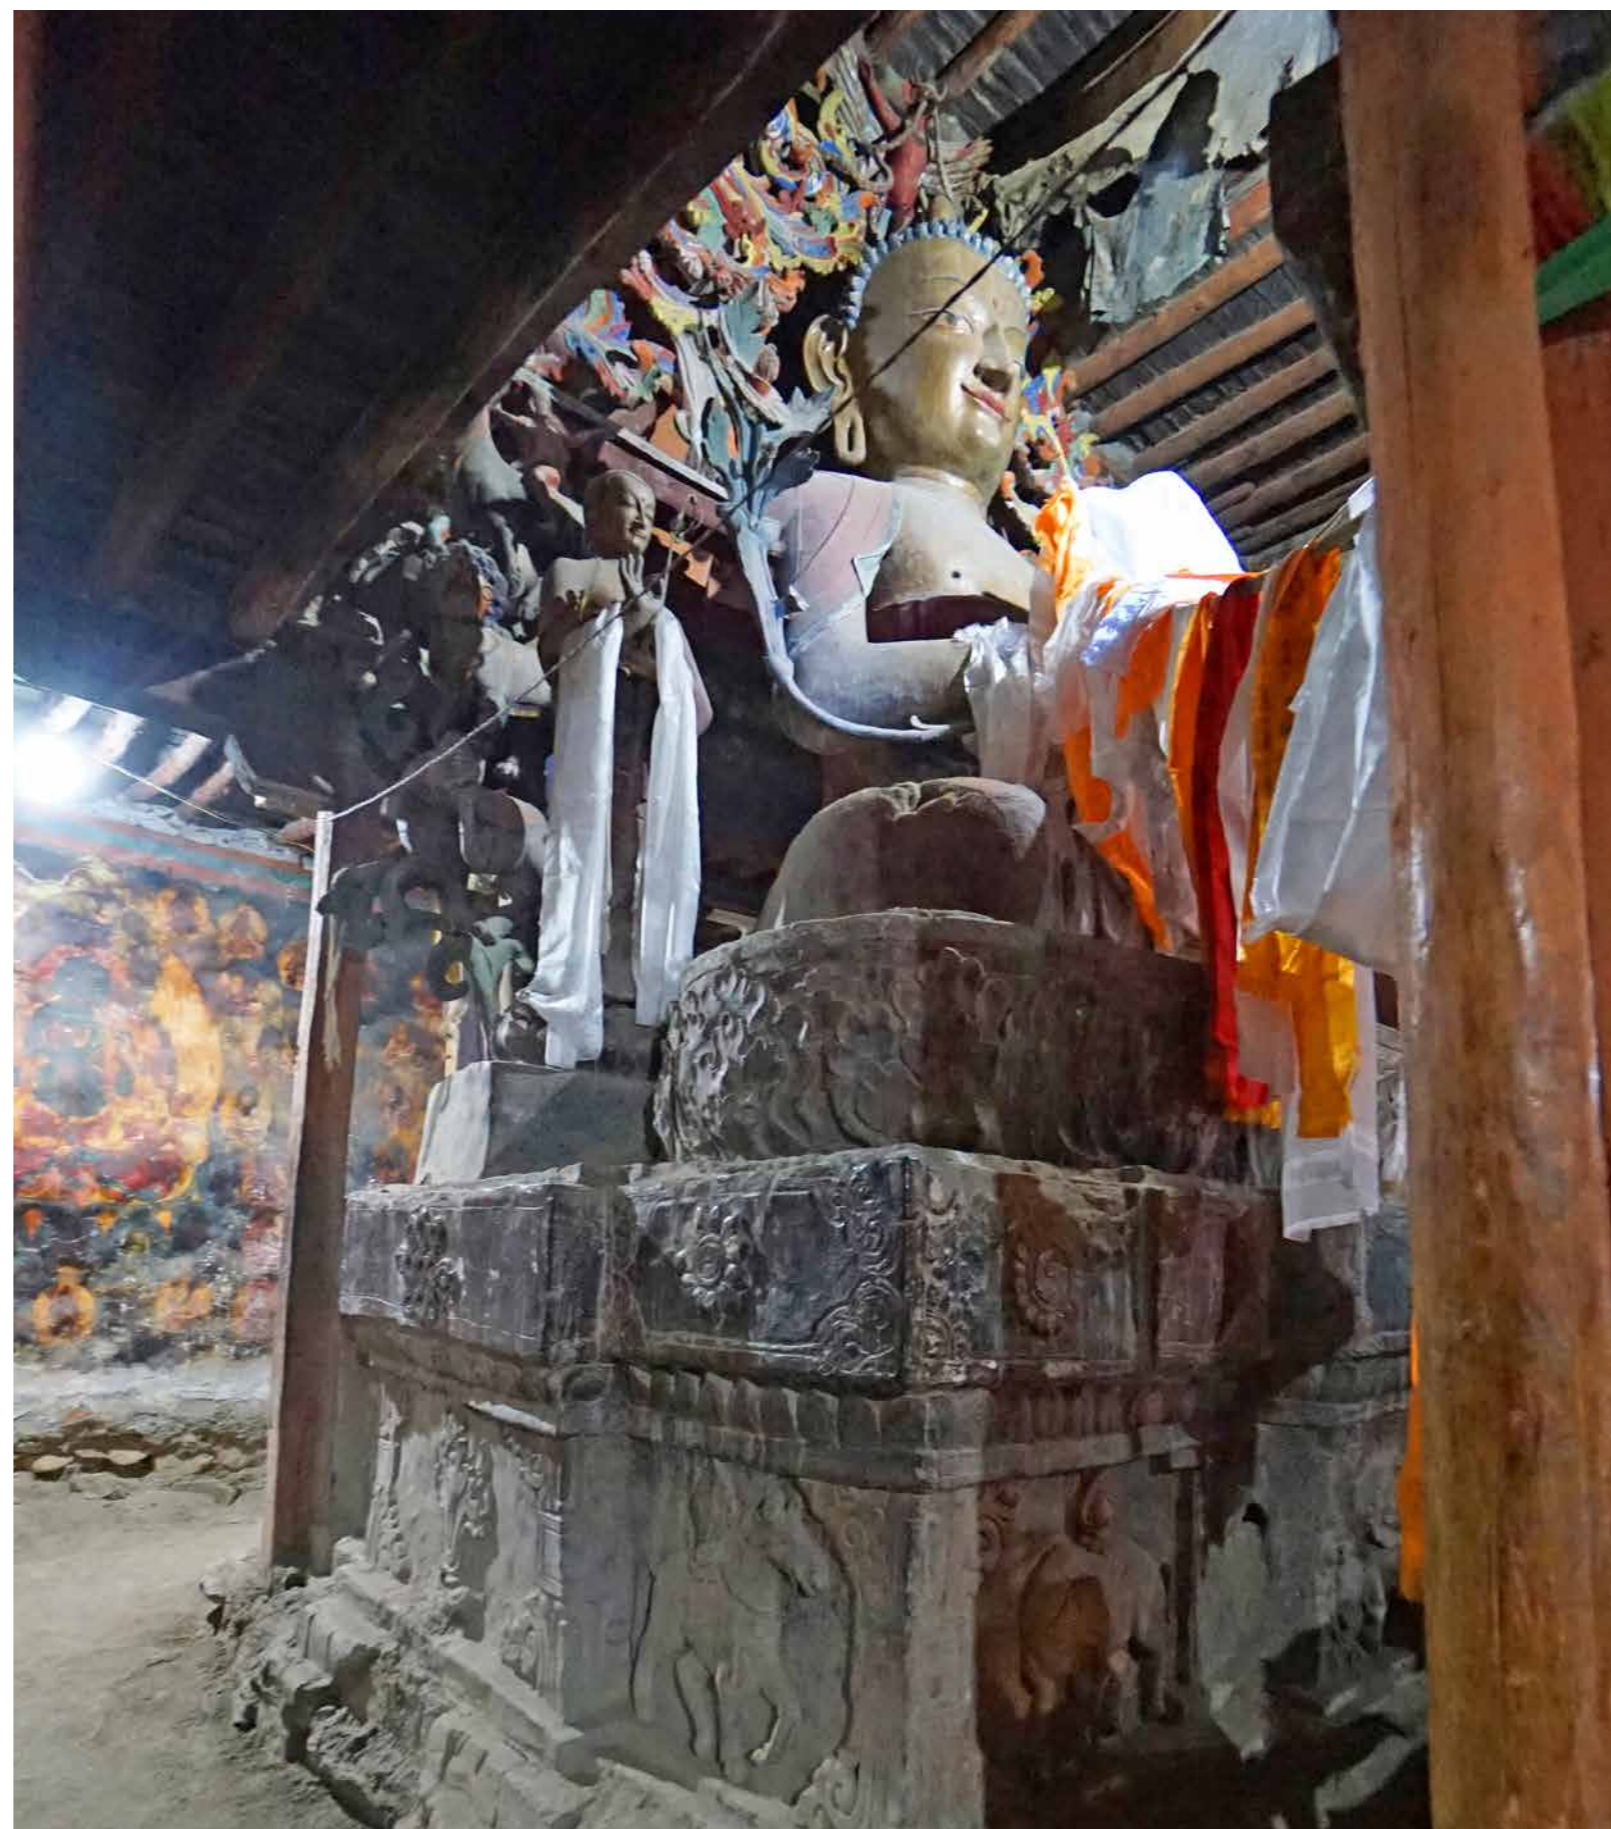
The sanctum's ceiling is supported by four peeled poplar posts with plain hand-hewn brackets and cross beams. The sagging balcony indicates structural problems. The sanctum is the best maintained and protected area of the monastery as no damage to the Maitreya statue, with the exception of the throne, is evident.

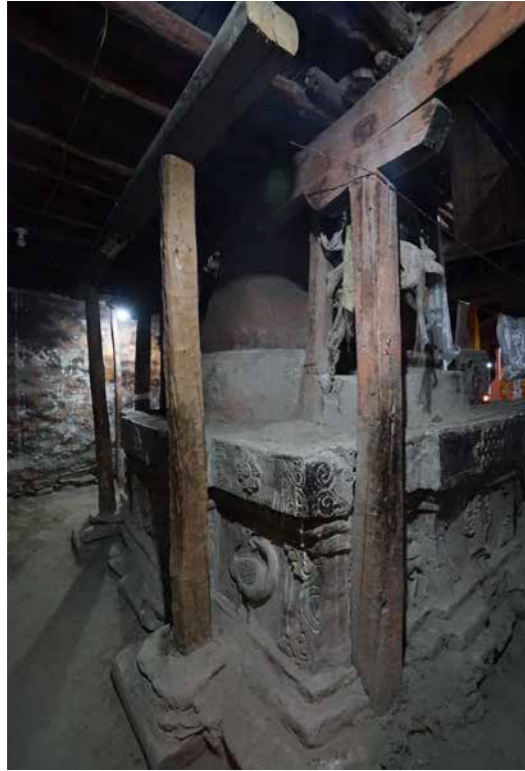
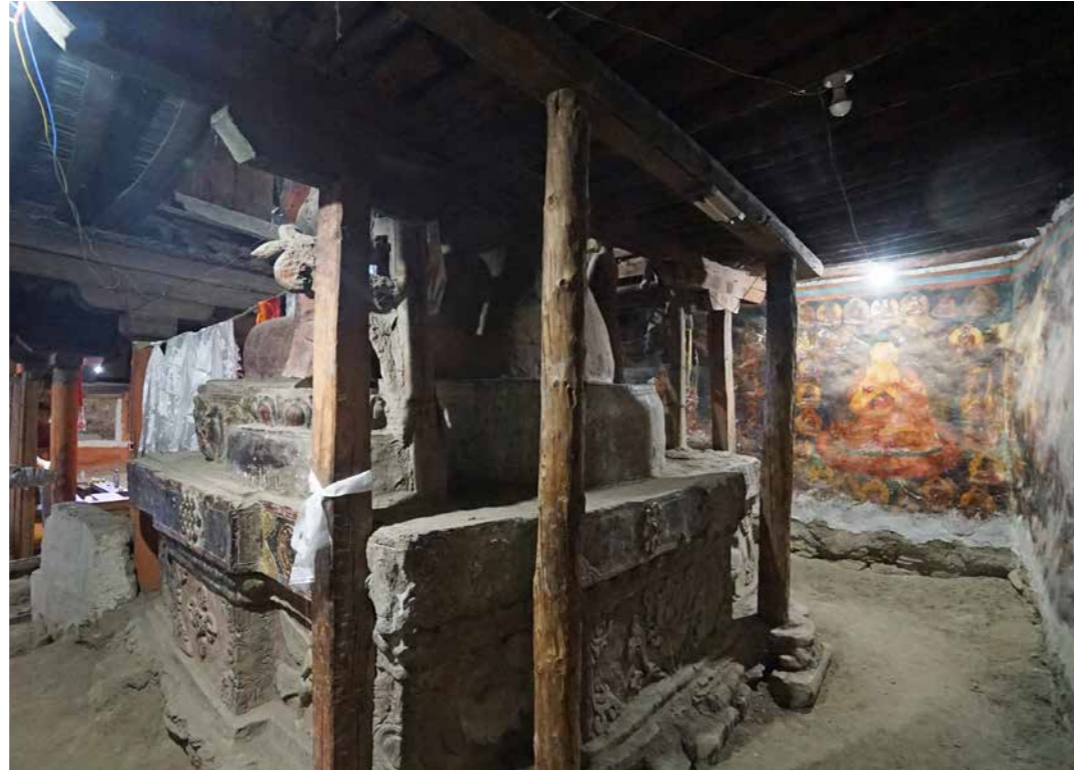
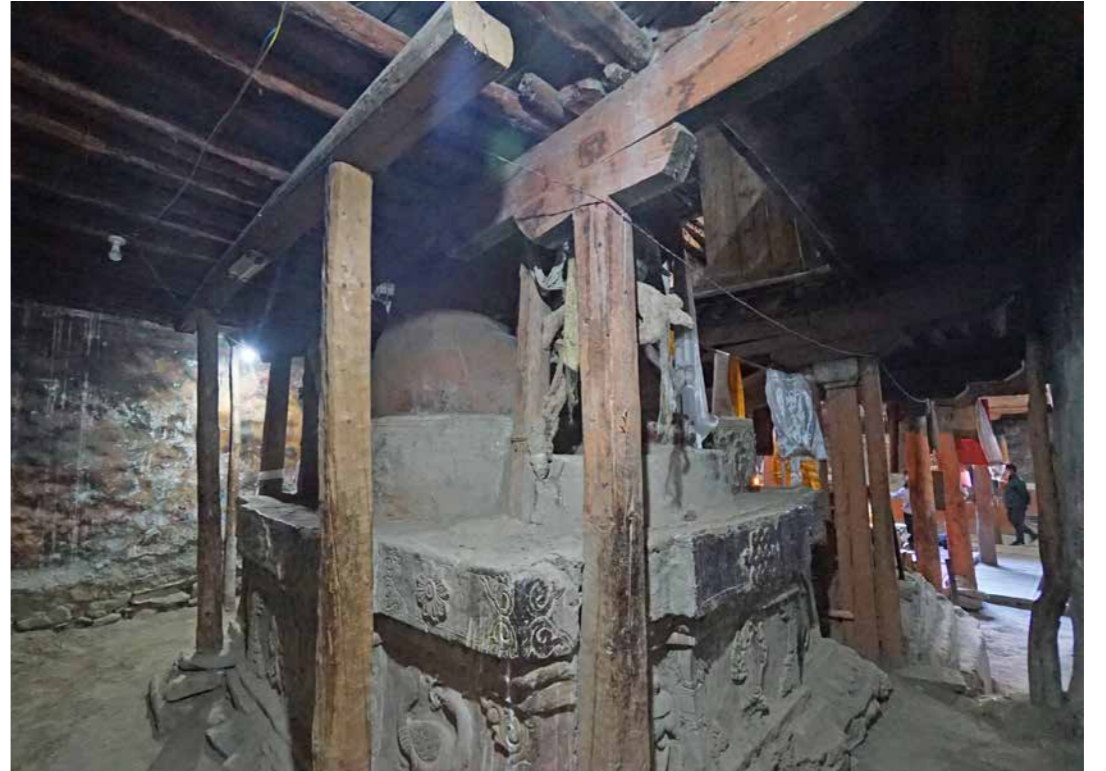
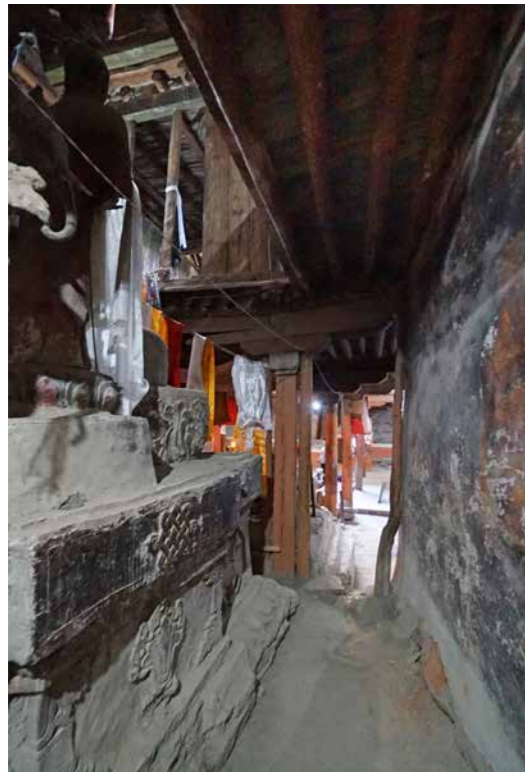
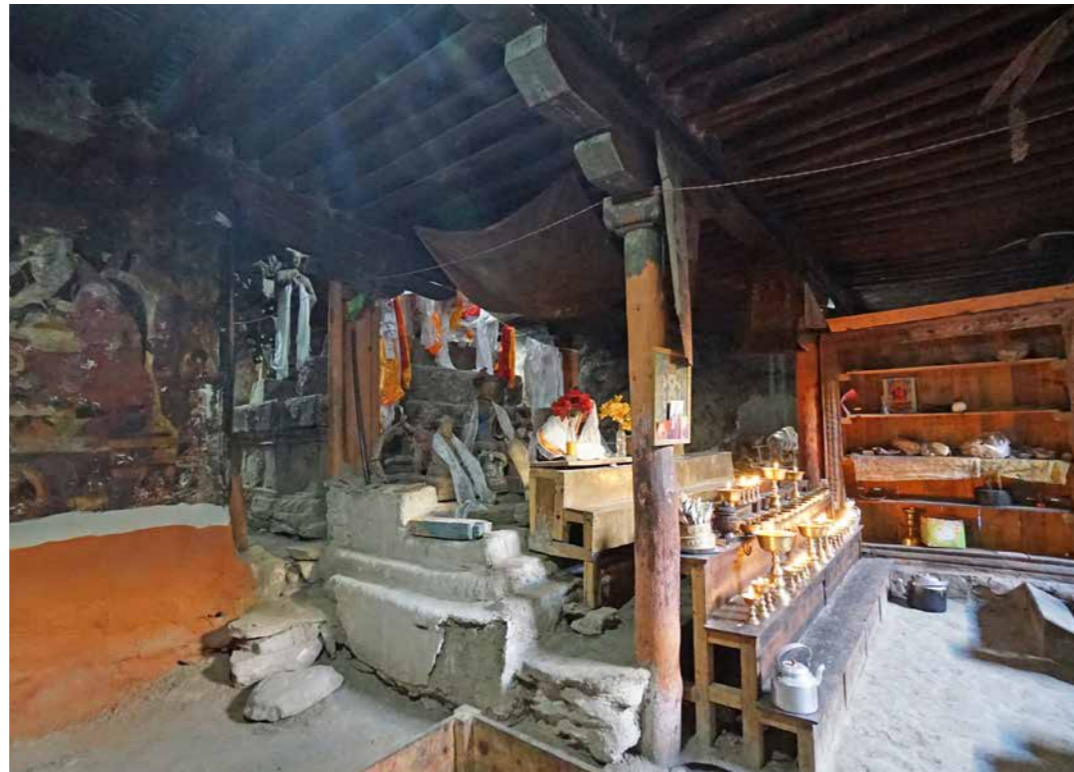
**SANCTUM WITH A CLAY STATUE OF MAITREYA**  
 The balcony above the sanctum has been propped up with additional posts and beams, It is evident that the bearing timber structure has been weakened by wet rot. The walls facing north and east are affected by damp which already caused to the wall paintings.

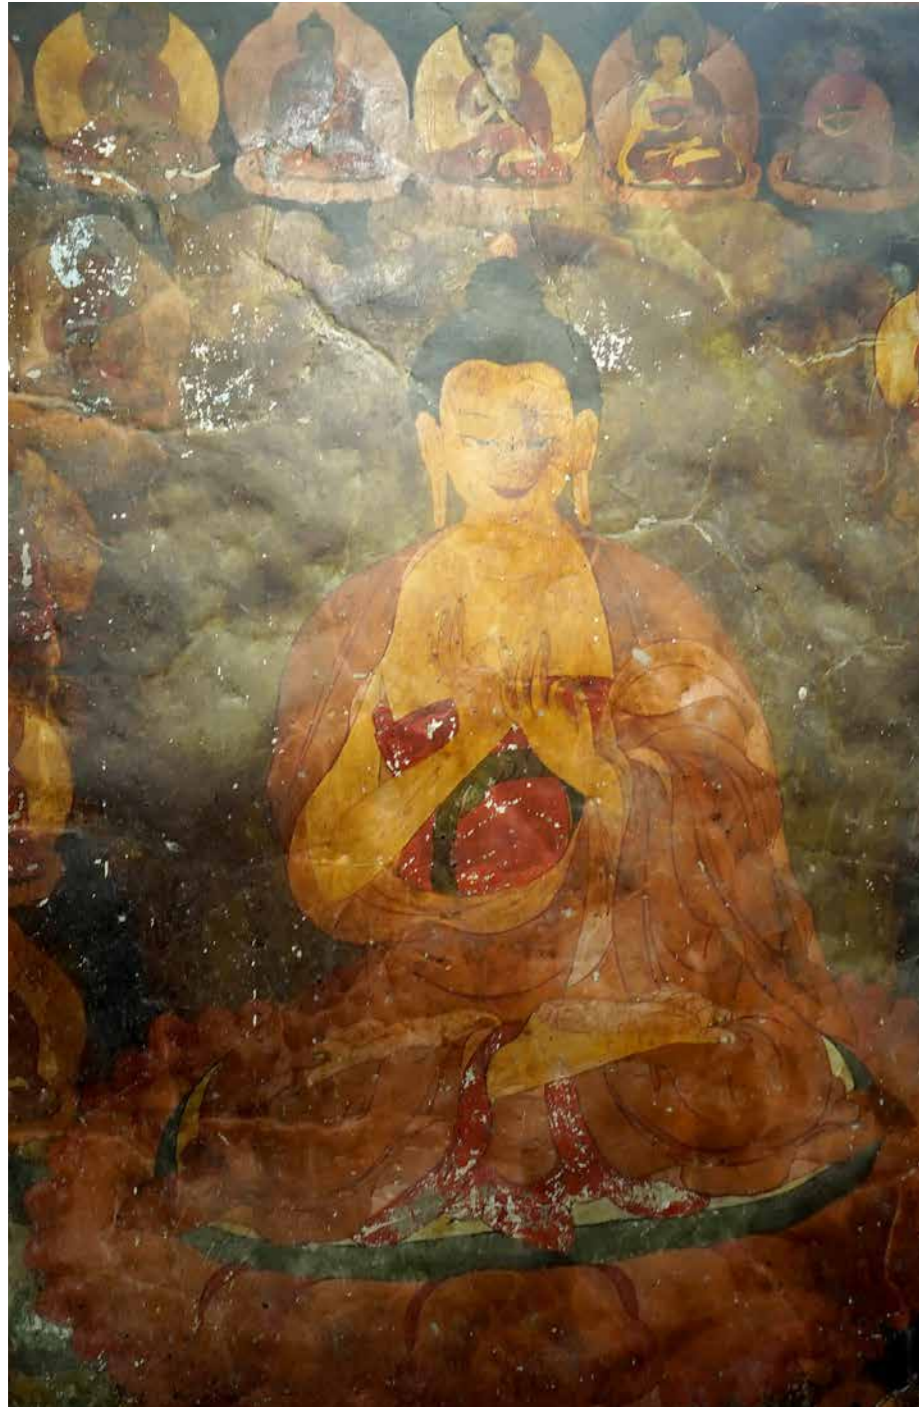
WALL PAINTING DEPICTING BUDDHA  
Flaking of the paint layer is an indication of damp walls.
