## **SEISMIC STRENGTHENING AND RESTORATION OF GONPA GANG**

DAMAGE ASSESSMENT AND RESTORATION CONCEPT

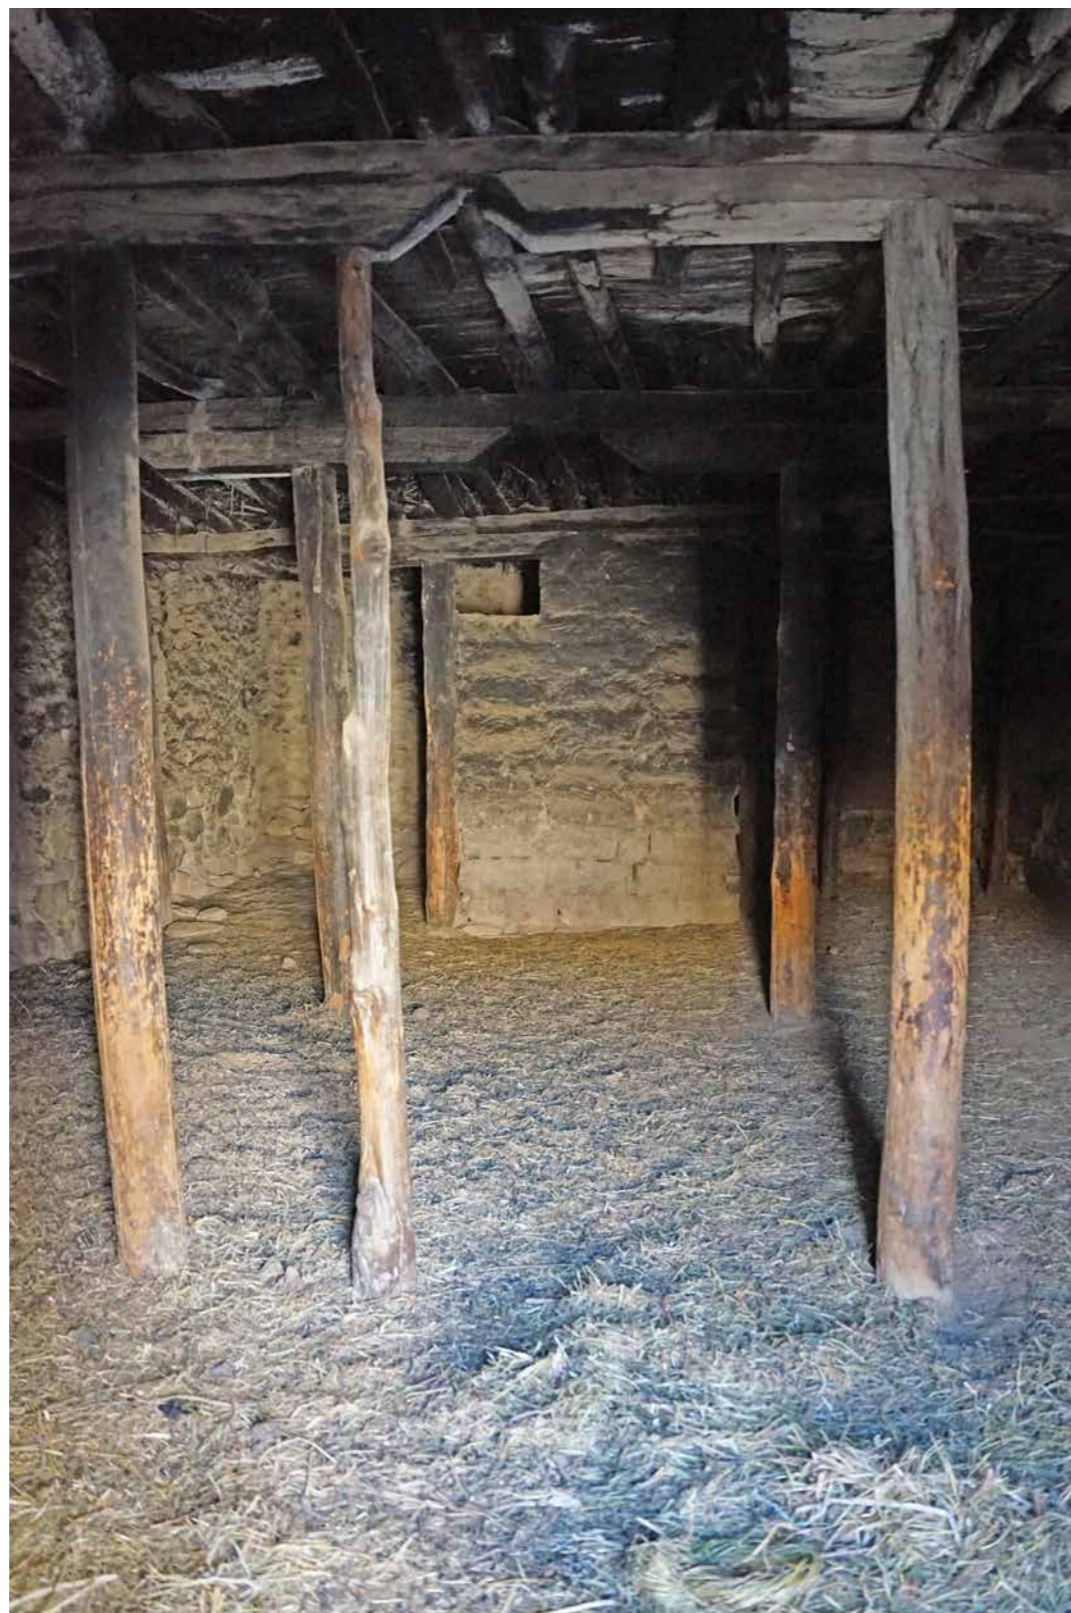
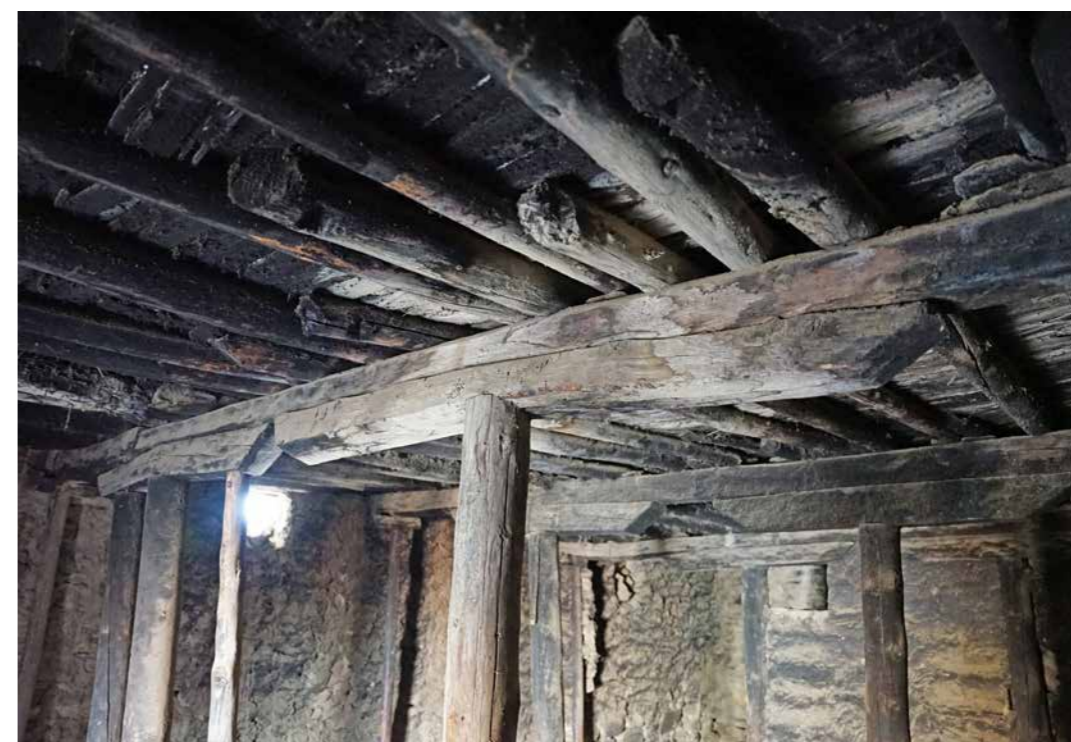
**MAKESHIFT REPAIRS**

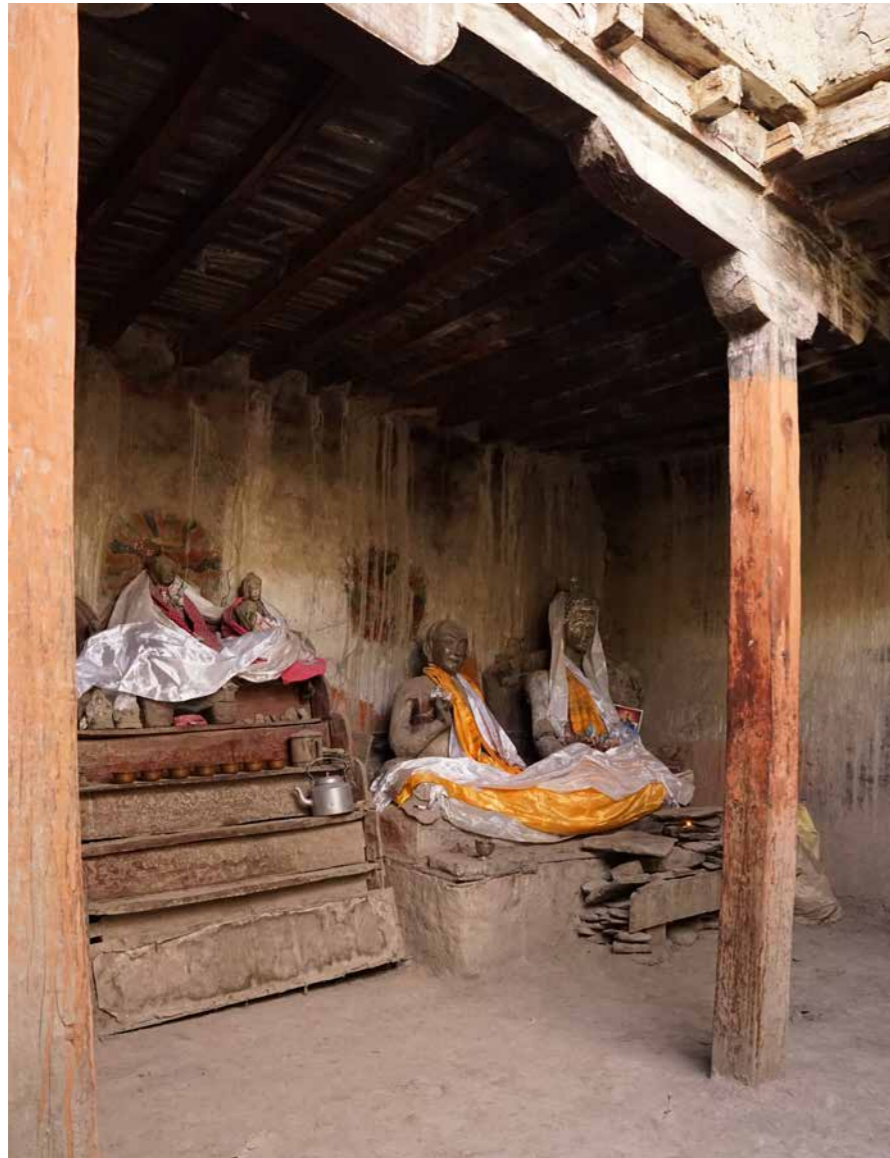
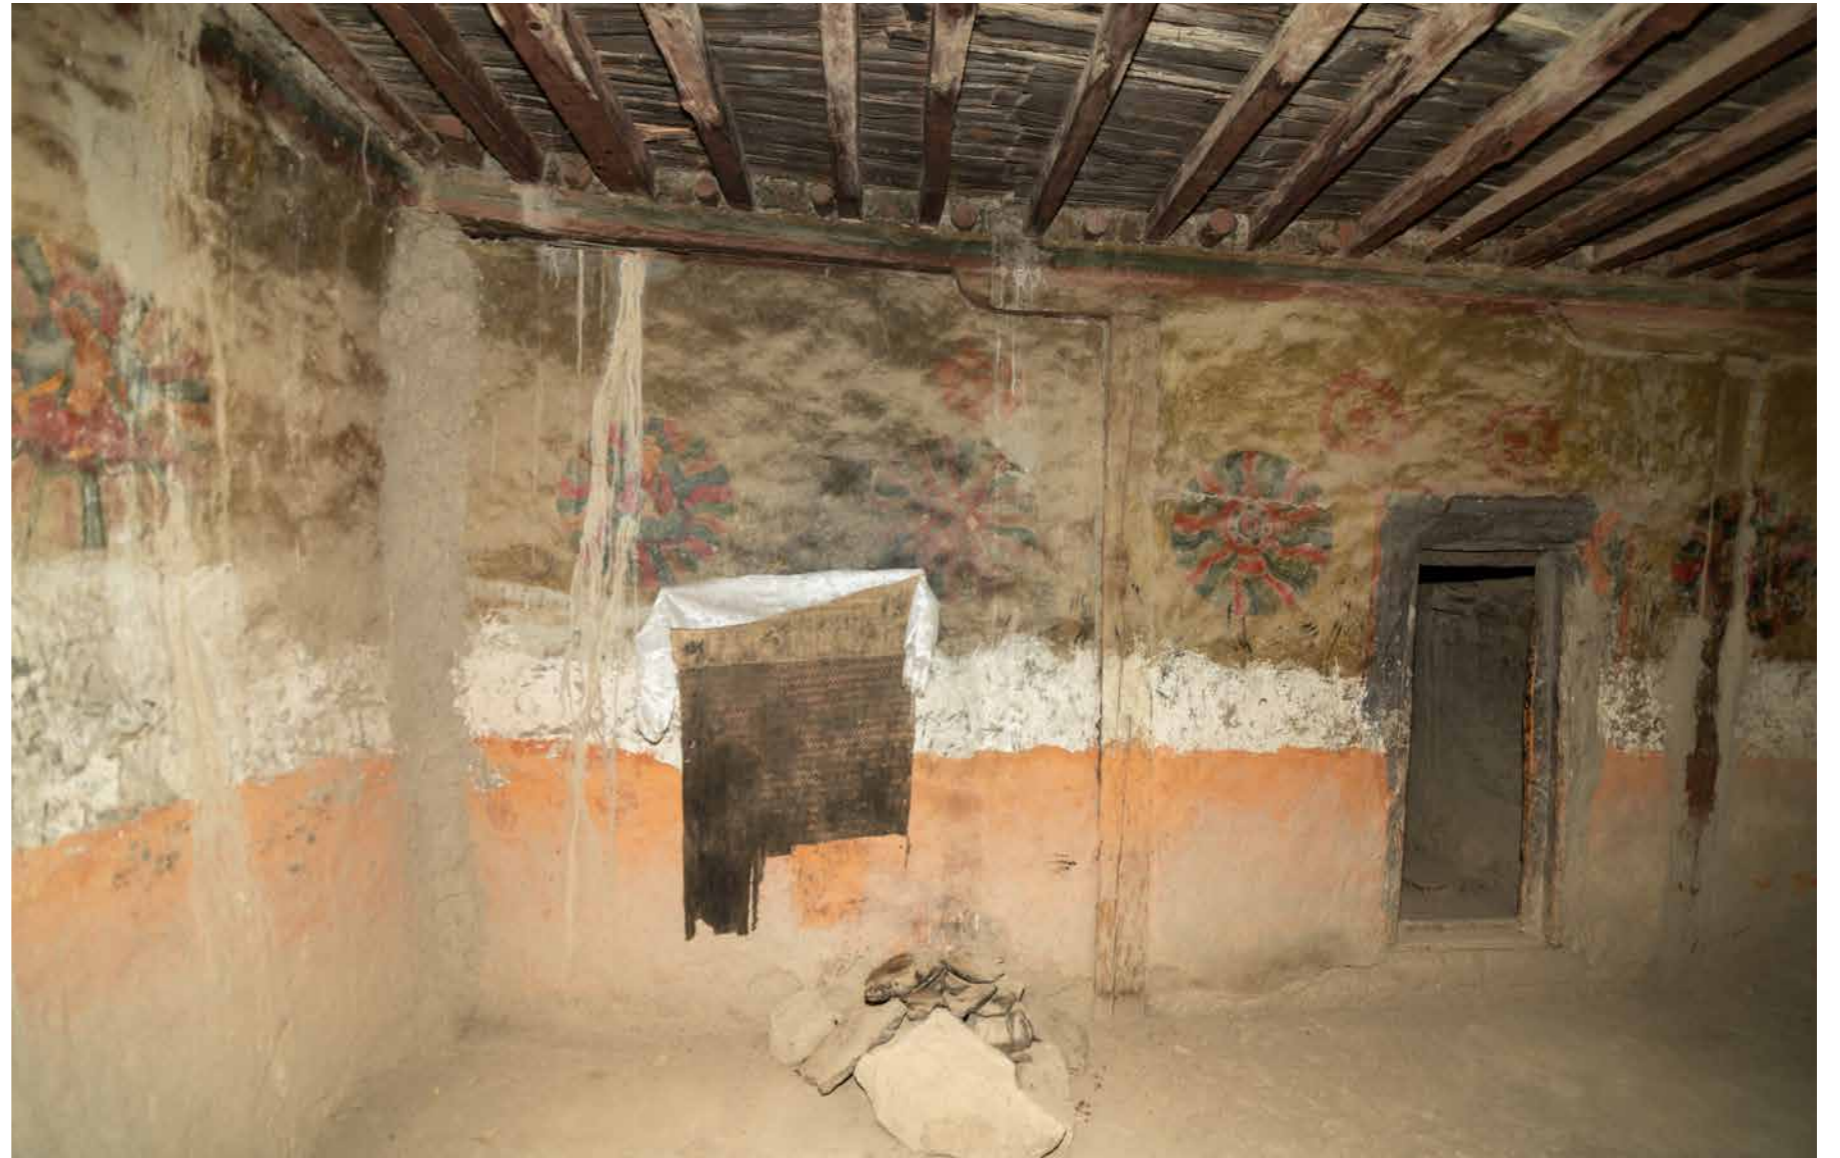
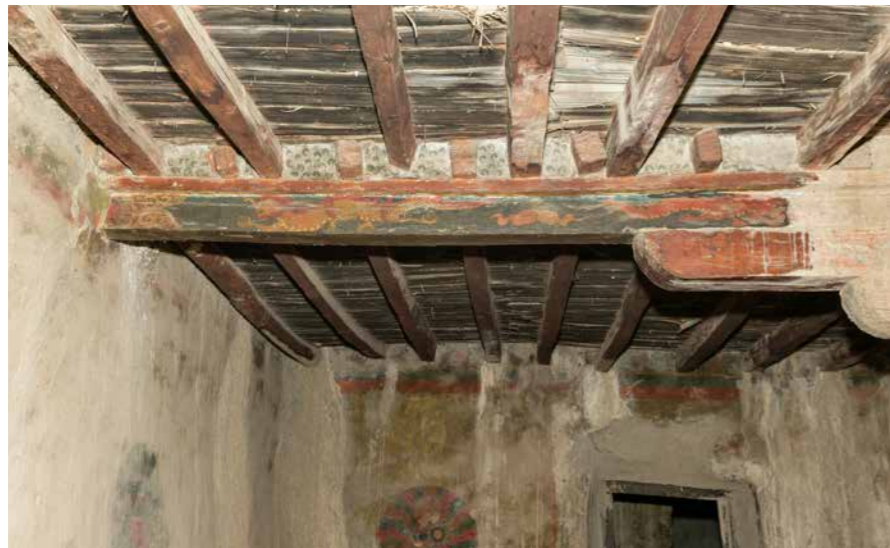
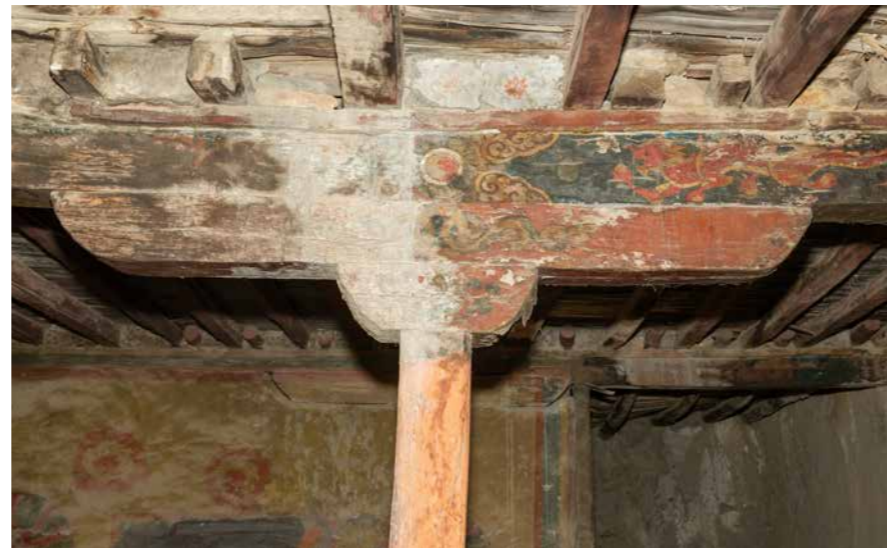
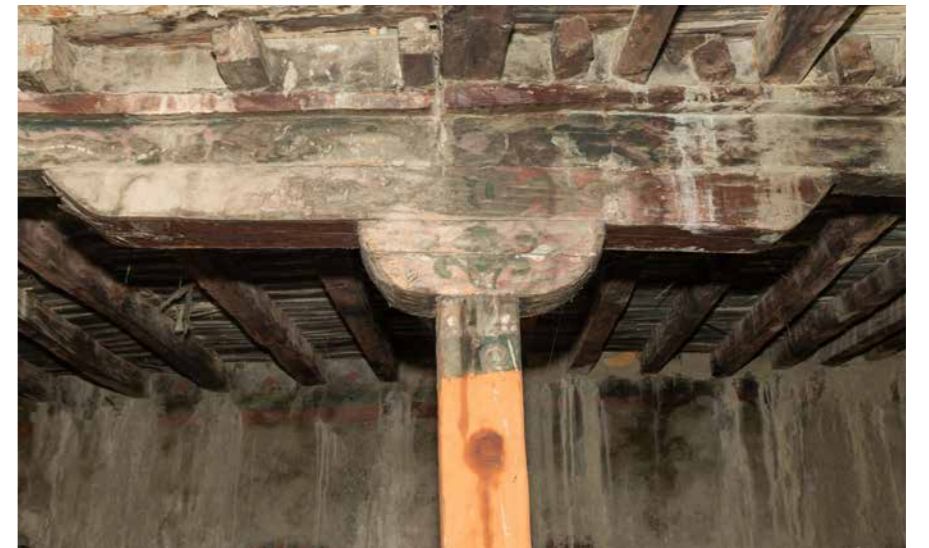
FODDER STORAGE  
GROUND FLOOR – L06

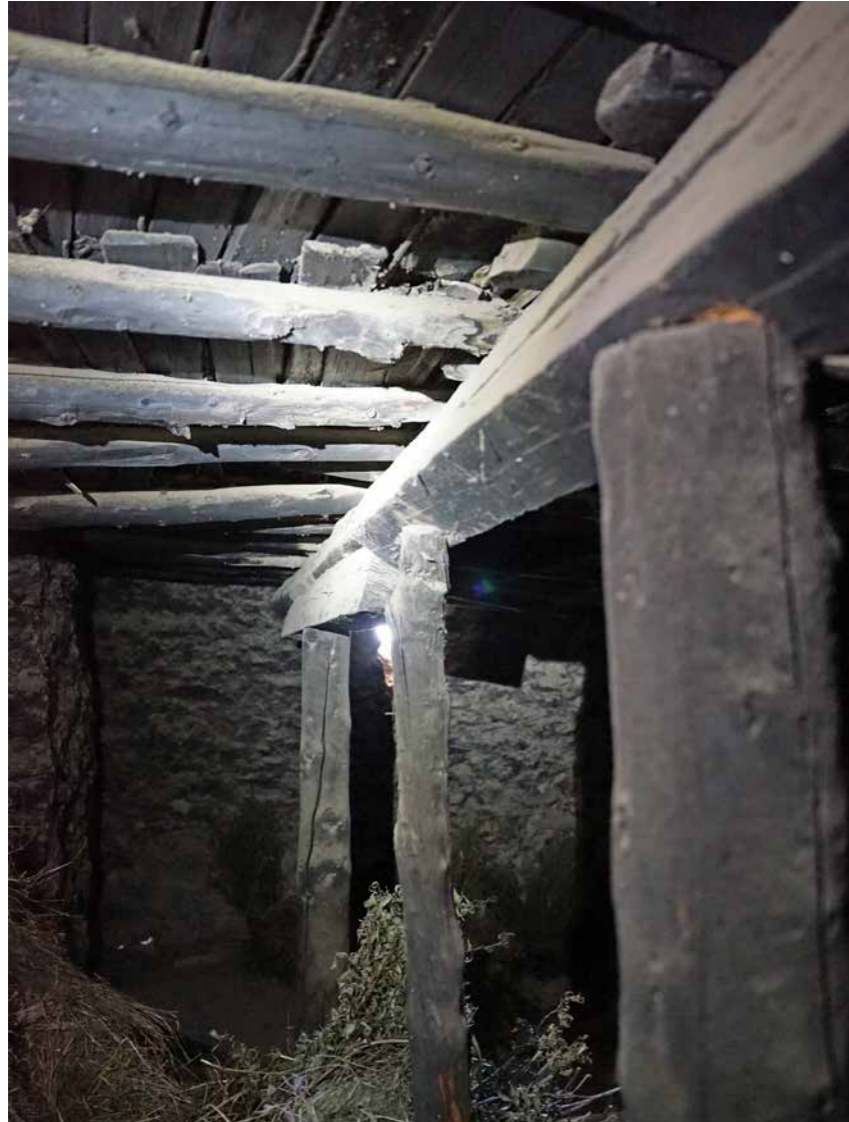
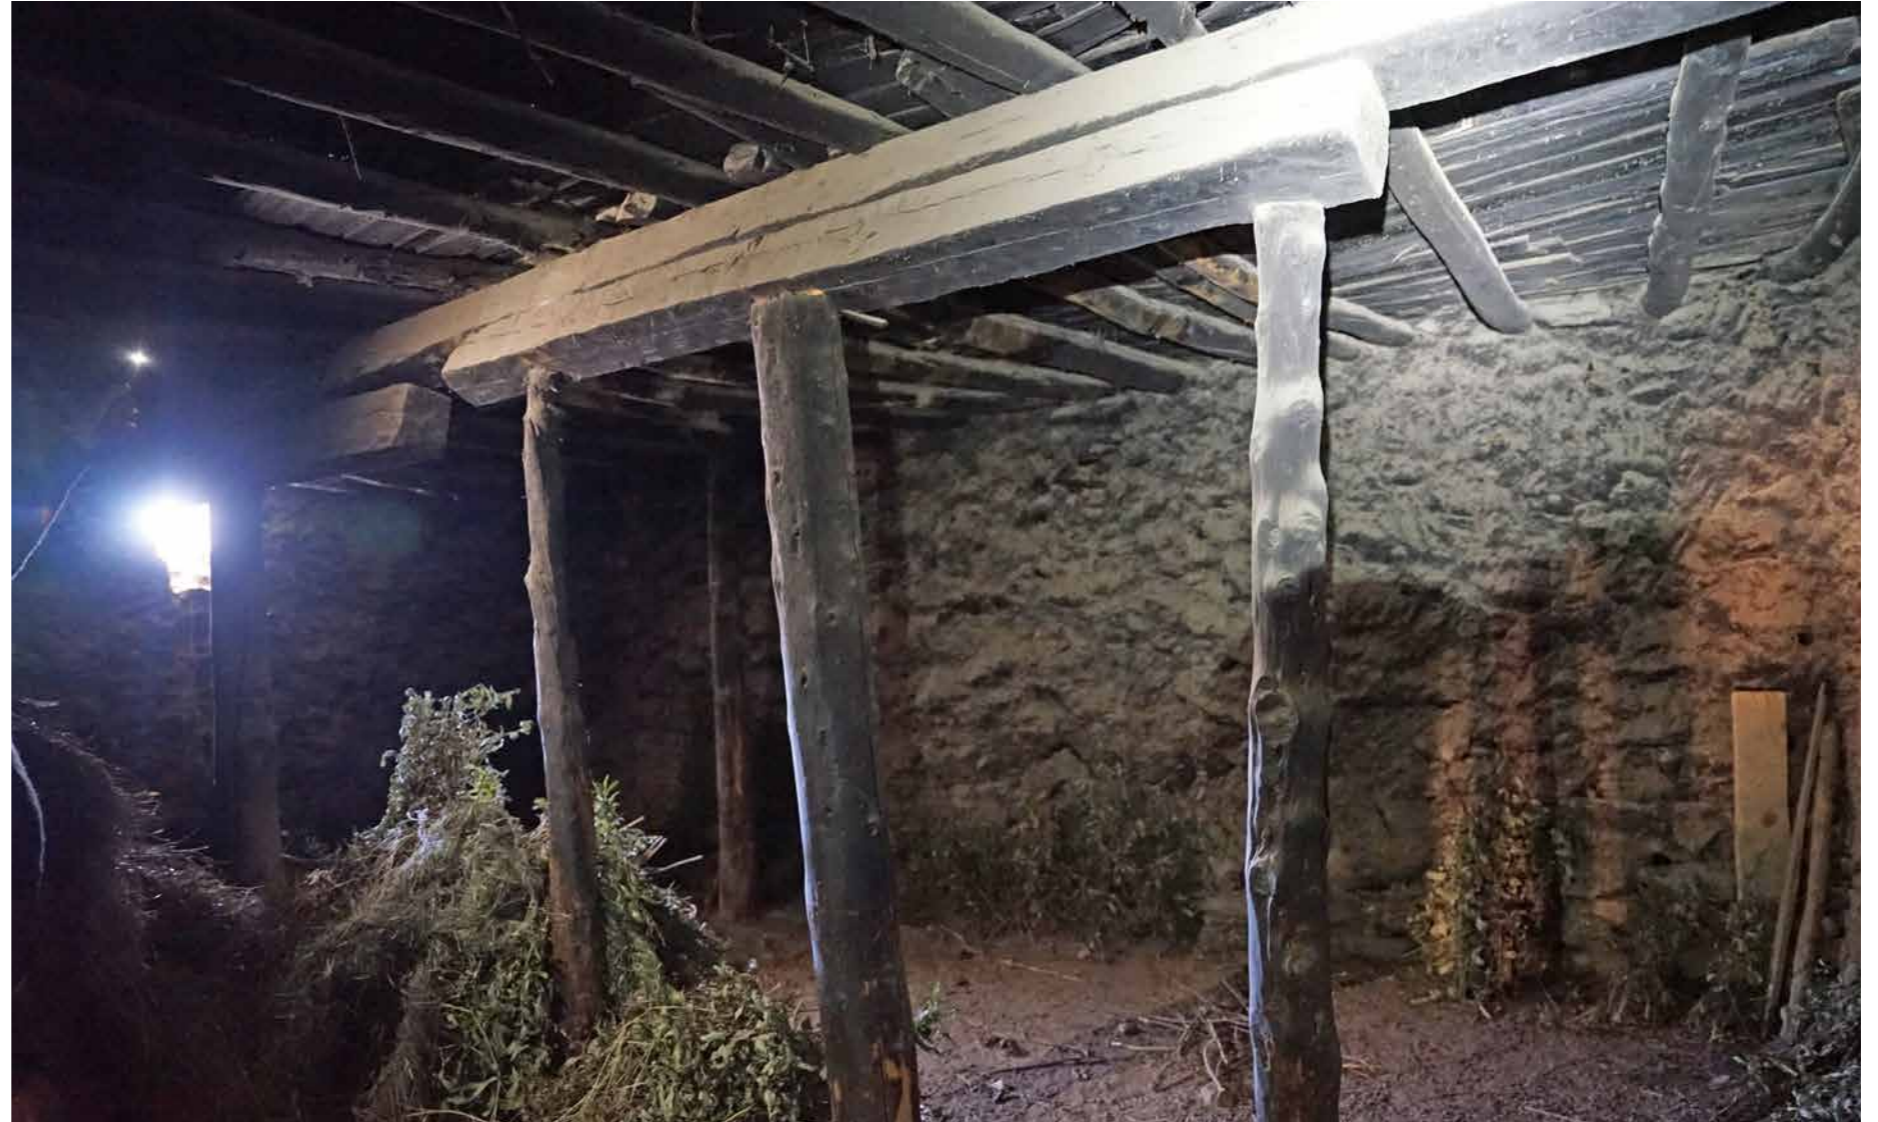
ROOM FOR FODDER STORAGE

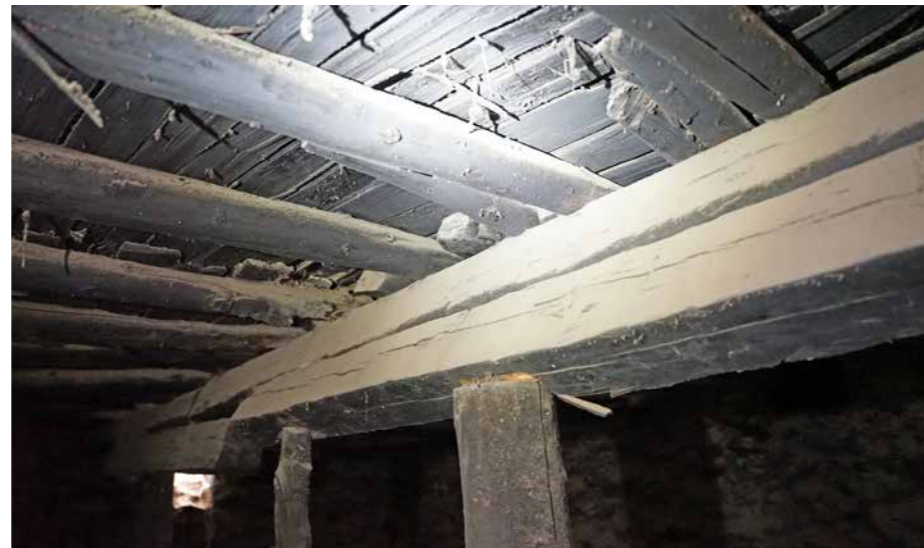
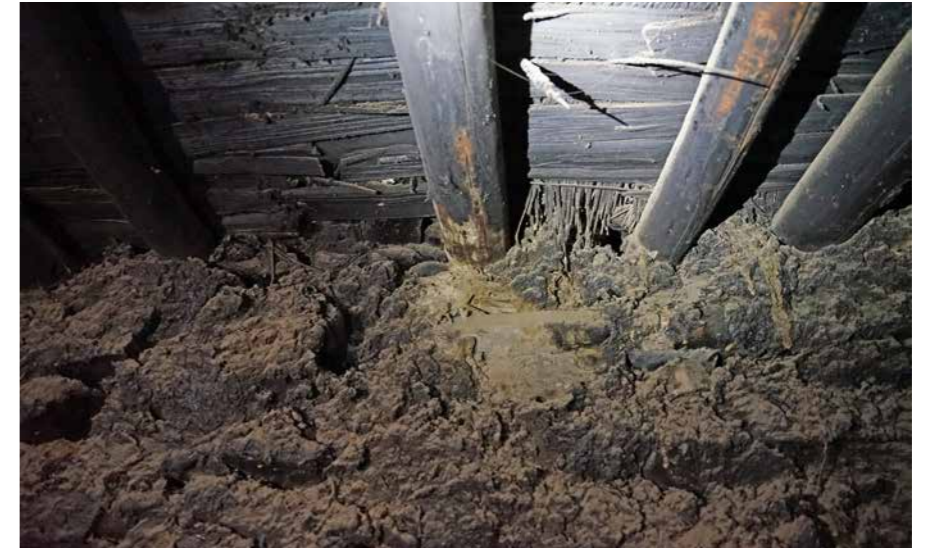
ROOM  
UPPER FLOOR – U04

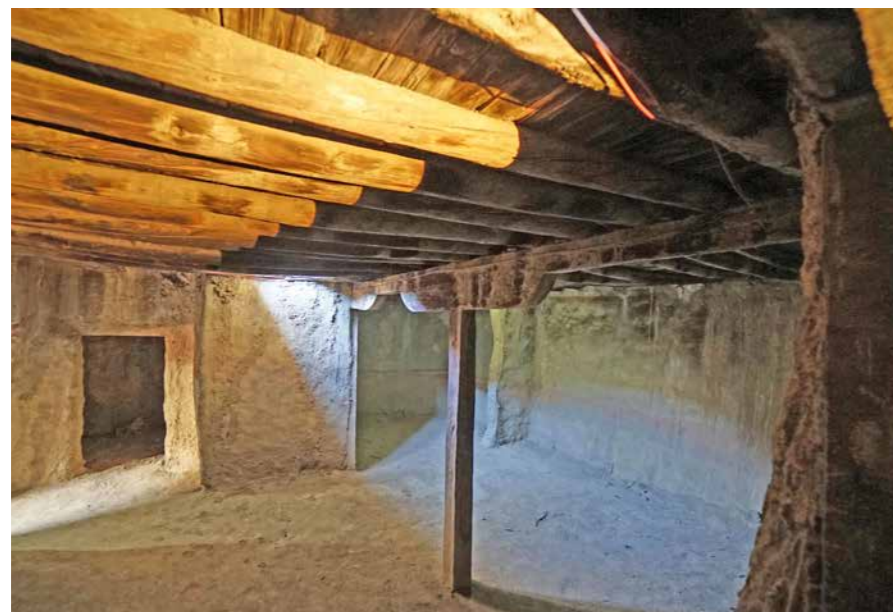
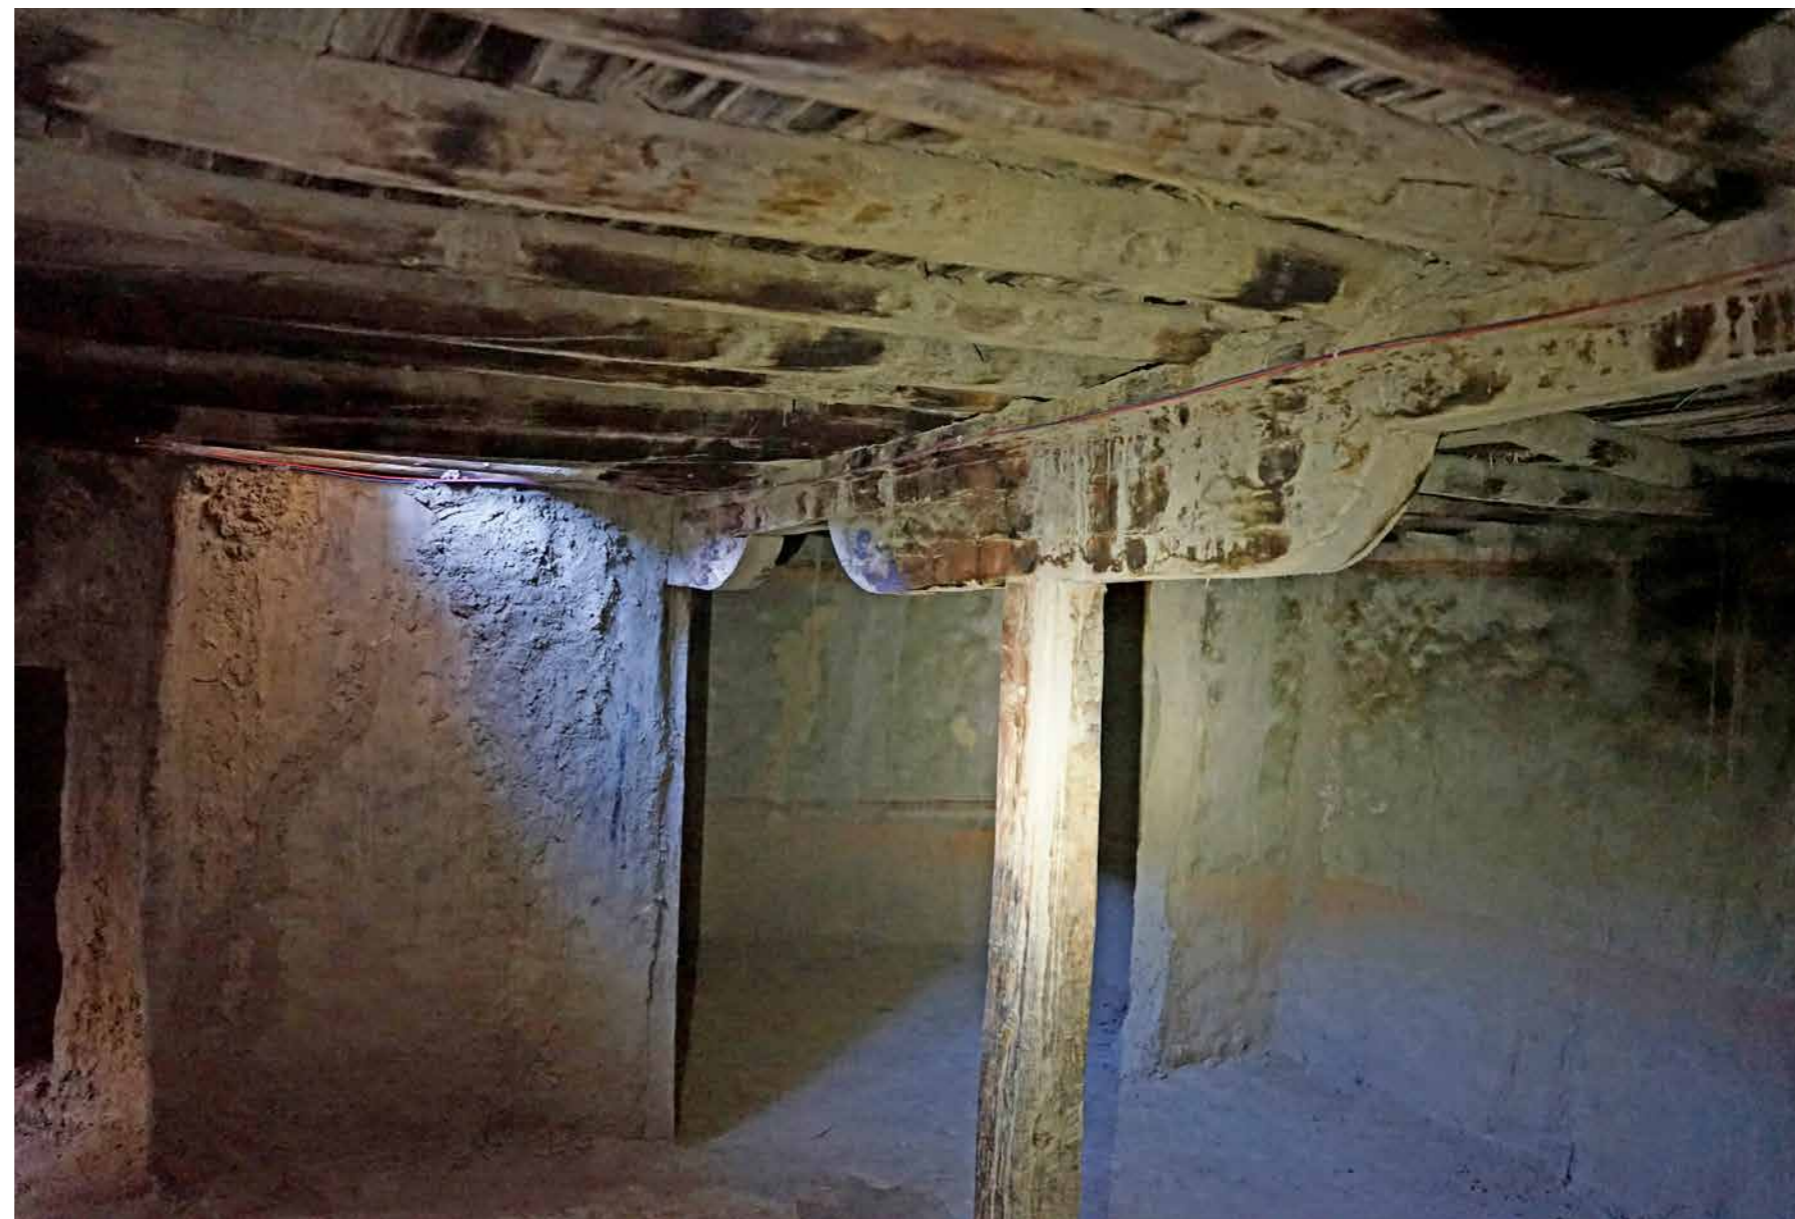
## STORAGE ROOM GROUND FLOOR – L07

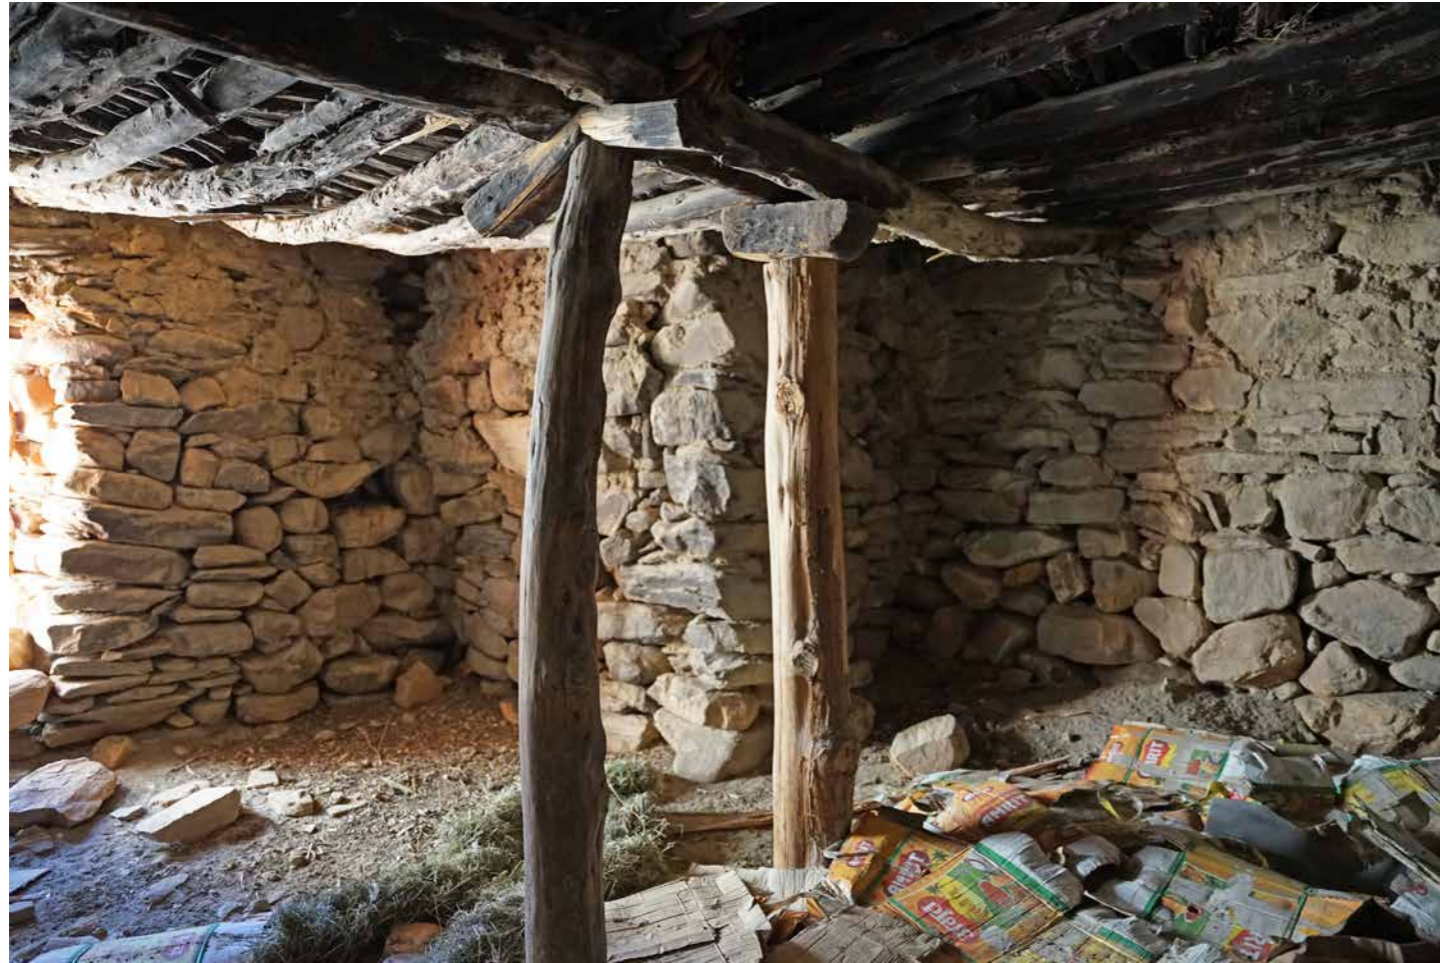
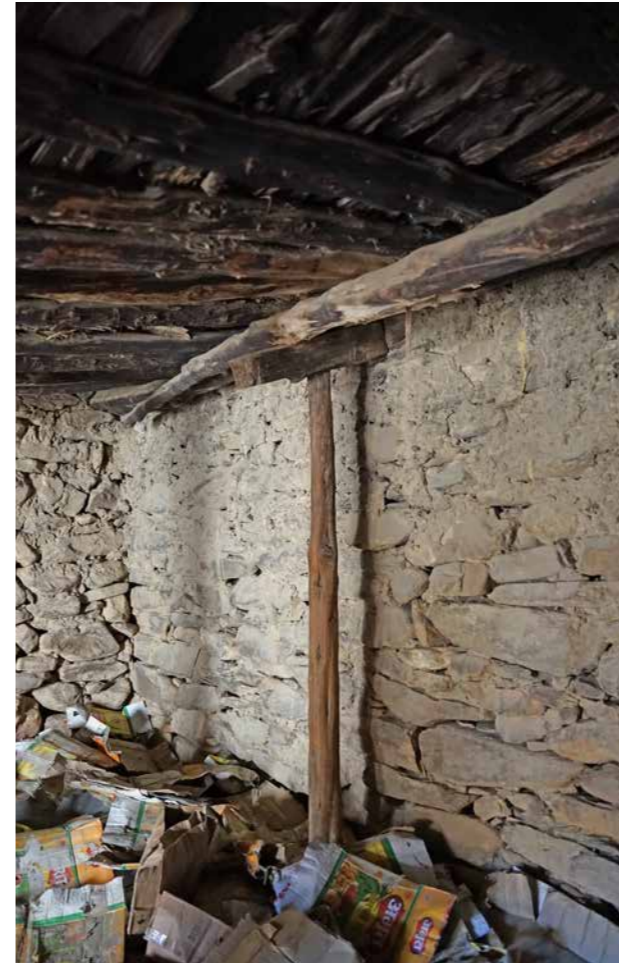
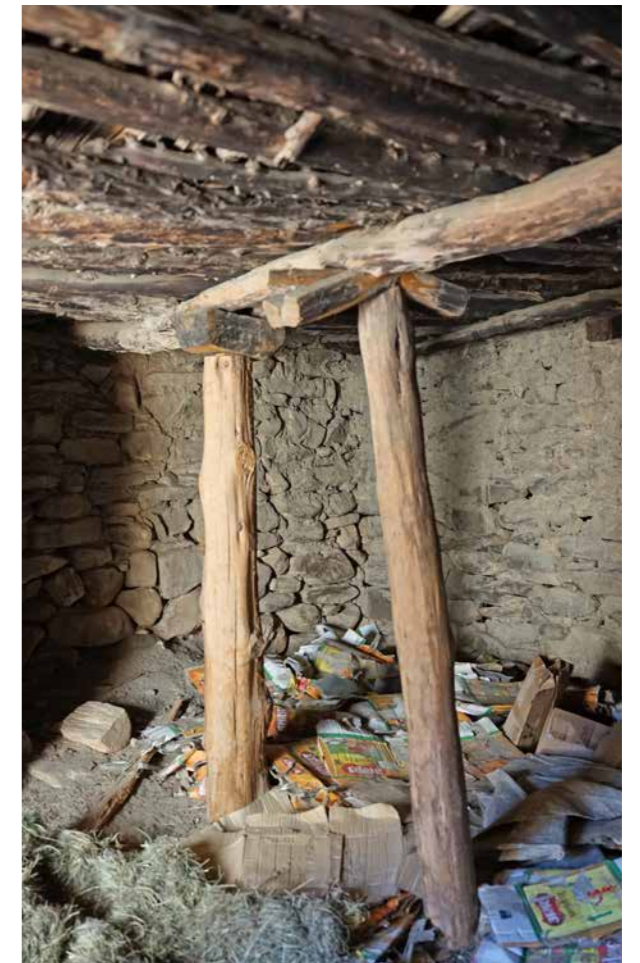
**TEMPORARY PROP**  
The temporary supports are affected by wet rot and might give way at any time.

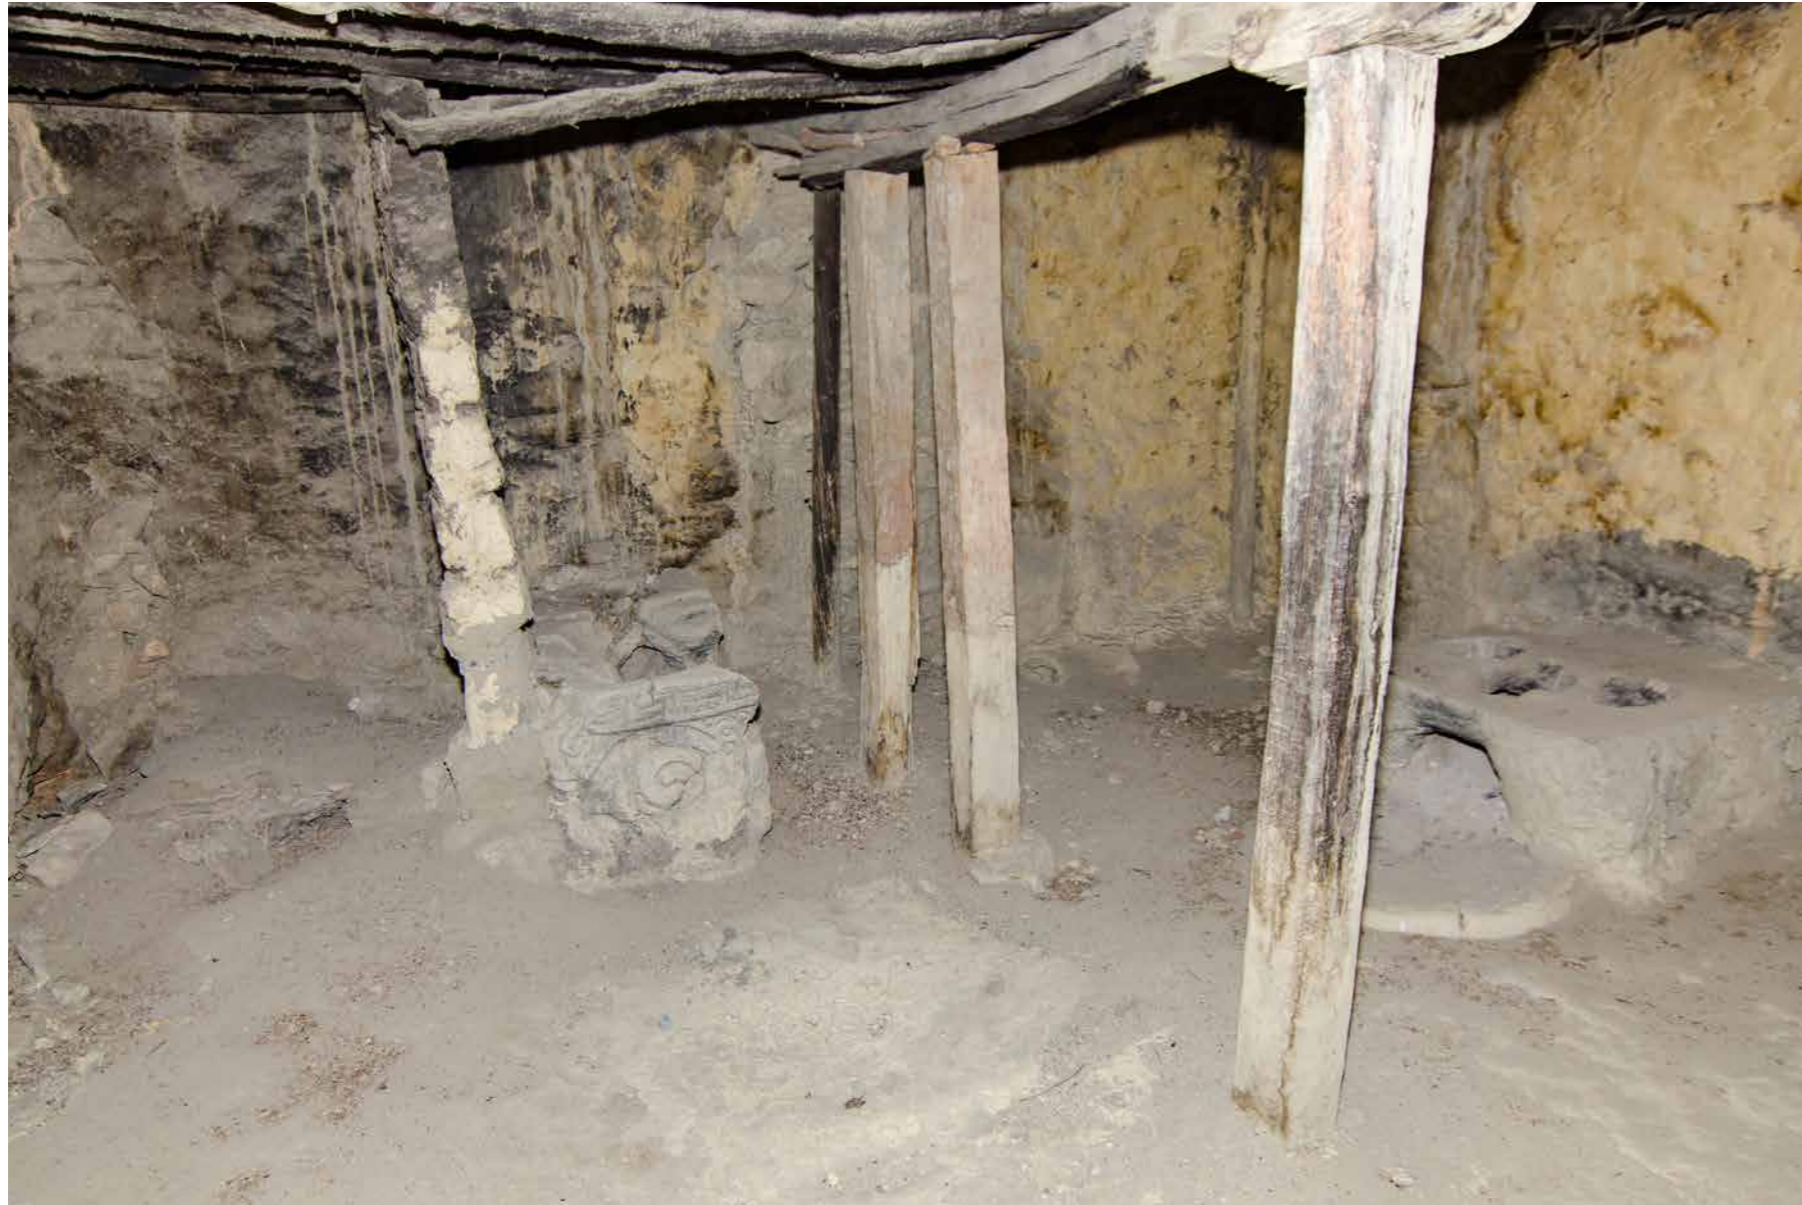
**VIEW TO THE NORTH**

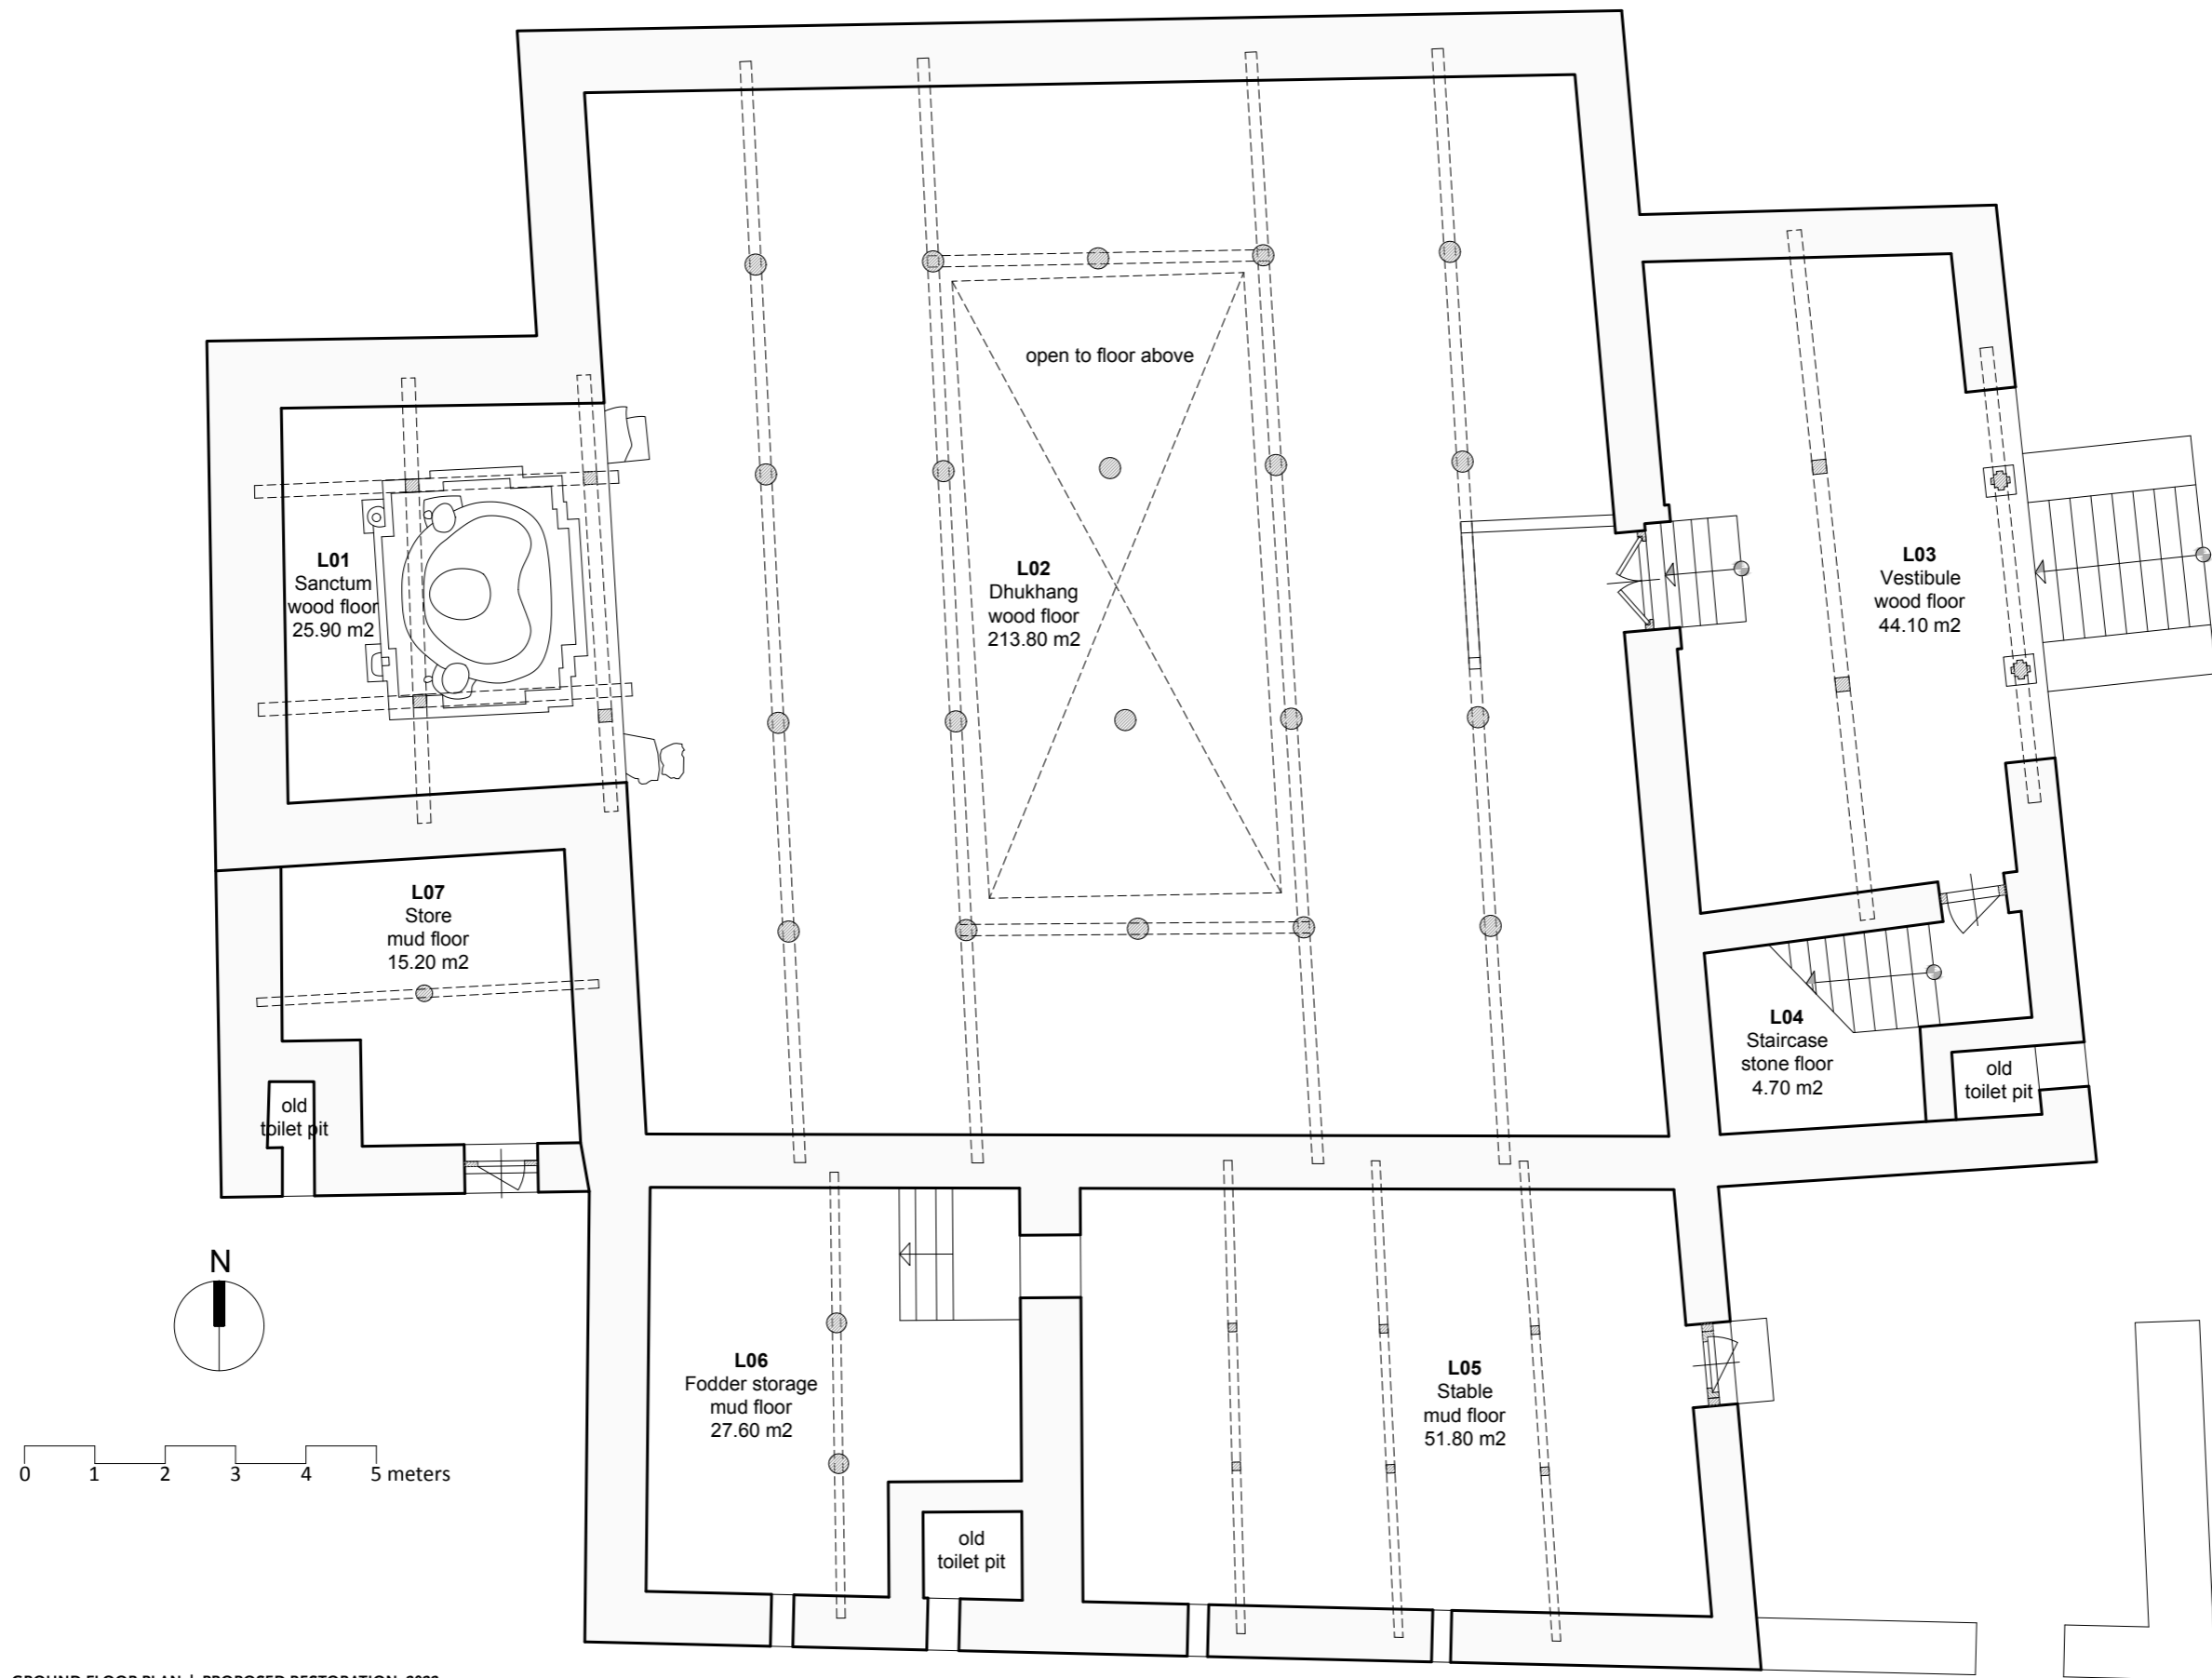
GROUND FLOOR PLAN | PROPOSED RESTORATION, 2022  
 Drawing by Thomas Schrom

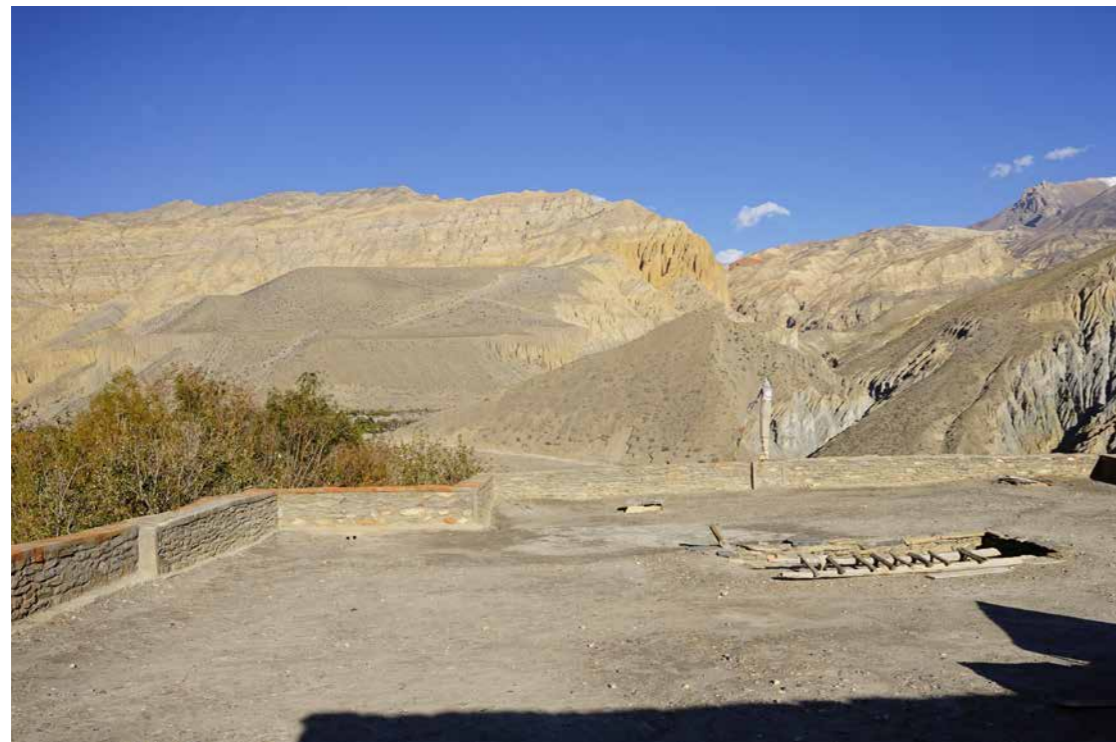
#### VIEW FROM THE WEST
