## **SEISMIC STRENGTHENING AND RESTORATION OF GONPA GANG**

DAMAGE ASSESSMENT AND RESTORATION CONCEPT

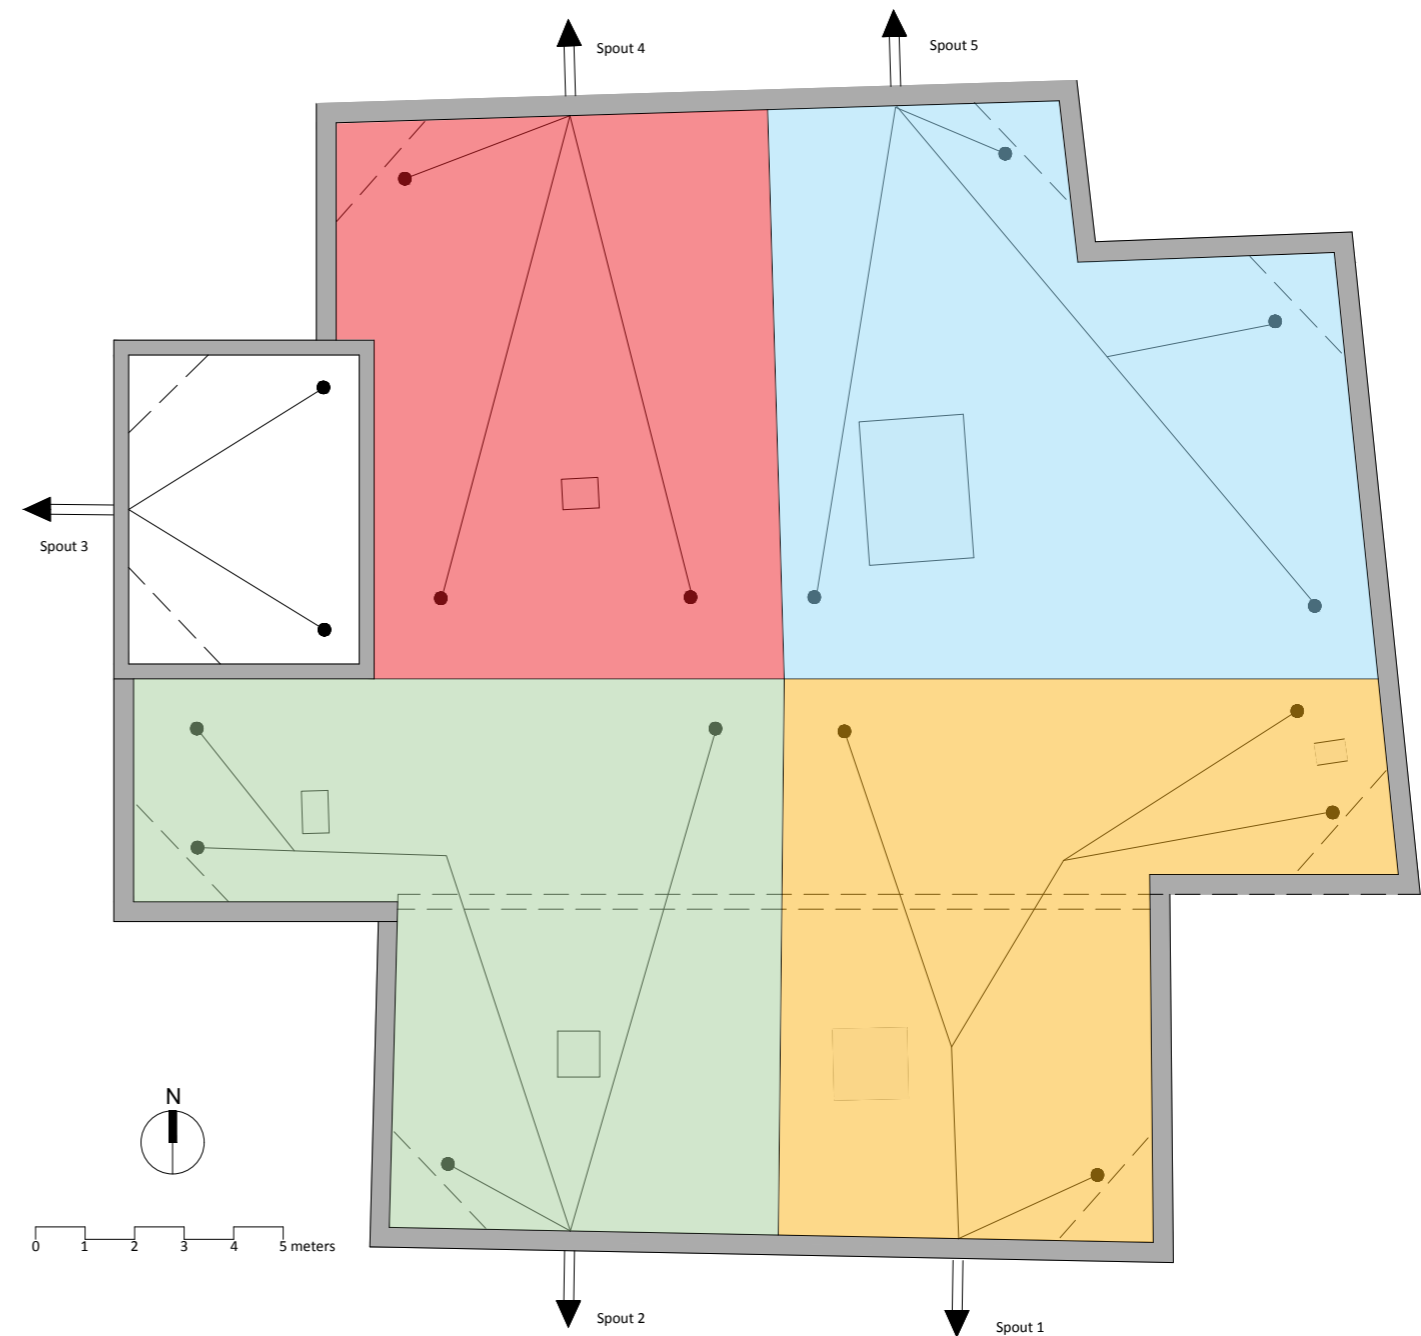
In 2015 the roof was repaired by means of a plastic sheet and the construction of new parapets using stone and cement mortar.

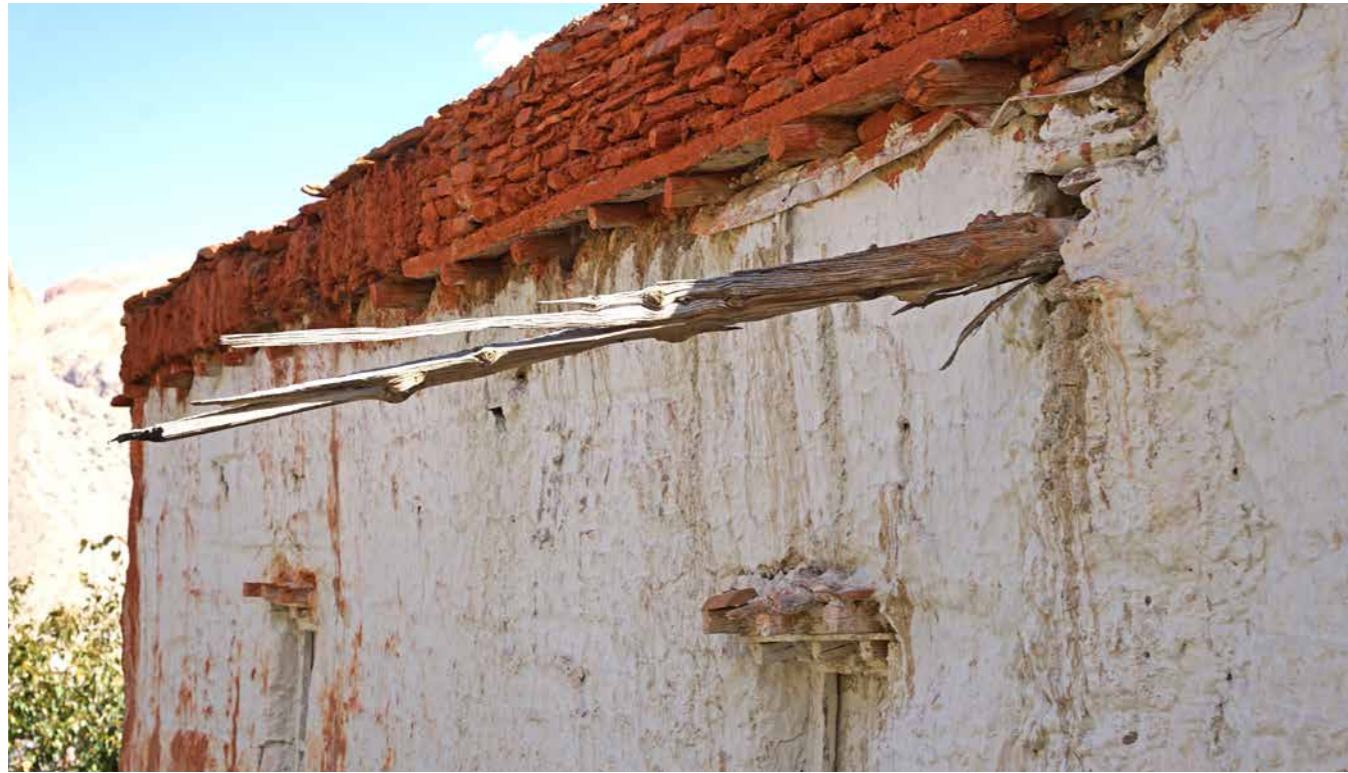
**HISTORIC WATER SPOUT**

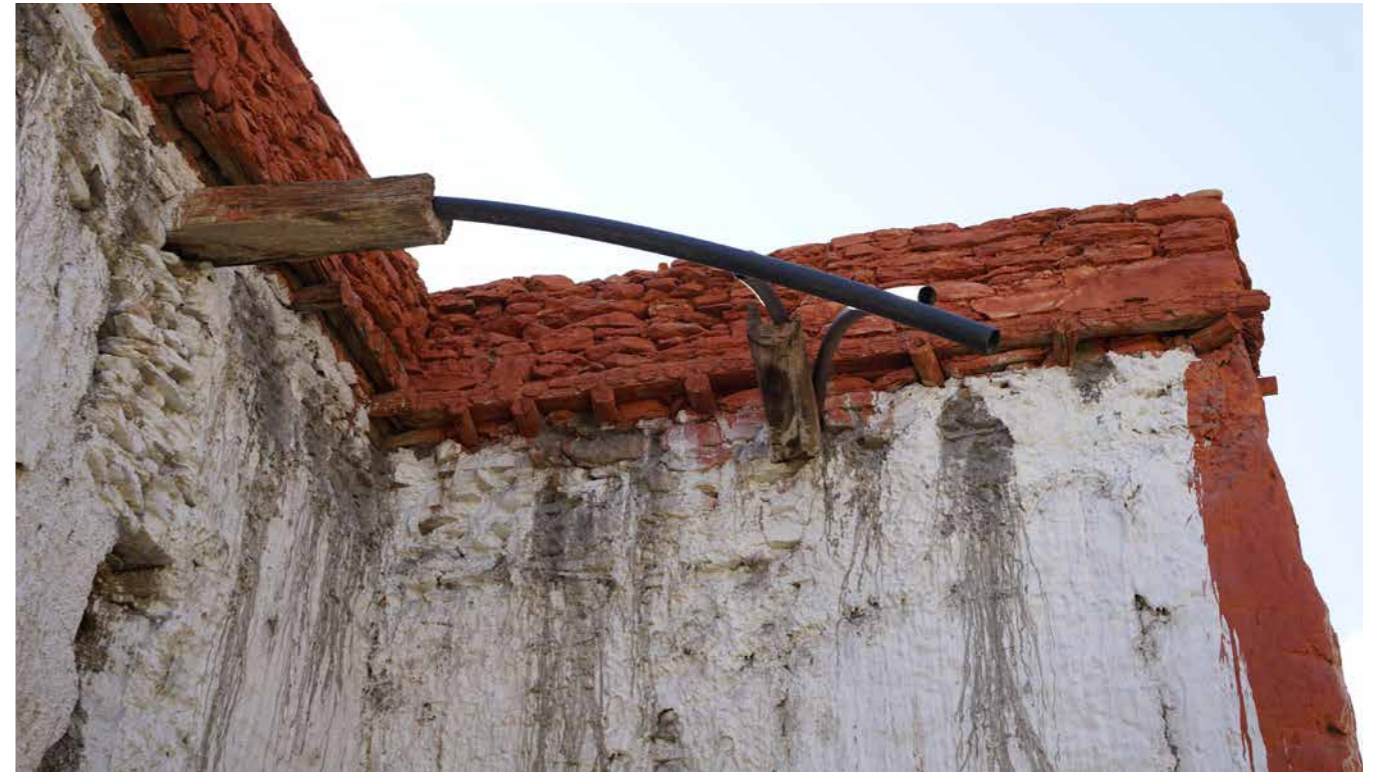
**DRAIN PIPES ON THE NORTH-EAST CORNER**
