Seismic Strengthening and Restoration of Lo Gekhar

U.S. Ambassadors Fund for Cultural Preservation, Award No. SNP40020GR0042

Project Report, Third Year, Third Quarter – April to June 2023

Norbusum Foundation (NGO)

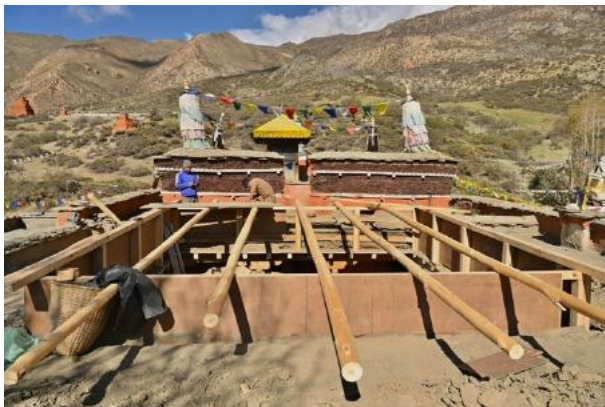
Accordingly, the adobe parapets around the courtyard were dismantled and a main supporting frame was built of wood above the existing timber structure. Round poplar beams were purchased from Sakre and were connected to the square frame to provide the support for the rafters and the fiber sheets (Figure 2). Rectangular rafters were then screwed onto the poplar beams (Figure 3), and the corrugated fiber sheets were screwed to the rafters to complete the skylight (Figure 4). Pine boards were installed over the prepared frames on the internal side while waterproof plyboards were used for the exterior surface. Similarly, bitumen sheets were extended on the ply board surface as a waterproofing measure and also for the durability of the exterior wooden surfaces from natural wear and tear.

Figure 2: The construction of the frame for the roofing of the courtyard.

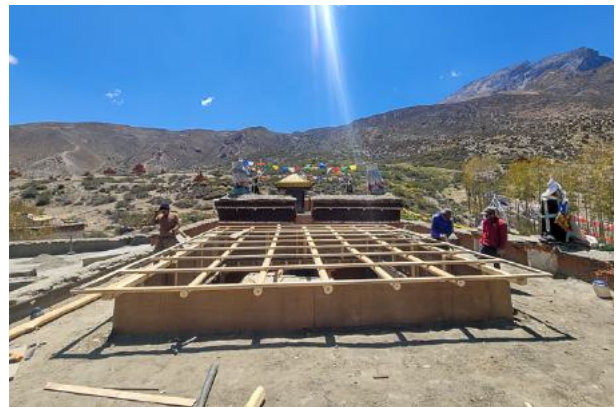
Figure 3: The finished frame for the courtyard roof.

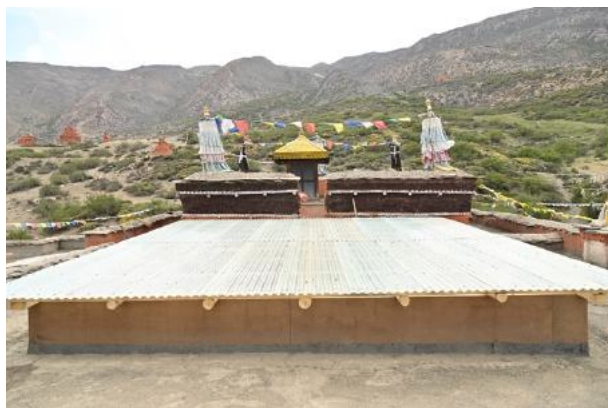
Figure 4: The roofing of the courtyard largely completed.

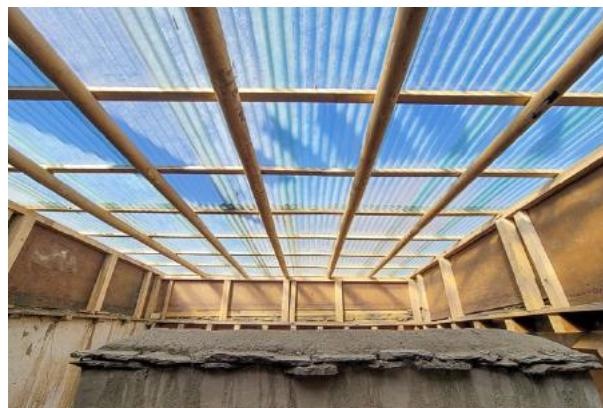
Figure 5: The interior of the roofed courtyard before finishing its side walls.

Figure 5 shows the construction from the interior of the courtyard. The surface of the square frame was later boarded up to give it a more smooth appearance.

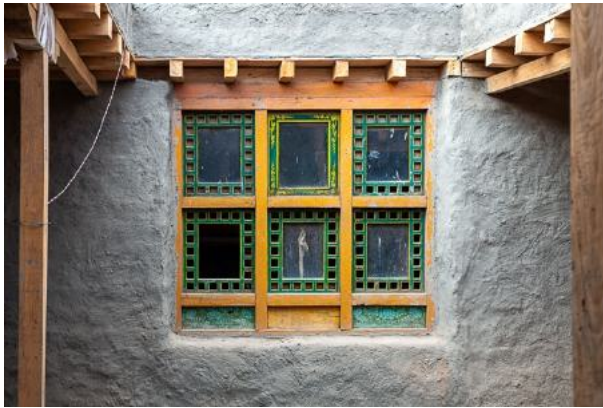
Figure 8: The window to the VIP room in September 2022.

Acrylic paints were used to restore the wall painting of the VIP room (Figure 7), the window of the VIP room (Figure 8, Figure 9), and the window in the guest lobby following their original decoration (Figure 10, Figure 11).

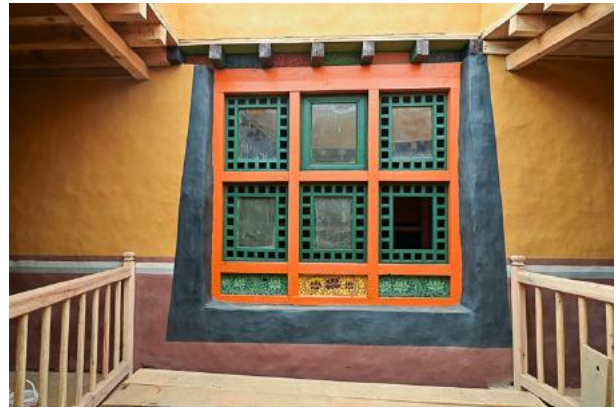
Figure 9: The newly painted window and surrounding courtyard in June 2023.

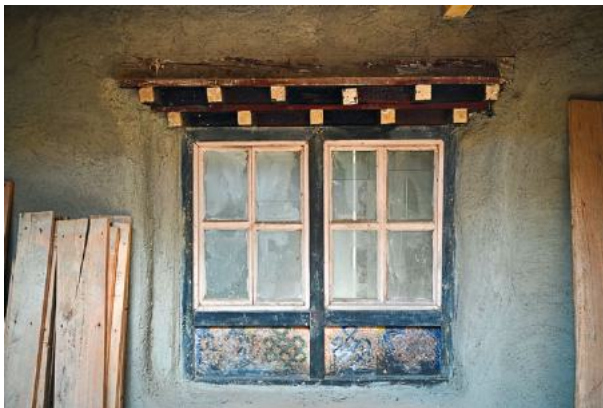
Figure 10: The window in the guest lobby before repainting.

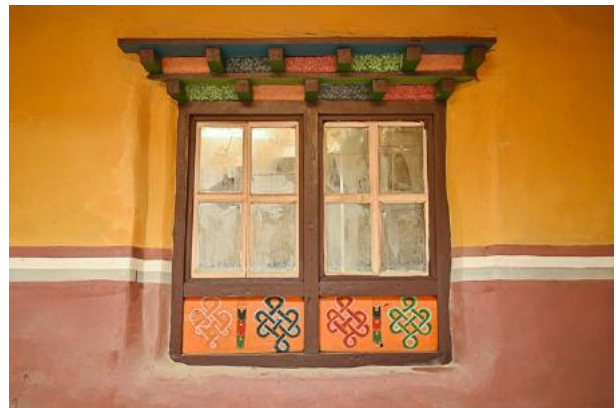
Figure 11: The window in the guest lobby after repainting.

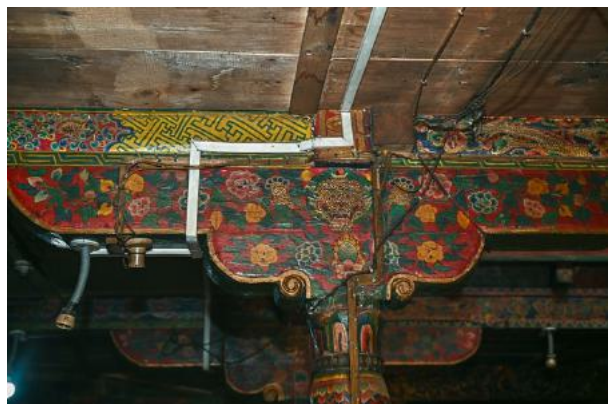
Figure 17: An example of the multiple, partially dysfunctional lighting systems used previously in the assembly hall.

Work began with the removal of old wiring, light points, and unused solar lines (Figure 17). Then new lightings were installed in the temple. Two flood lights were installed on the two sides of the main statue, while a center light was installed for backup solar power (Figure 18). Focus lights were used to light the statues on the left and the right sides in the main shrine that previously had no dedicated lights and were not properly visible to the pilgrims and visitors. The stone panels in the assembly hall were also lit using flood lights installed on the capitals (Figure 19).

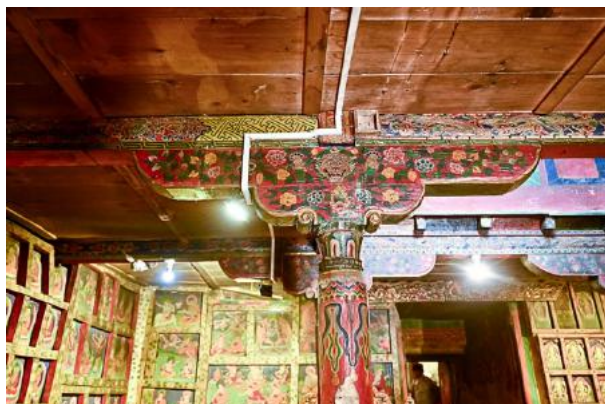
Figure 18: The same area of the assembly hall after the installation of the new lighting.

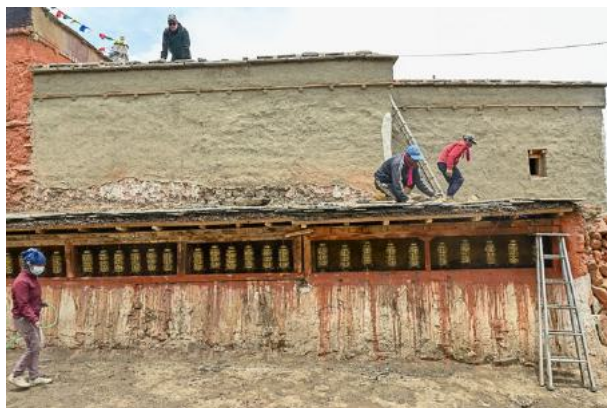
The mani wheels installed on the south and west of the temple were repaired. The old joists and round sticks were rotten and the prayer wheels had tilted outward. The roof was completely dismantled and reconstructed using salvaged and new wood. Round sticks salvaged last year from the floor of the Guru Lhakhang were used for the roofs. A layer of brushwood was laid and then the mud mortar was added. Finely sieved clay was spread before laying the plastic sheet. The plastic sheet was then covered with mud mortar and flat stones were arranged (Figure 23).

Figure 23: Repair of the mani wheels to the back of the caretaker's quarter.

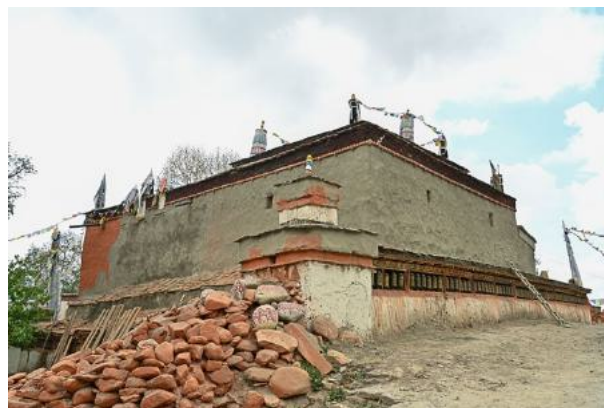
The only chörten with brushwood on the north-east side was repaired last year. The other chörten were repaired in this quarter. The weed and grass grown on the roofs were removed along with pile of mud gathered over the time. Some of the tops that had either sunk or tilted were dismantled and rebuilt using the mud bricks. The flat stones were rearranged and replaced where necessary to divert the water from draining over the plastered surface. The chörten will be given a color wash in the next quarter (Figure 24).

Figure 24: The temple after the repair of all mani wheels and chörten as well as plastering the temple.

As part of the exterior work the exterior of the temple has been replastered (Figure 24). In the coming quarter a new color wash will be added to the entire structure.

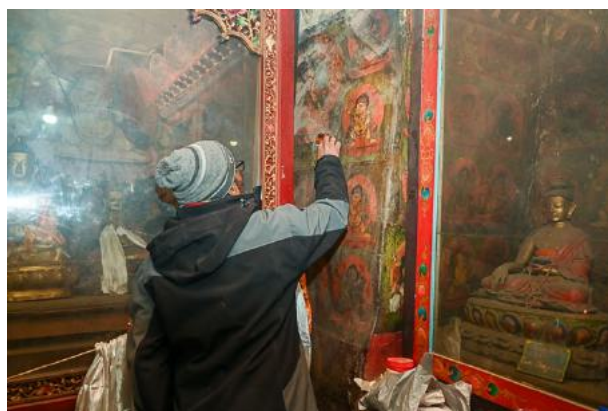
Figure 25: Sreekumar Menon cleaning some of the wall paintings in the sanctum.

The painting conservator Sreekumar Menon visited Lo Gekhar in April and assessed the stone panels and the wall paintings in the main shrine area. Some of the broken stone panels were fixed and he also strengthened the broken panels that were already fixed previously. Likewise, the crack on wall to the right of the main statue in the shrine area was also filled (Figure 26). Some cleaning of the wall paintings was also done during his stay at

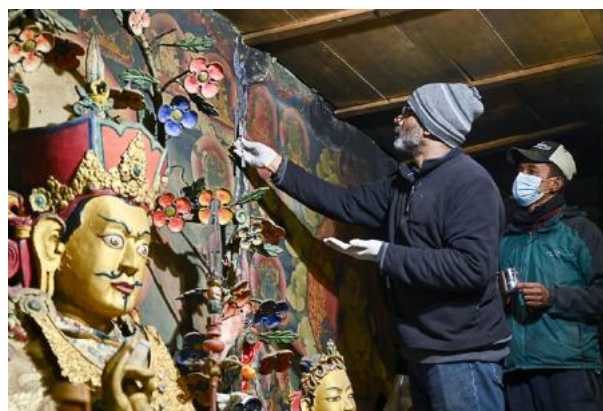
Figure 26: Sreekumar Menon assisted by Dawa Tsering Gurung filling a major crack on the main wall of the sanctum.

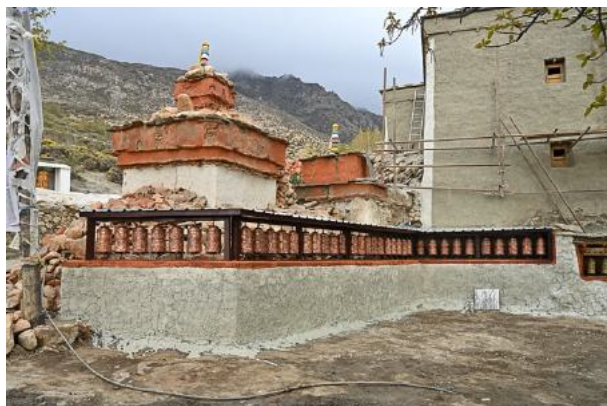
Against the advice of the Norbusum Foundation, Marang locals installed new set of prayer wheels with tin roofs on the south side of the caretaker's mansion (Figure 27) just a few days before HH the 42nd Sakya Trizin paid a visit to Lo Gekhar. The chairperson of Marang village committee Mr. Kunga Tenzing Gurung himself was the lead person during all this

Figure 27: The new prayer wheels added by villagers of Marang to a short section that was without previously.

This addition to the main temple begs the question how it can be avoided that this work is mistaken as part of this project. It may well be necessary to clearly mark this donation through information boards as independent of (and contradictory to?) the restoration work. Any advice on this matter by the embassy is welcome.

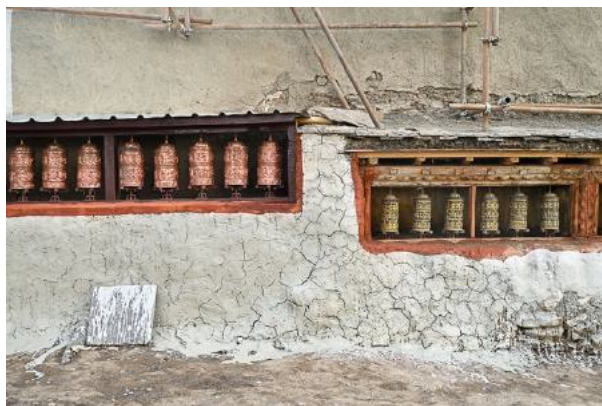
activity. These prayer wheels have been constructed without any attempt to match them to the existing ones in either appearance or technology and they feature a simple tin roof that now considerably disturbs the appearance of the temple. In addition, a part of them was constructed directly in front of the toilet area drainage, making access to this area in case of a technical fault impossible (Figure 28).

Figure 28: The contrast between the old and new and old prayer wheels in appearance. Further, at the foot of the new part the toilet drainage pipe can be seen.
