Report of the work at Ghar Gumba, Lo Gekar, Mustang, Nepal

By Sreekumar Menon

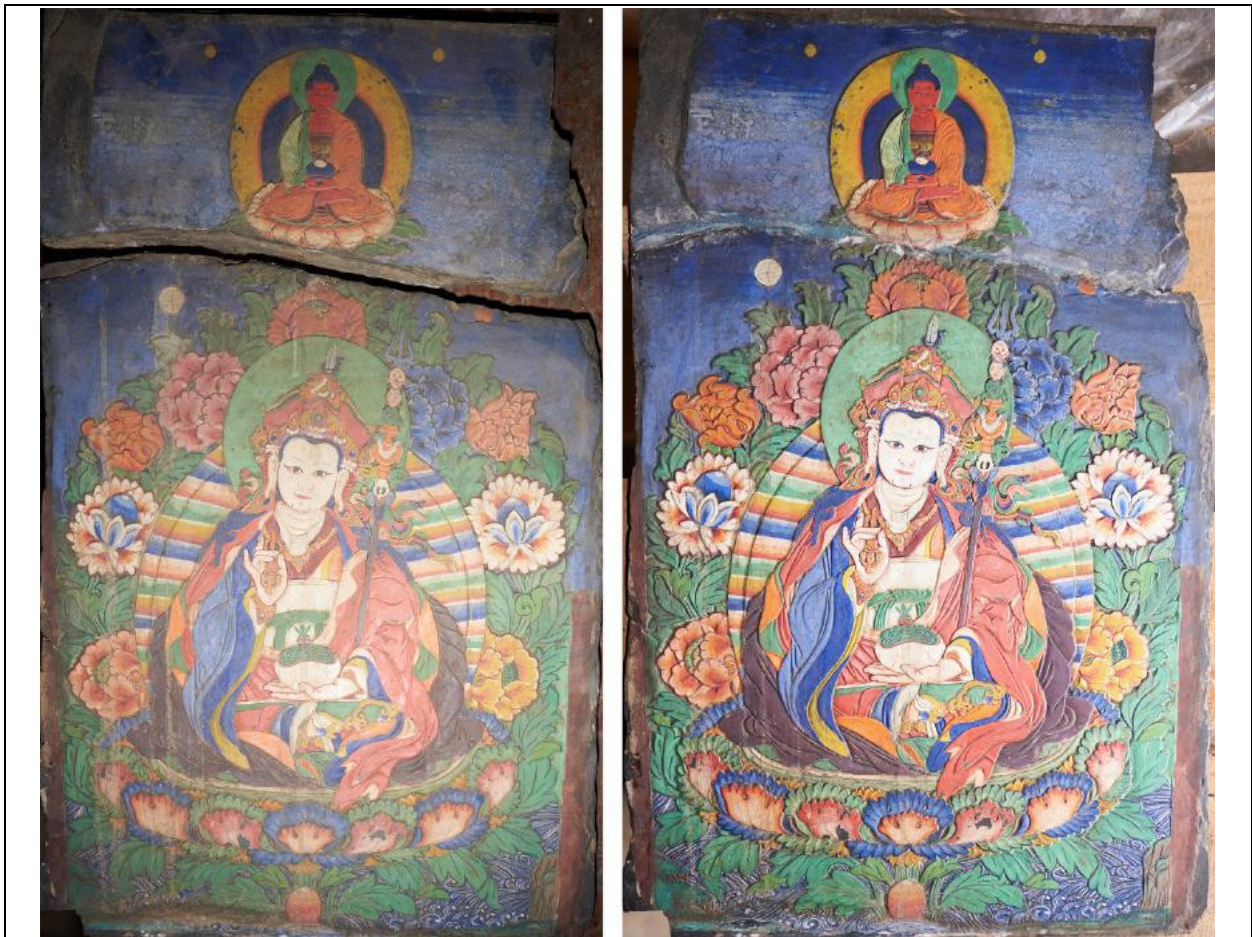
Fig 1 : A broken painted stone stele after joining with epoxy, cleaning, filling and toning down the losses.

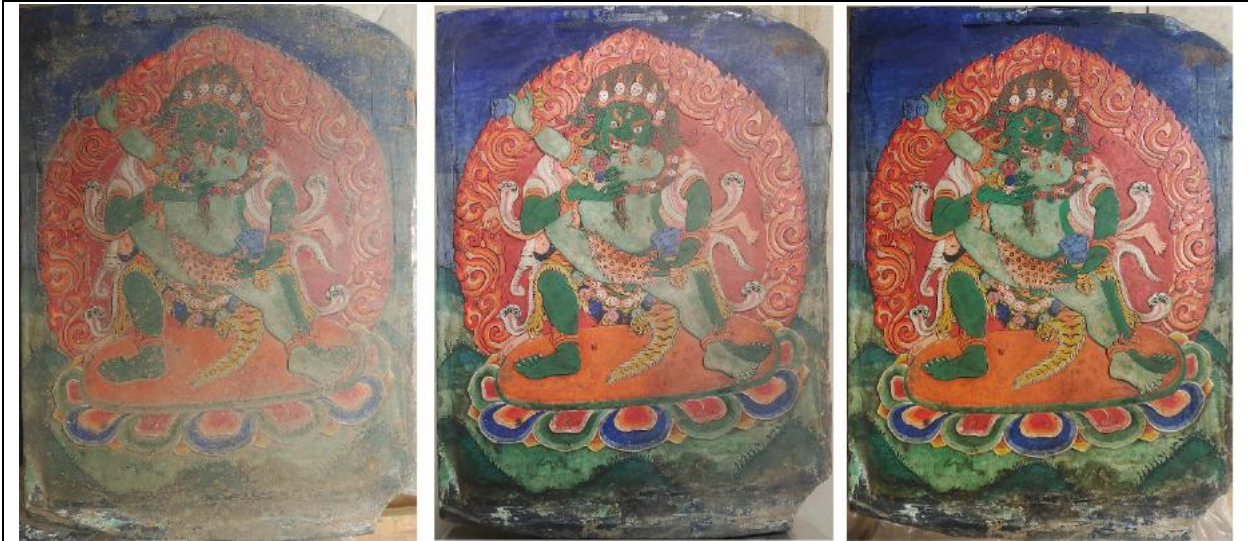
Fig 2 : A panel before (left), during (centre) and after (right) cleaning.

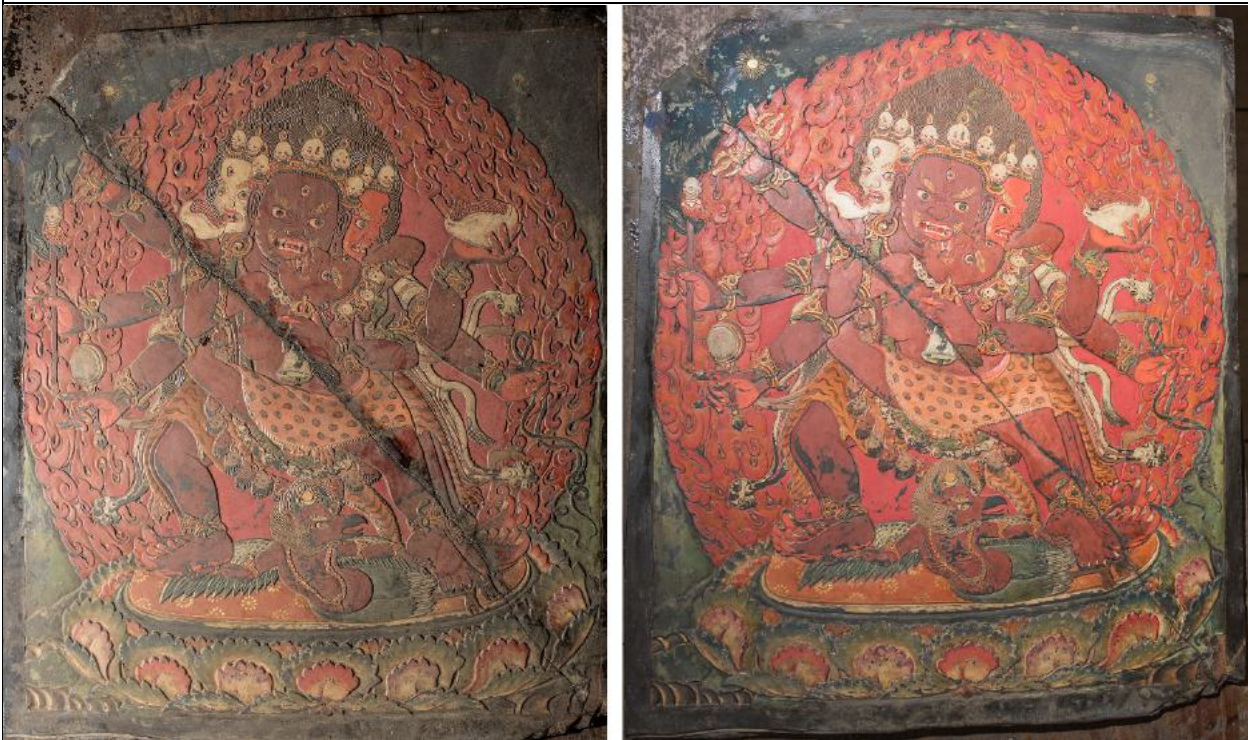
Fig 3 : Darkened deposits along the crack (left) and the panel after removal of the darkened deposits and cleaning (right).
