Gönpa Gang, Mustang, Nepal

Condition assessment and emergency stabilization
of wall paintings

By Sreekumar Menon

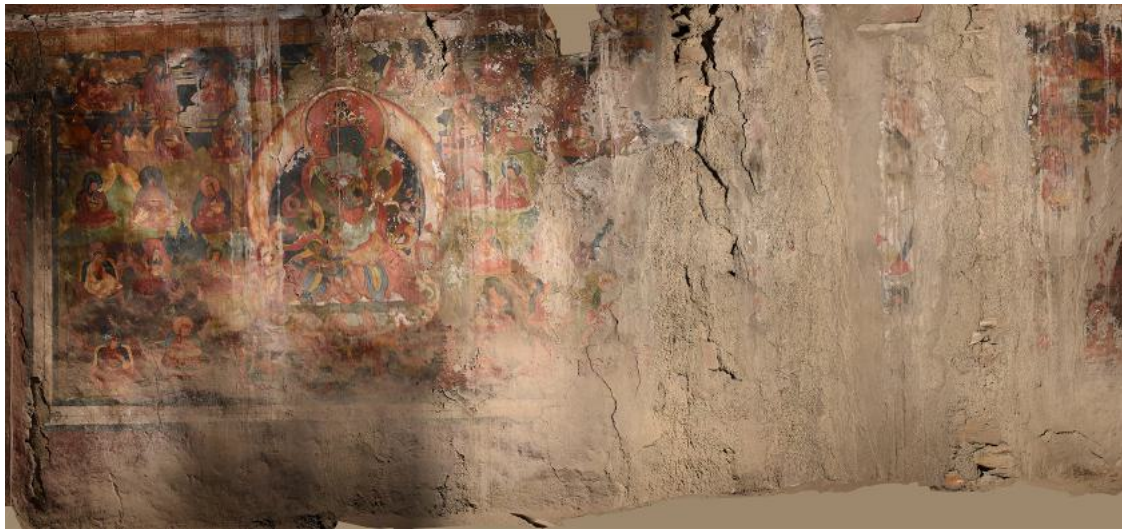
Fig 3. Highly damaged paintings in the first floor of the shrine, north wall. Images merged by photogrammetry.

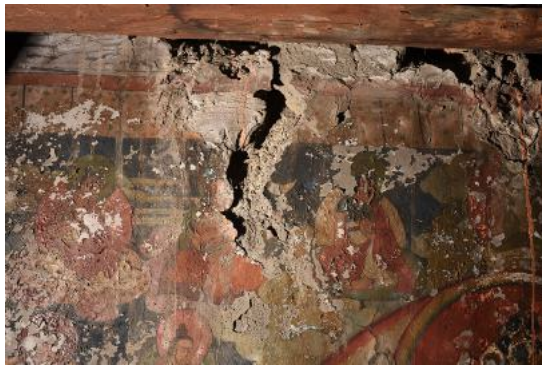
Fig 4. Detachment and flaking of paint layer. North wall of the shrine, first floor.

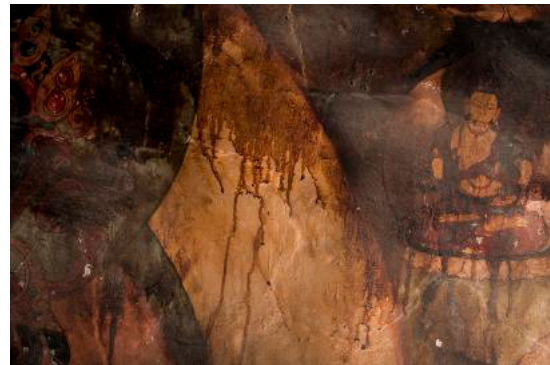
Fig 5. Discoloured varnish. West wall of the shrine, ground floor.

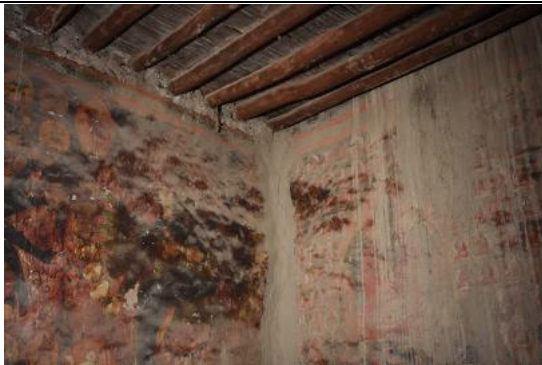
Fig 6. Dust and dirt depositoin on the painted surface due to leaking roof.

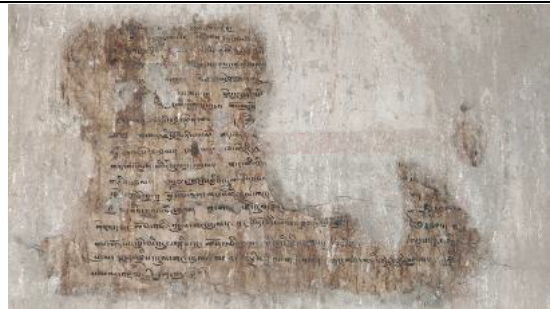
Manuscripts were pasted on the east and west walls of the entrance hall were found to have been delaminated in some places and these were re-adhered to the wall with gluten-free starch paste.

Fig 7 Manuscript pasted on the east wall of entrance hall.
