Architectural Restoration and Seismic Strengthening of Gönpa Gang

U.S. Ambassadors Fund for Cultural Preservation, Award No. SNP40022GR0039

Project Report, Second Year, Quarter 1 – October to December, 2023

Norbusum Foundation (NGO)

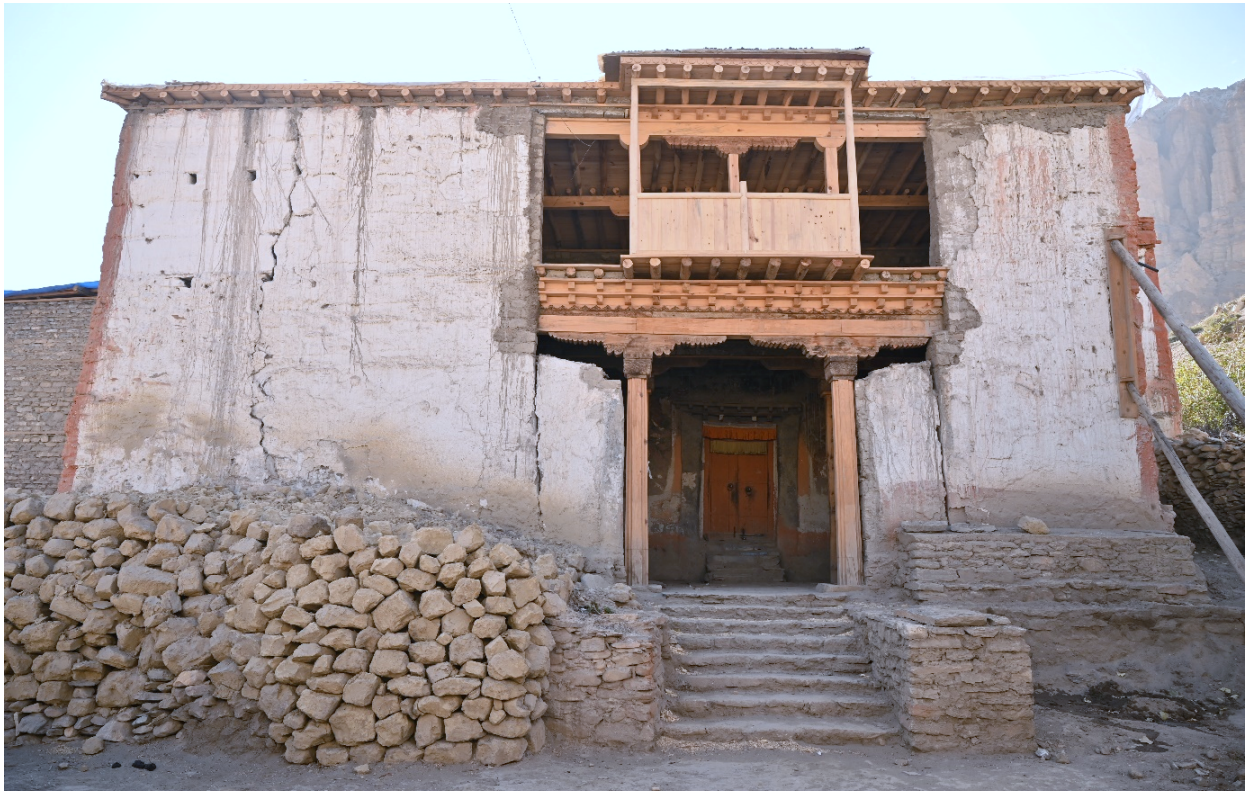
Figure 1: Photo of the reconstructed entrance taken on the last day at the site.

After finishing the temporary roof work, we moved on to the balcony installation work. A balcony was assembled in place assimilating the previous one in both appearance and technique (Figure 1).

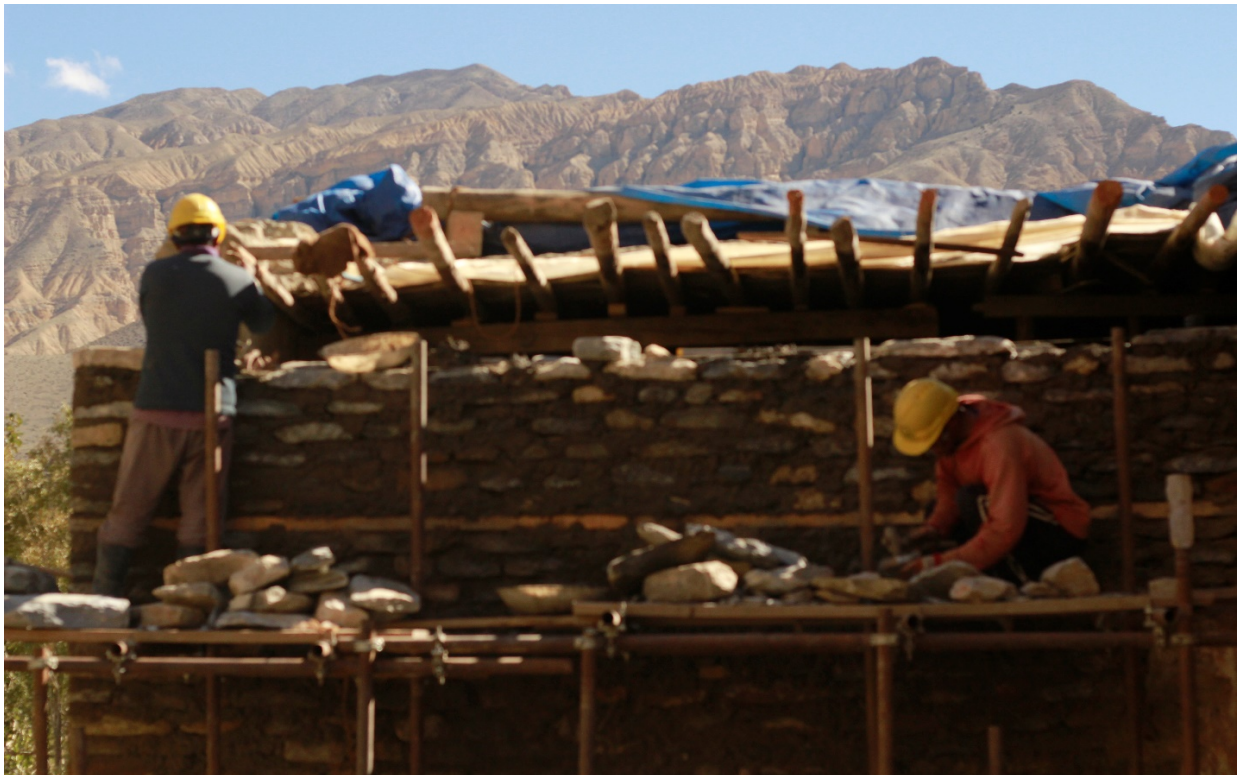
Figure 10: Reconstructing the northwest corner wall with wall ties.

We continued the repair work at the northwest corner wall up to roof level. When reconstructing the wall, we made sure that it was properly joined with the walls to its sides. For this we used wooden ties and wall ties at different levels.

Technically, tying the northwest corner wall to the building was the greatest challenge.

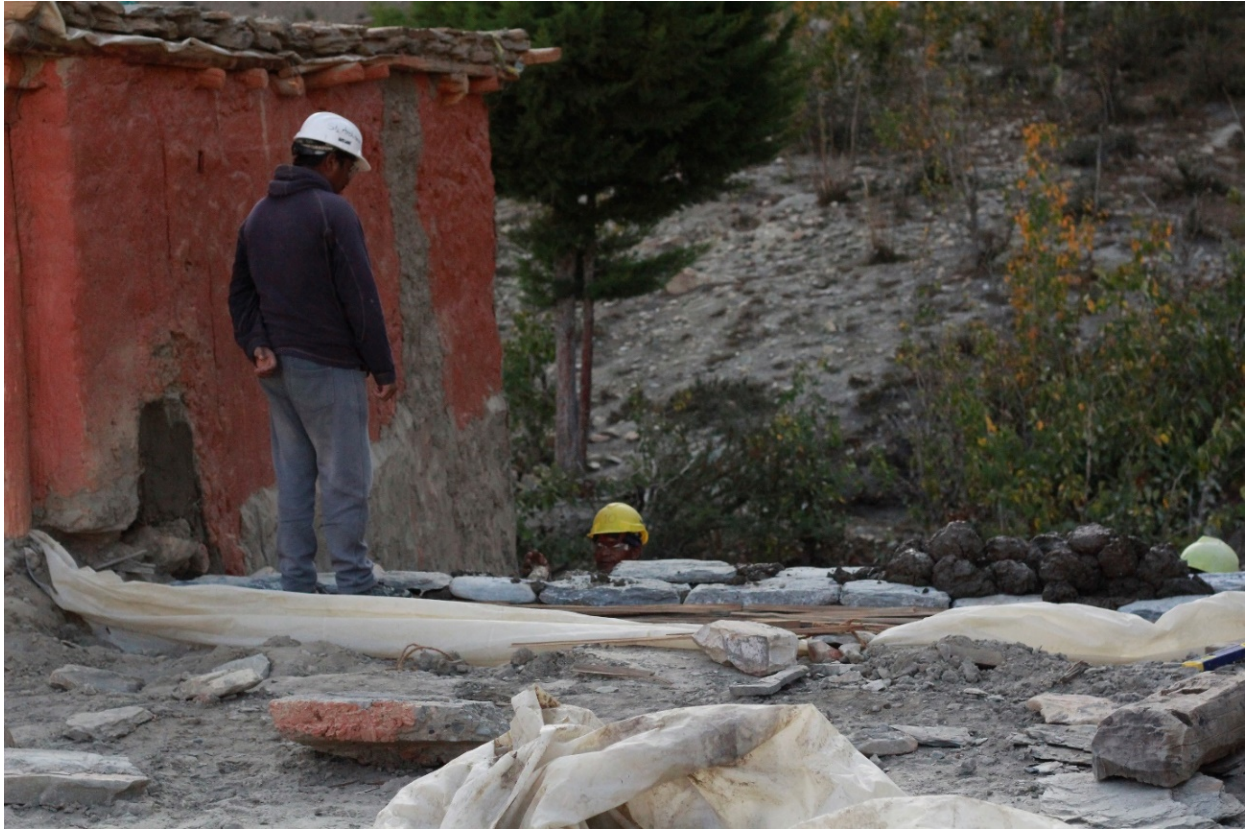
Figure 11: Installing the temporary roof above the new northwest corner wall.

The wall had been constructed with wooden ties. For the winter, it has been covered with plastic sheets to prevent snowfall damage. We also left the roof supports that were installed before work as a security measure.

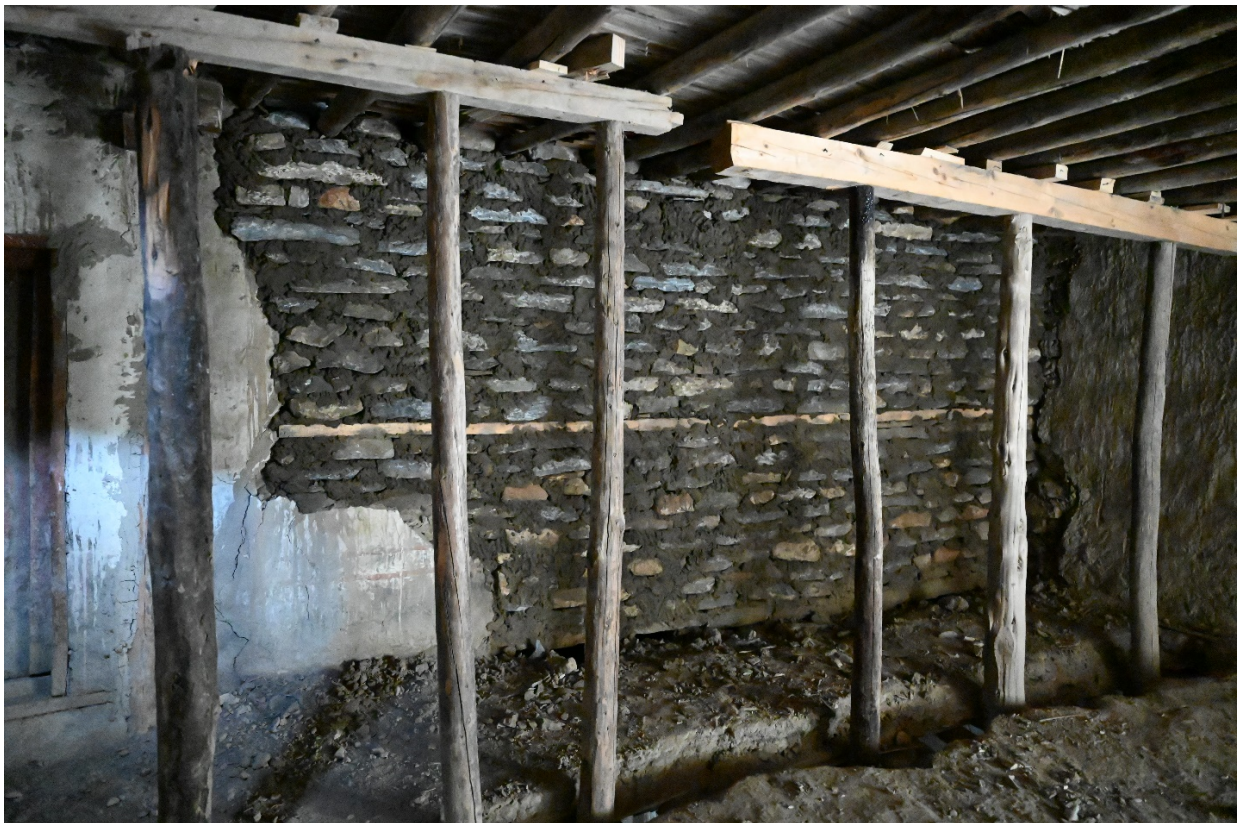
Figure 12: The second floor of the newly constructed wall from the interior.

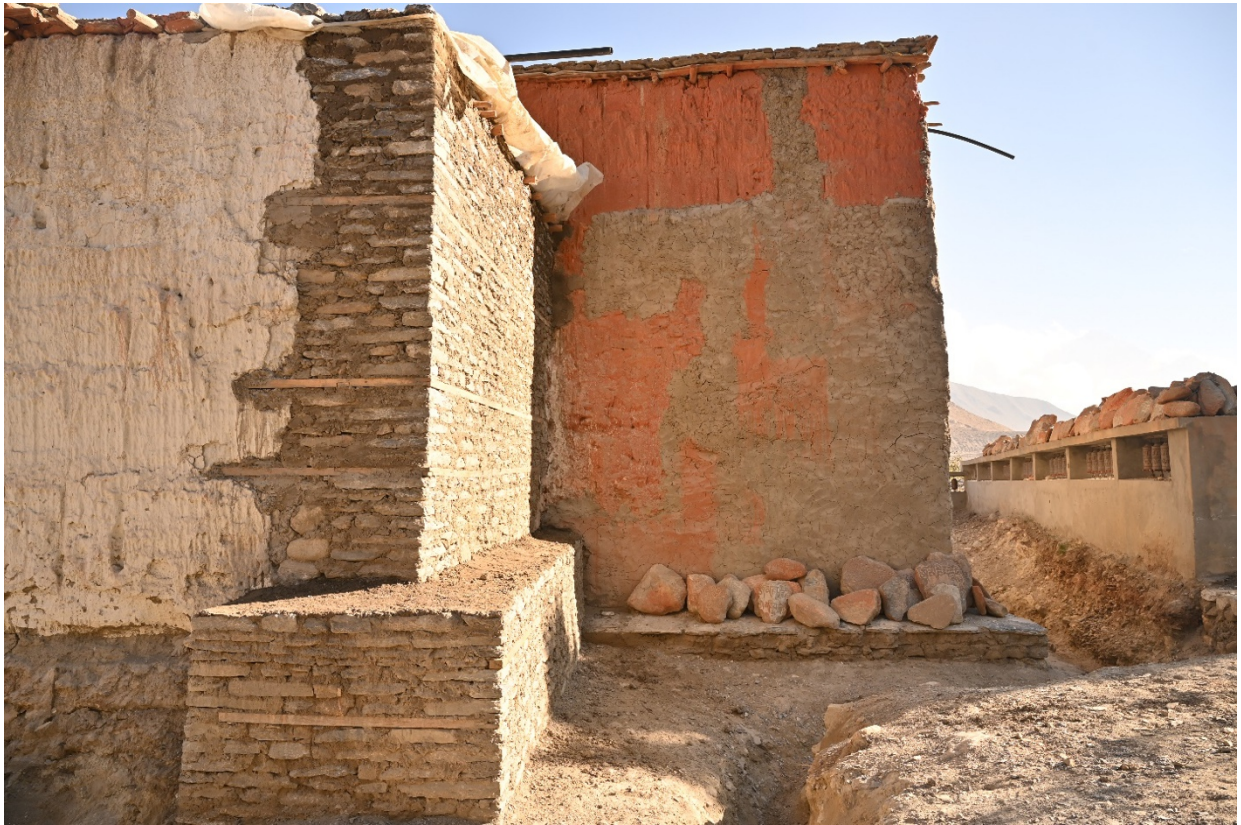
Figure 13: Northwest corner wall after completion.

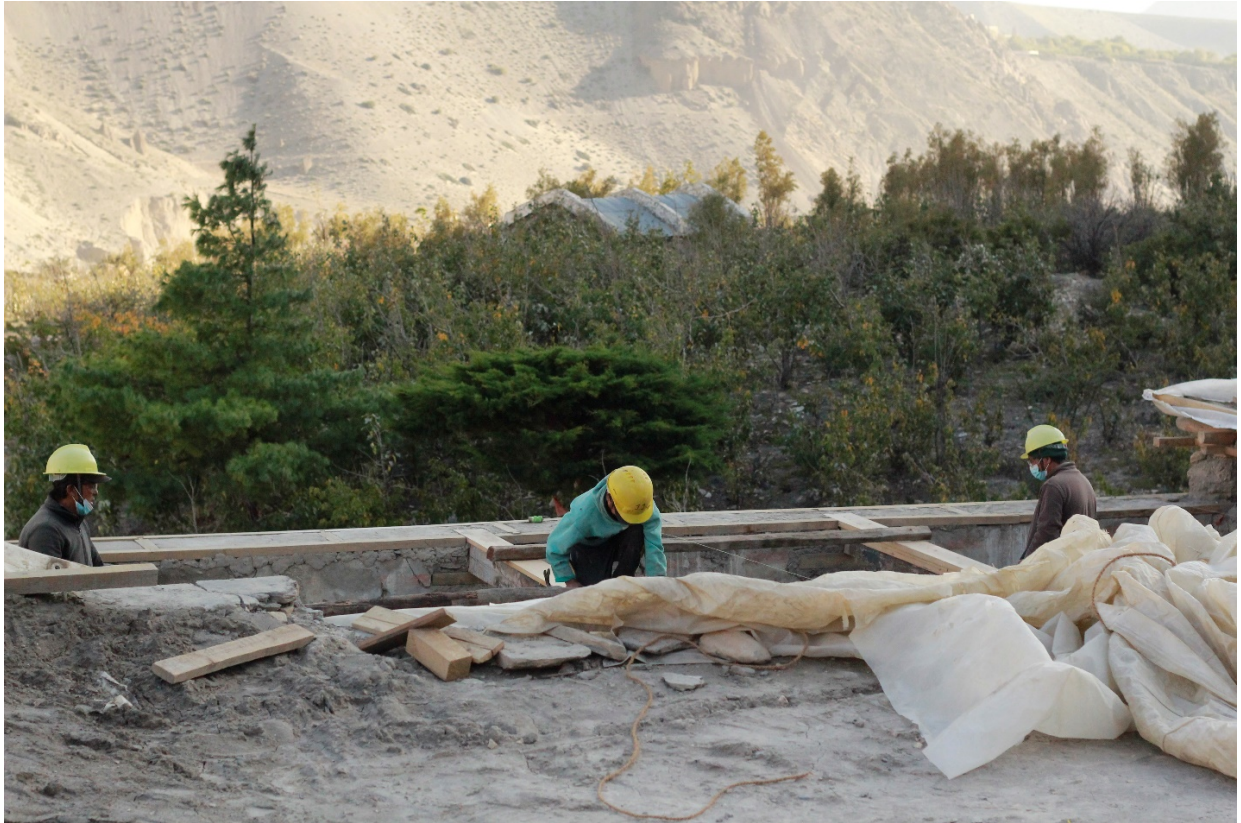
Figure 14: Installing the temporary roof above the south wing.

In the south wing area, which was a focus of this year's work, we installed a temporary roof for the winter. We made sure that it is properly supported from the inside to make sure that it can bear heavy snowfall.

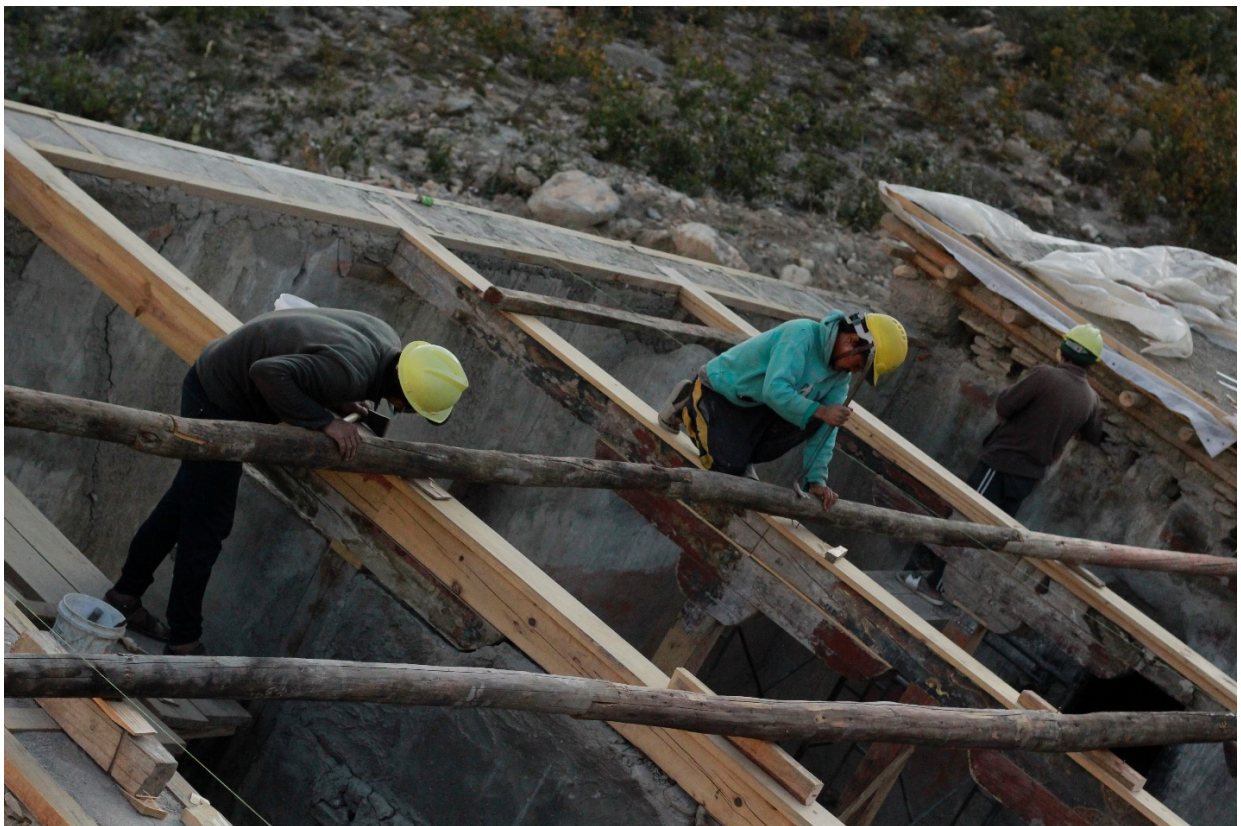
Figure 15: Installing temporary roof at south wing.

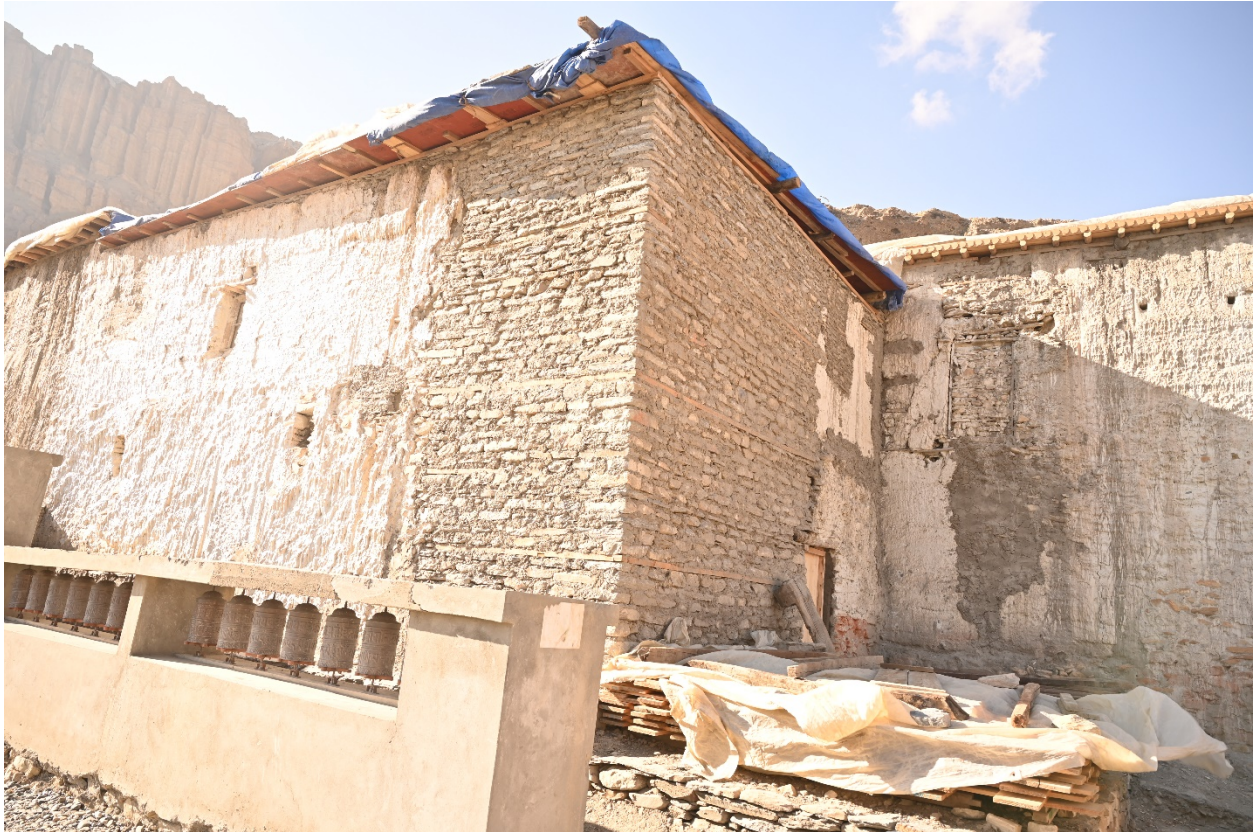
Figure 16: Temporary roof after completion.

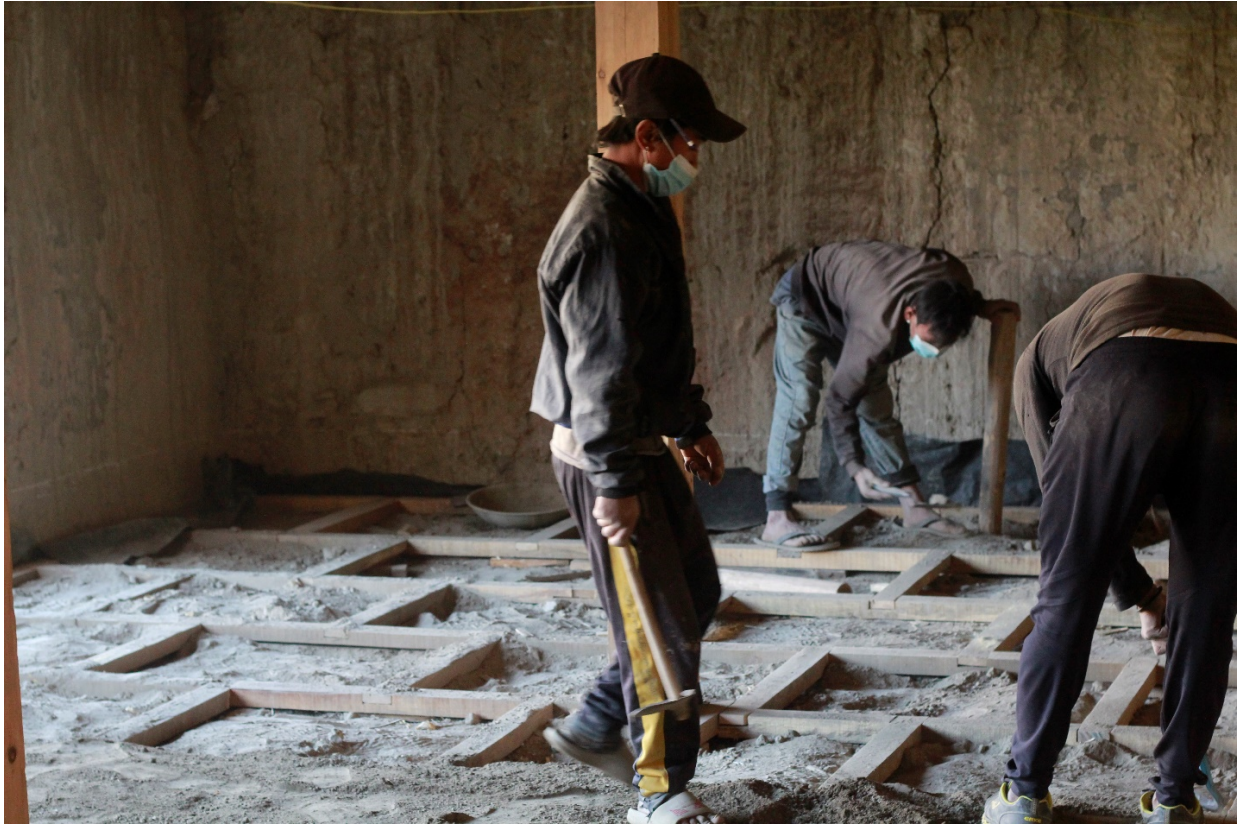
Figure 17: Laying out the wooden batten and mud for flooring.

Further, we finalized the flooring in the room above the entrance. We maintained the level upon wooden splits and layout the wooden batten filled with mud in between and finished with wooden planks. Then the floor was finished by wooden planks.

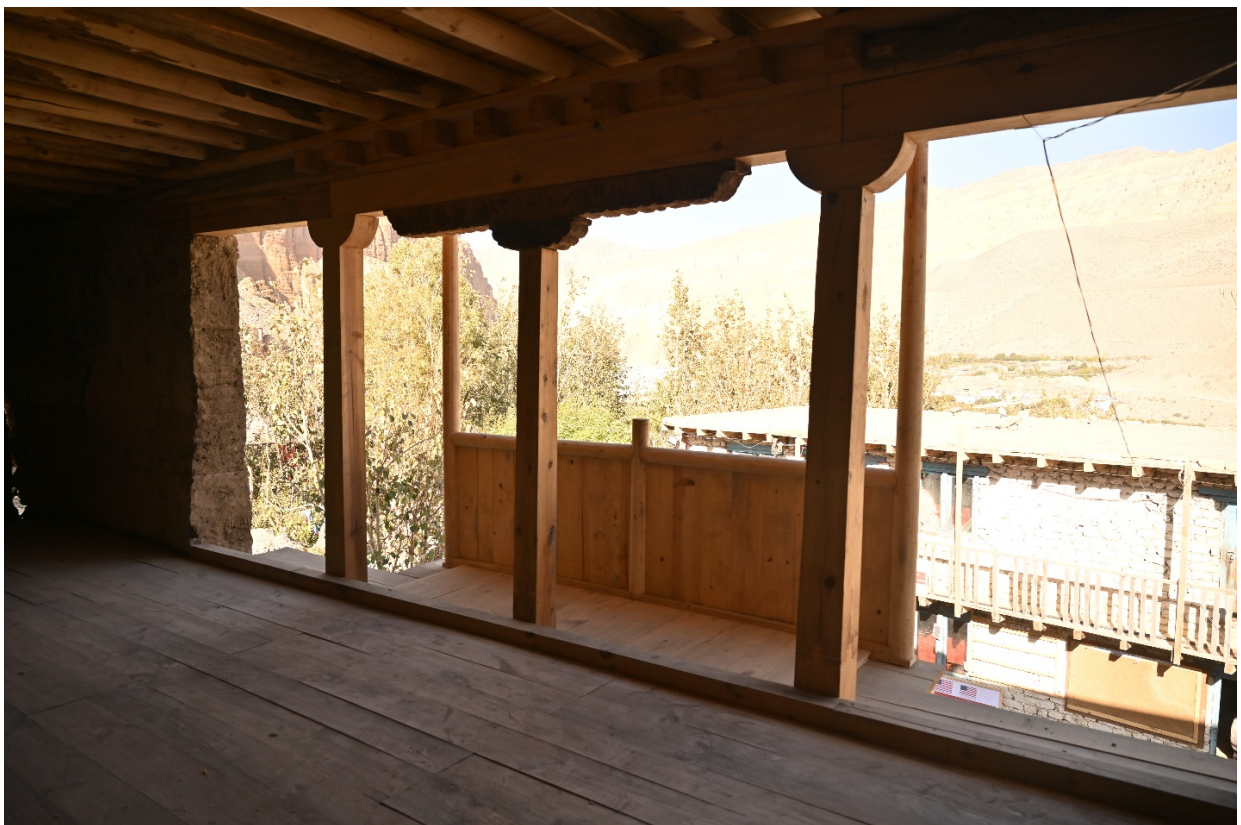
Figure 18: Photo showing the new flooring and balcony in the room above the entry to the monastery.

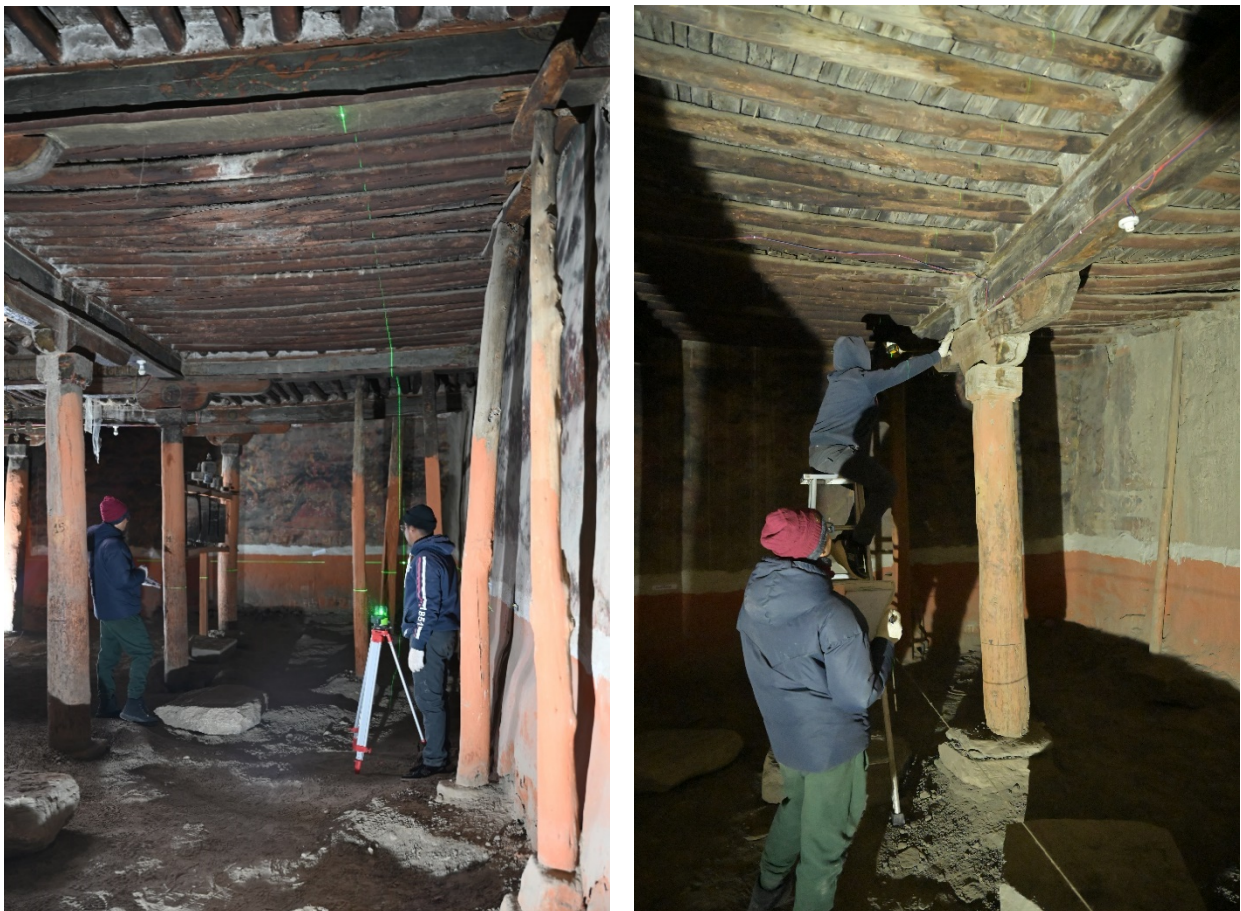
Figure 19: Measuring details inside the monasteries' main hall.

In December I together with a helper and Santosh went back to the site to measure the details of the existing wooden members anew and compare them with previous drawings. Thereby, we focused on the Dhukang area which will be the main working area next year. We then also updated the existing drawing in sketches drawn by hand which in the following quarter will be converted into a digital format.

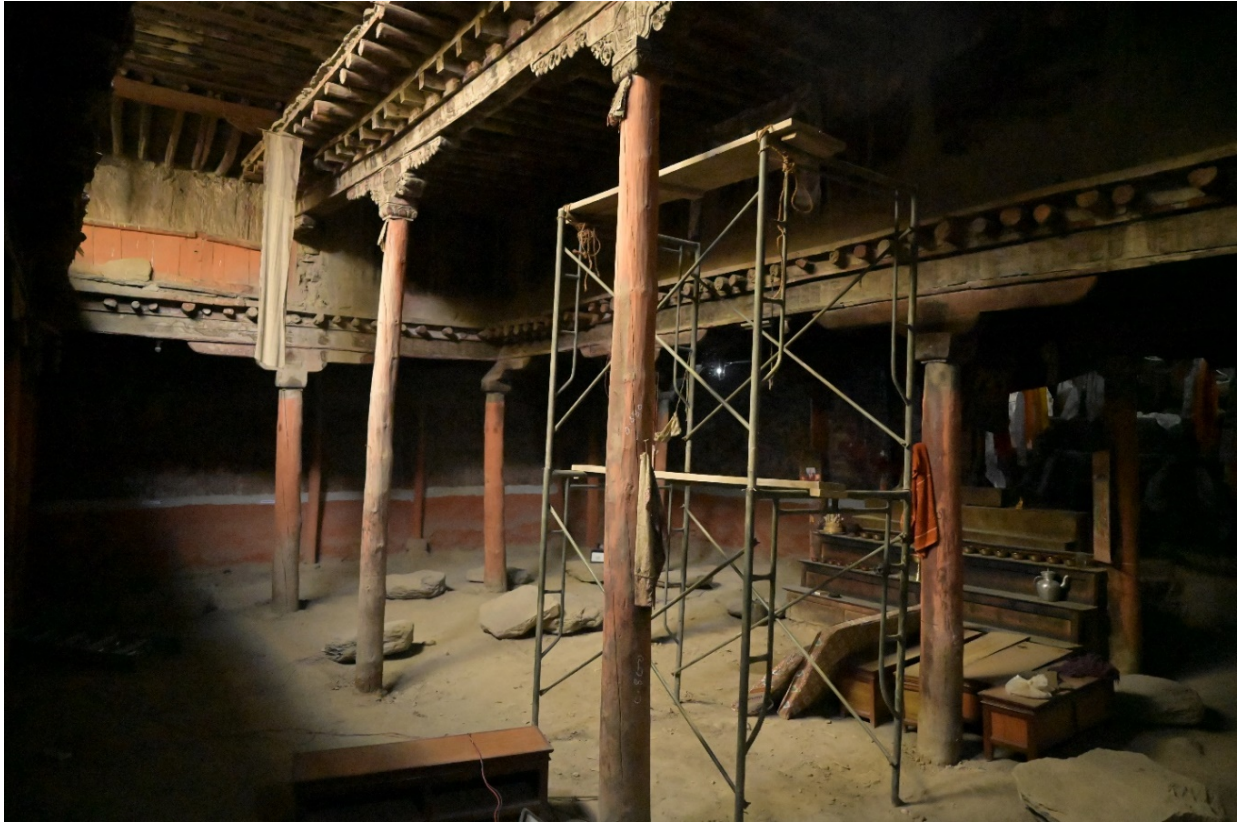
Figure 20: The scaffolding set up to be able to measure the detail of columns.

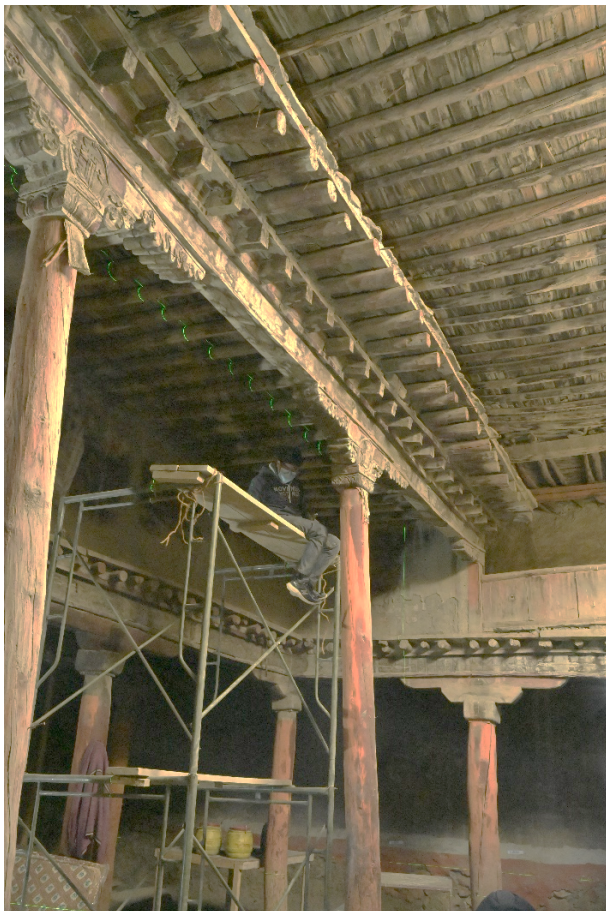
Figure 21: Taking detailed measurement of the capital on one of the long columns and discussing the measurements on site.

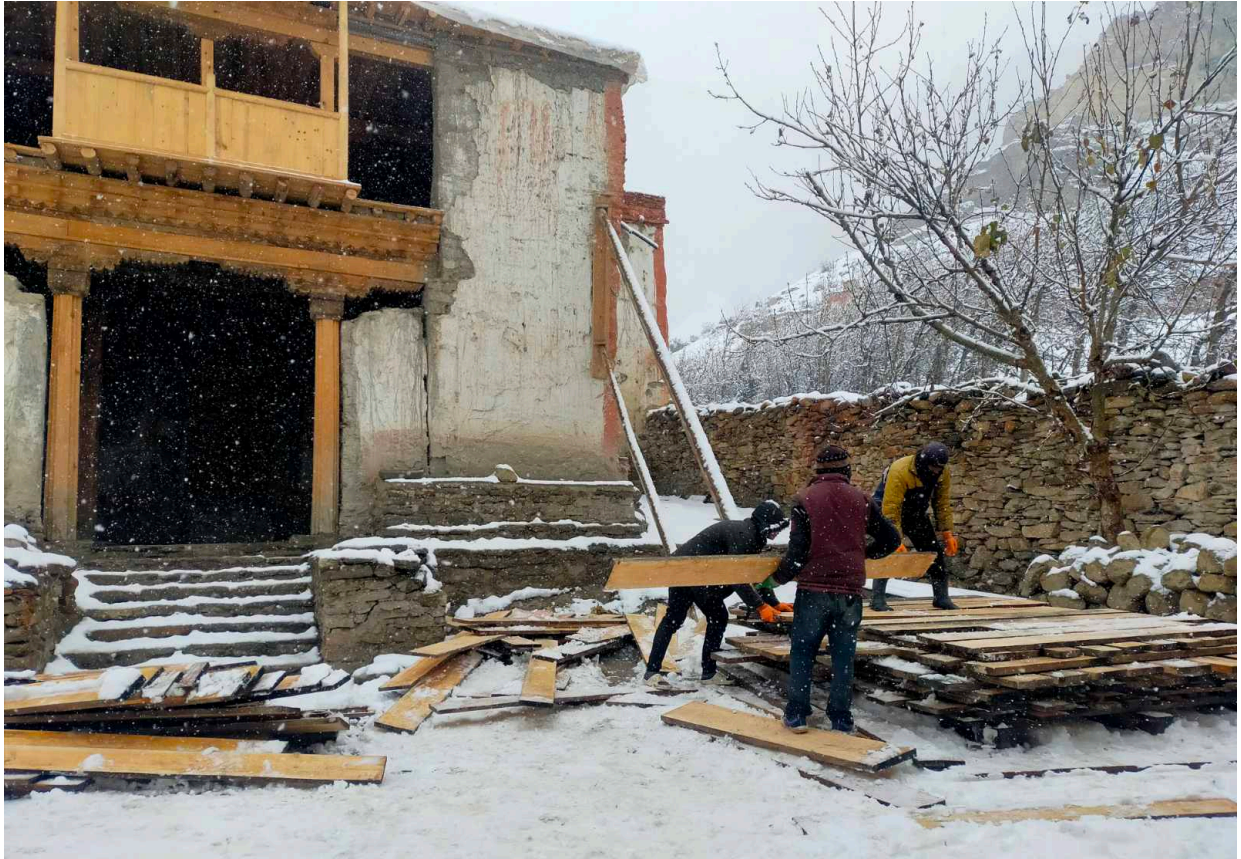
Figure 25: Stacking the wood properly.

We estimated the wood needed for the next year by considering the wood left at the site. In December we then purchased most of the wood needed for the next year and stored it properly. This will ensure that the wood is dry and ready to use when needed.

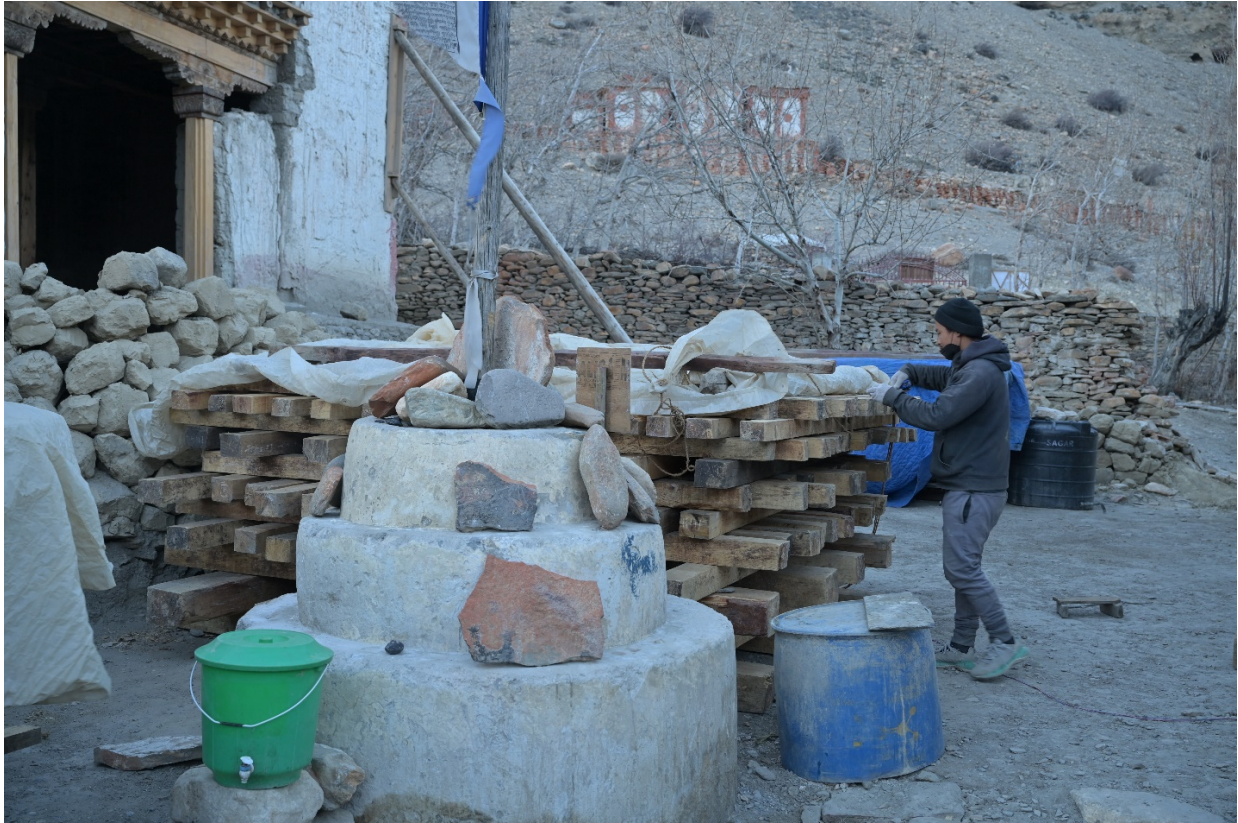
Figure 9: Covering the wood to protect it from snow.
