# Architectural Restoration and Seismic Strengthening of Gönpa Gang

U.S. Ambassadors Fund for Cultural Preservation, Award No. SNP40022GR0039

**Project Report, Second Year, Quarter 2 – January to March, 2024**

**Norbusum Foundation (NGO)**

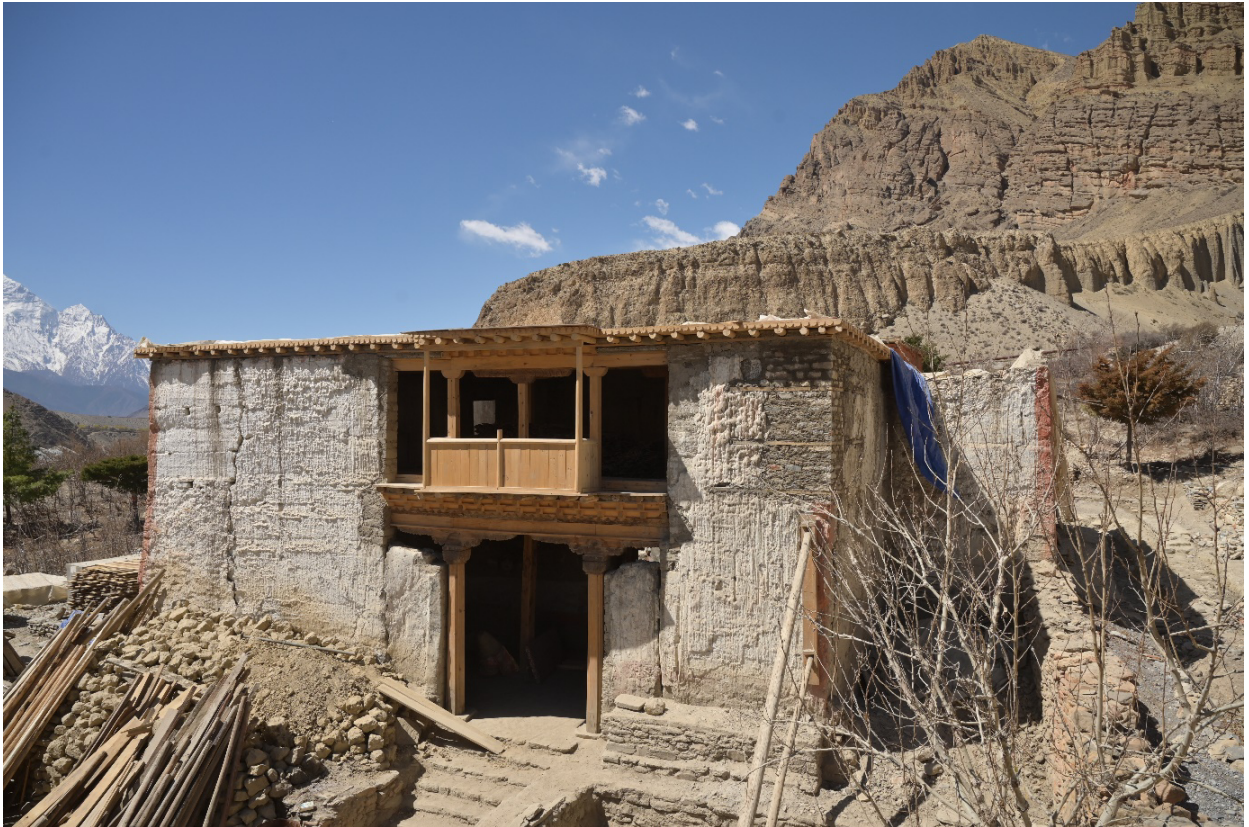
*Figure 1: Photo taken on March after renovation of corner wall.*

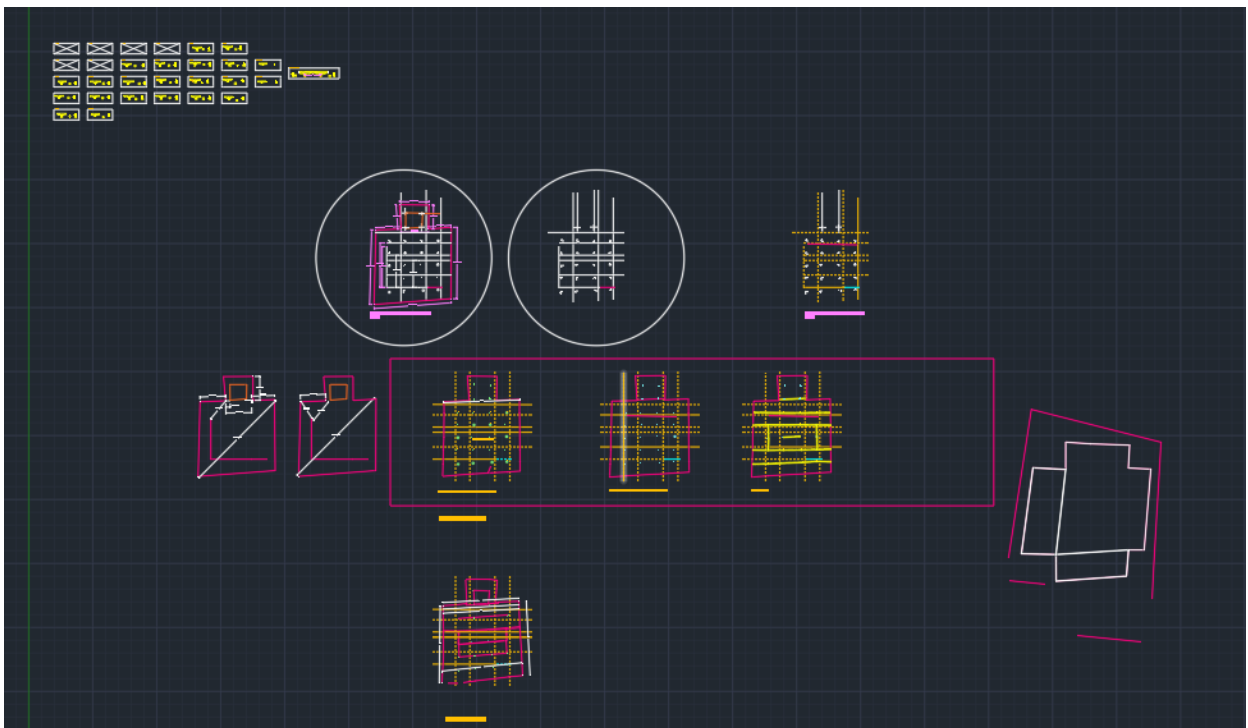
Figure 2: Screenshot of the digital drawings showing different elements of the temple in different colors.

In January, Sabin Shrestha updated his digital drawing from the measurements he took in December. These not only document the state prior to restoration, but they also document the restoration work by recording the changes made.

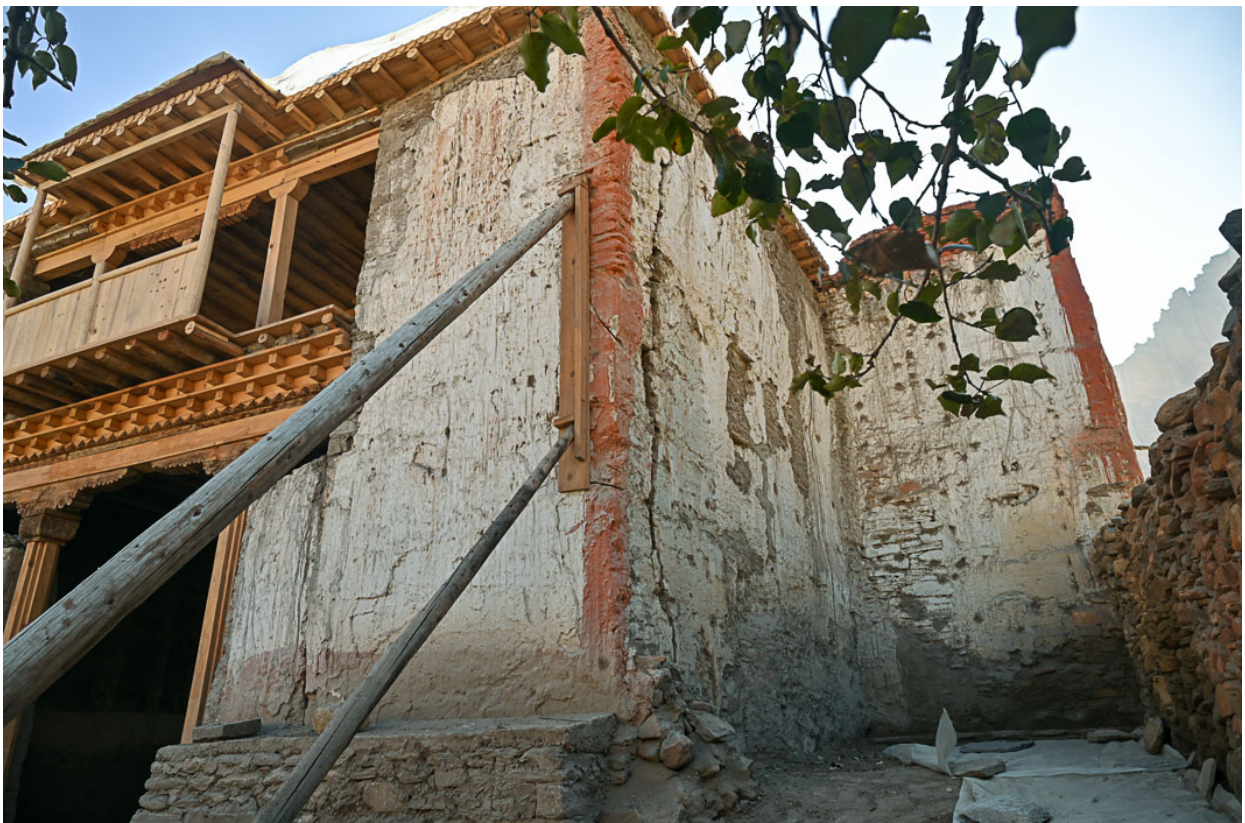
An issue remaining from last year's work was a major crack in the northeast corner of the Entry Hall. On the ground floor the inner walls are covered with murals, the walls there thus cannot be rebuilt. Therefore, we decided to take down a larger section of the corner on the upper floor and rebuild it in a way that ties the two corner walls together and thus avoids that the crack widens on the lower floor.

*Figure 5: The severe crack at the northeast corner of the Entry Hall in October 2023.*

First, the walls at the corner had to be taken down, which we started on March 19. We then reconstructed the walls using wooden ties with rammed earth to connect them across the corner. This work was finished by March 22.

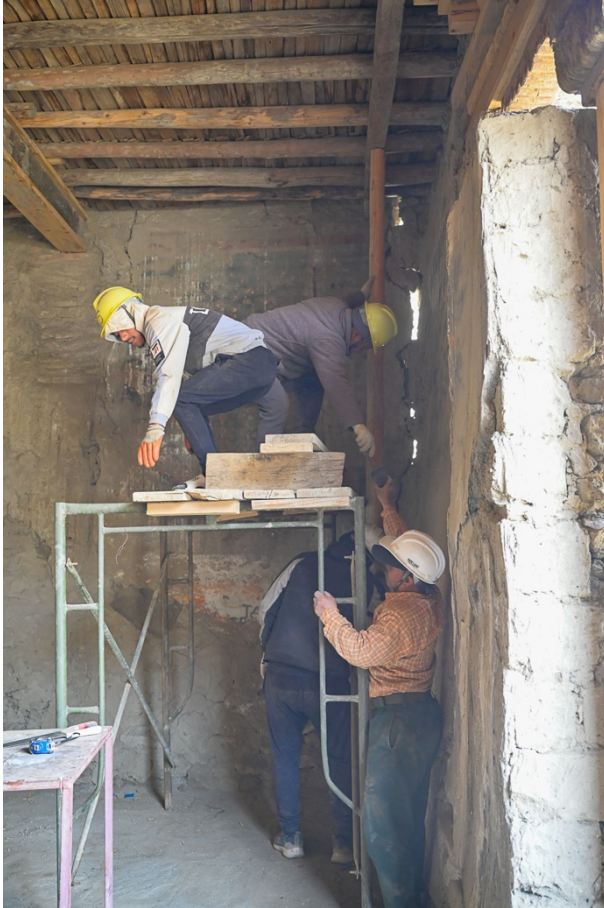
*Figure 6: Supporting the cross beams of the northeast corner on the ground floor level.*

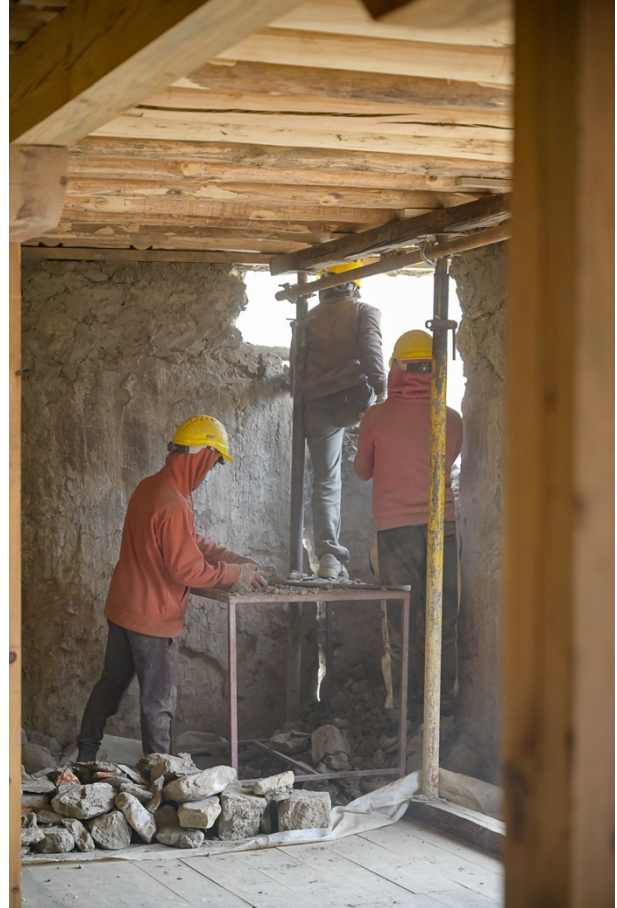
*Figure 7: Opening the northeast corner on the upper floor level by dismantling the walls.*

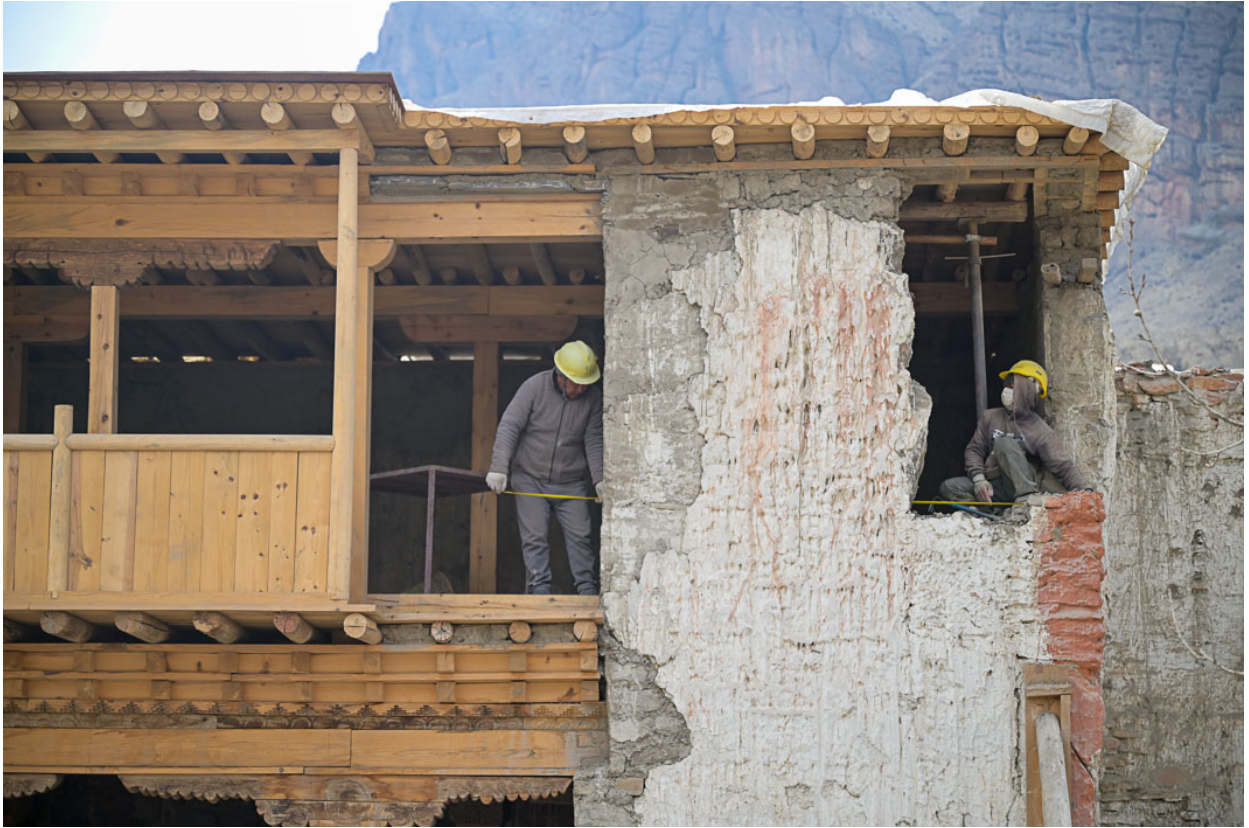
Figure 8: The upper part of the northeast corner after dismantling.

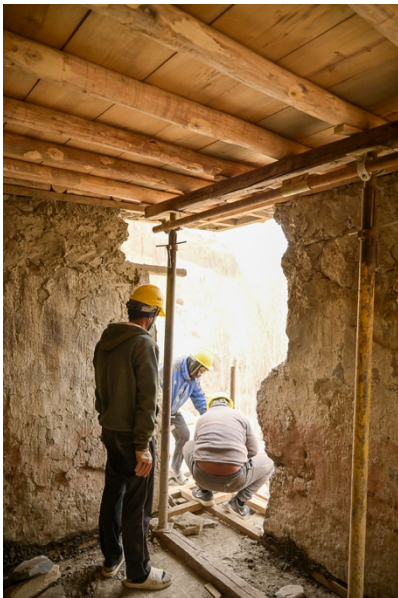
Figure 9: Placing the lowest wall tie on the upper floor of the northeast corner.

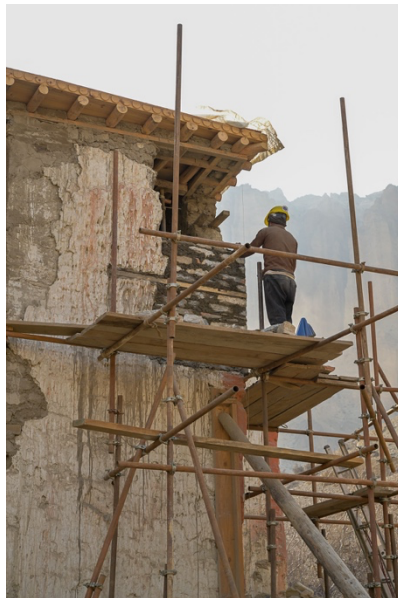
Figure 10: The northeast corner during reconstruction.

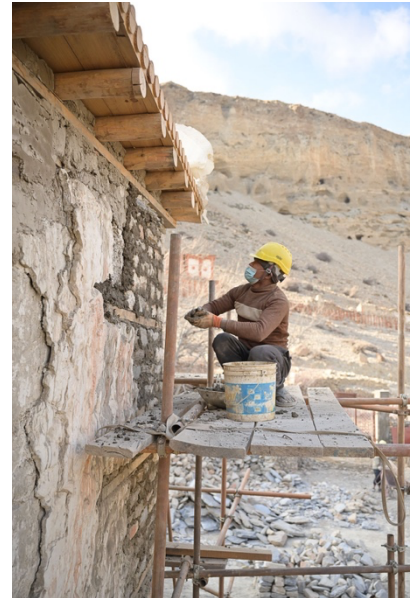
Figure 11: Finishing the reconstruction of the northeast corner.

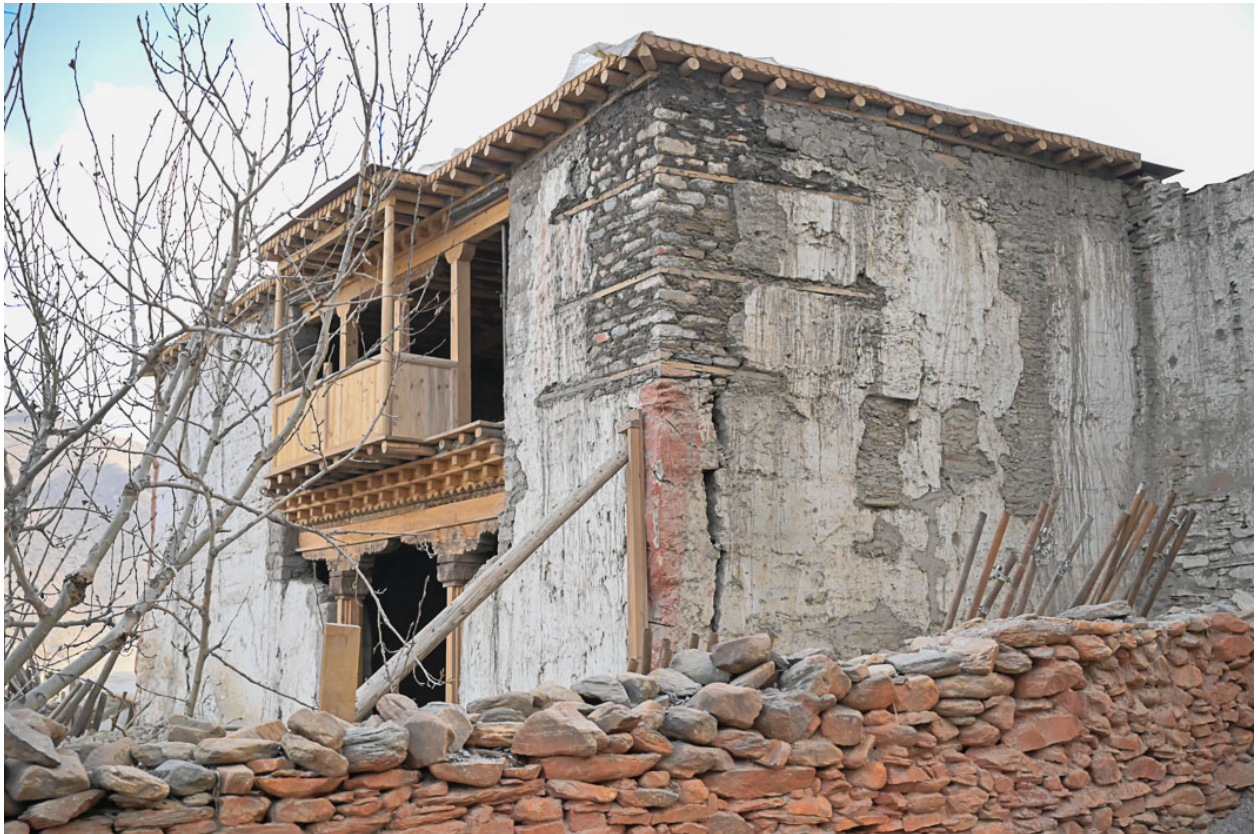
*Figure 12: The northeast corner after reconstruction, the crack still visible on the lower floor.*

The balcony design has been a contested issue over the past months (see Figure 12). On the one hand, it is clear that the balcony as it was preserved was not original but a later construction that likely was much narrower than the original, which should have been of the width of the lower parts above the door. On the other hand, its original appearance cannot be reconstructed anymore.

The version added last year did replicate what was preserved at the site, but the areas to its sides remained to be decided on. It was decided to keep the narrow balcony and to introduce screens to its side. Accordingly, some adjustment work on the balcony was undertaken March 20 and finished by March 21.

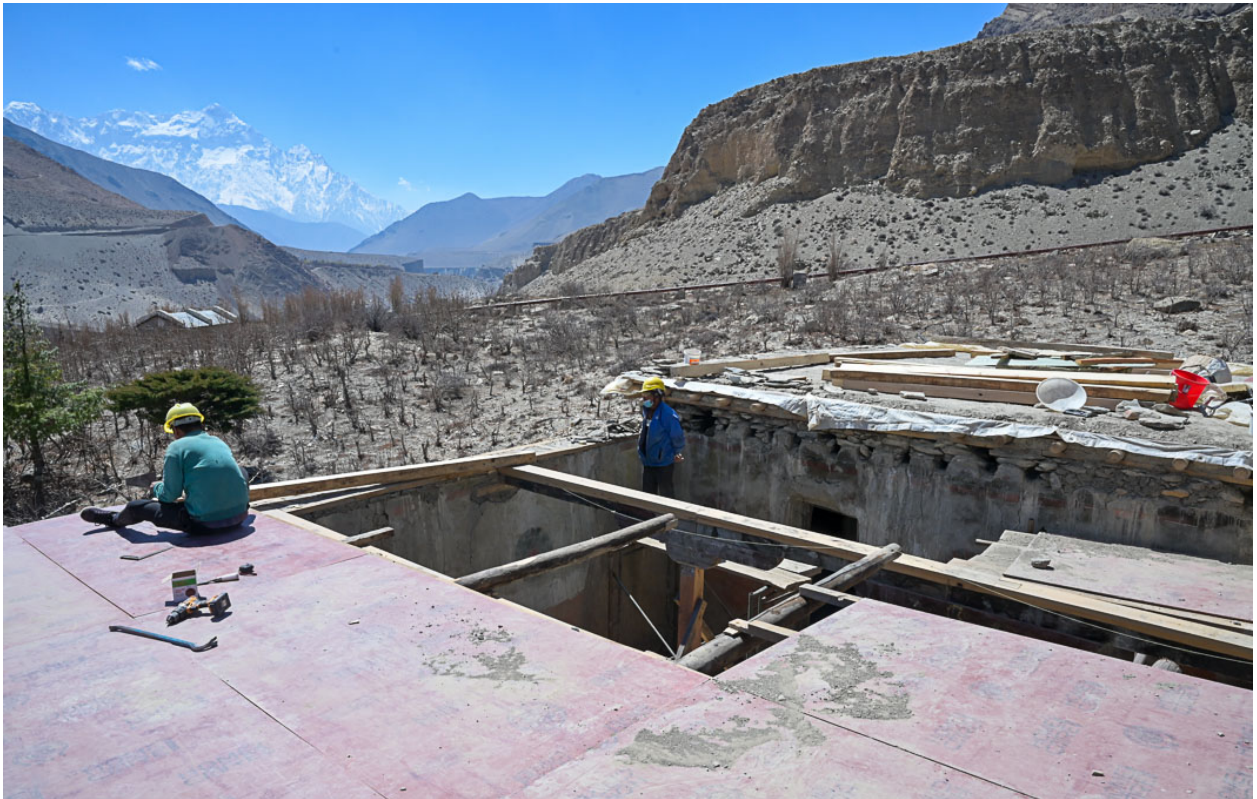
Figure 13: Removing the temporary roof of the south wing.

In the area of the south wing, we first dismantled the temporary roof and started to add the joist that were prepared when work began in March. After adding the joists, we did the planking of the roof. Then we shifted to batten work to finish the floor of the southeast room. We also integrated an electrical pipe before the mud

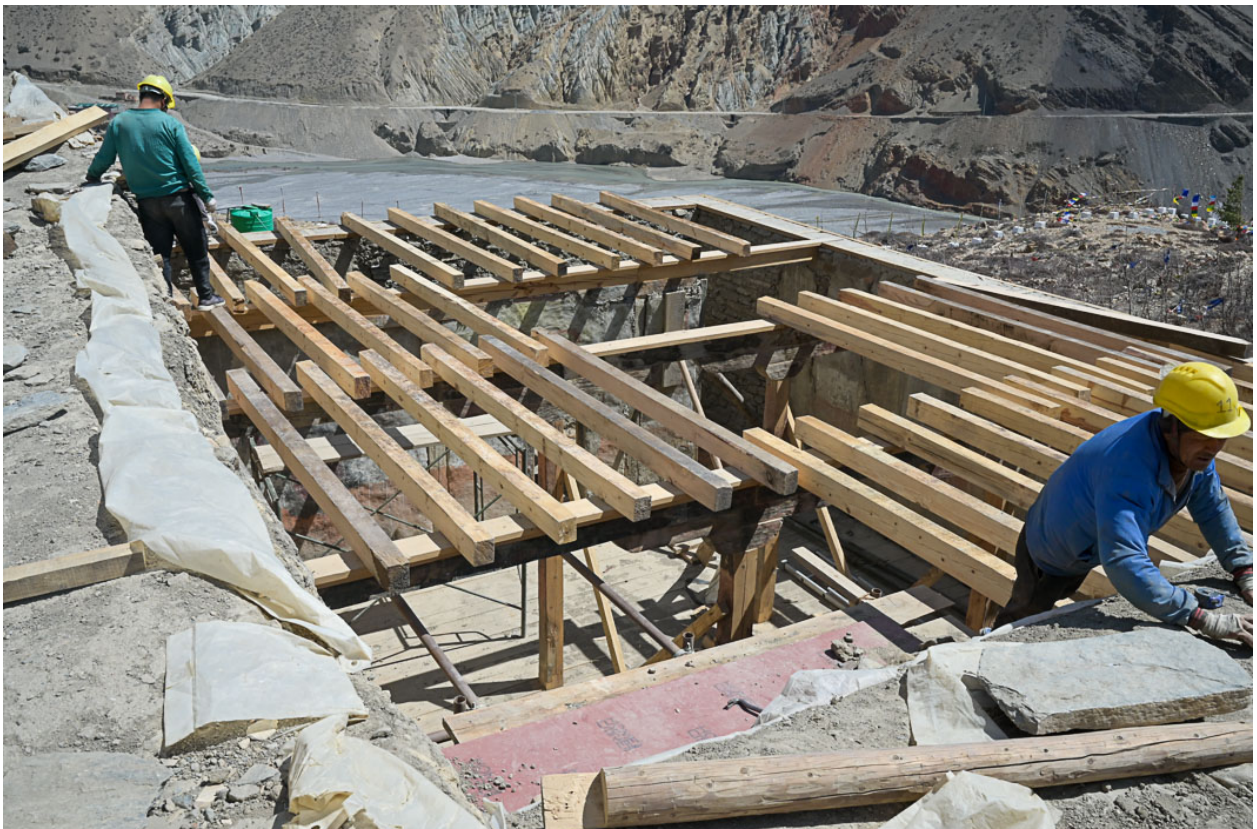
Figure 14: Placing the joists above the south wing.

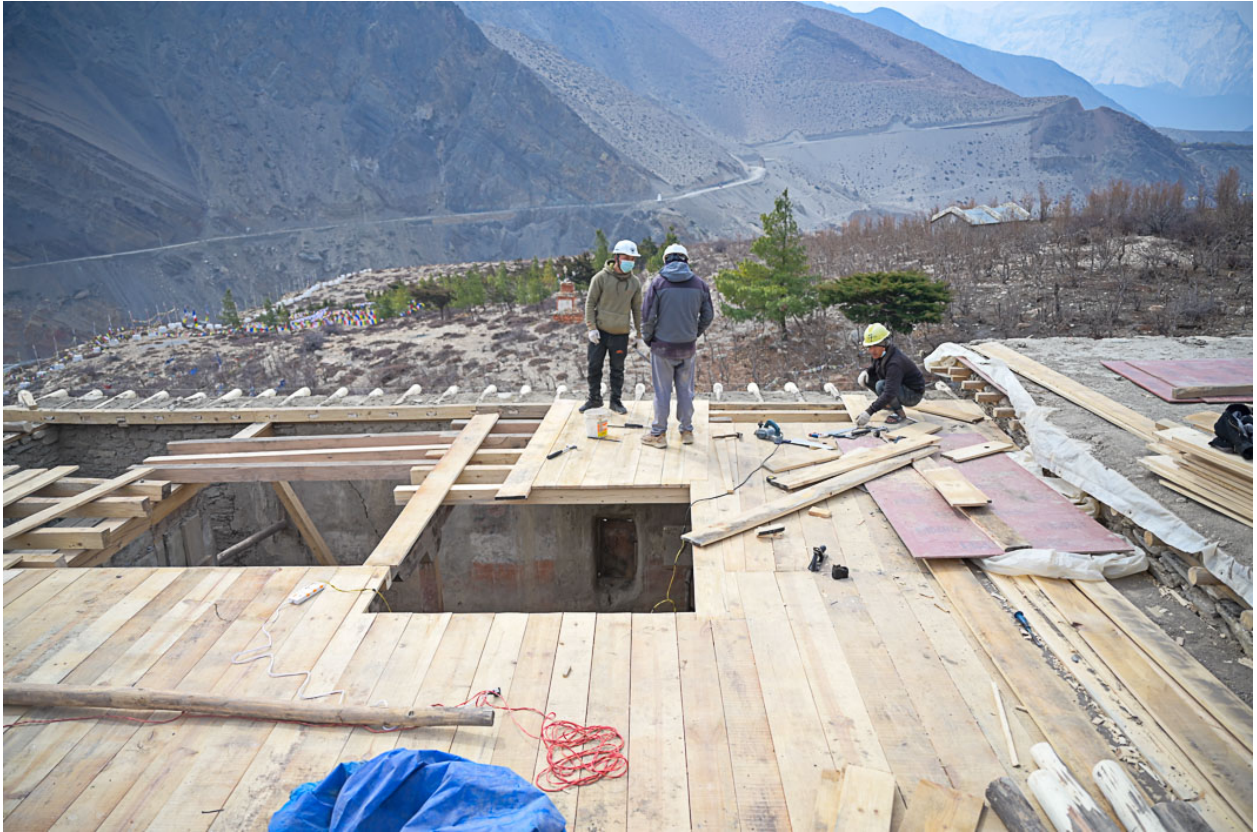
Figure 15: Adding the planking to the roof of the south wing.

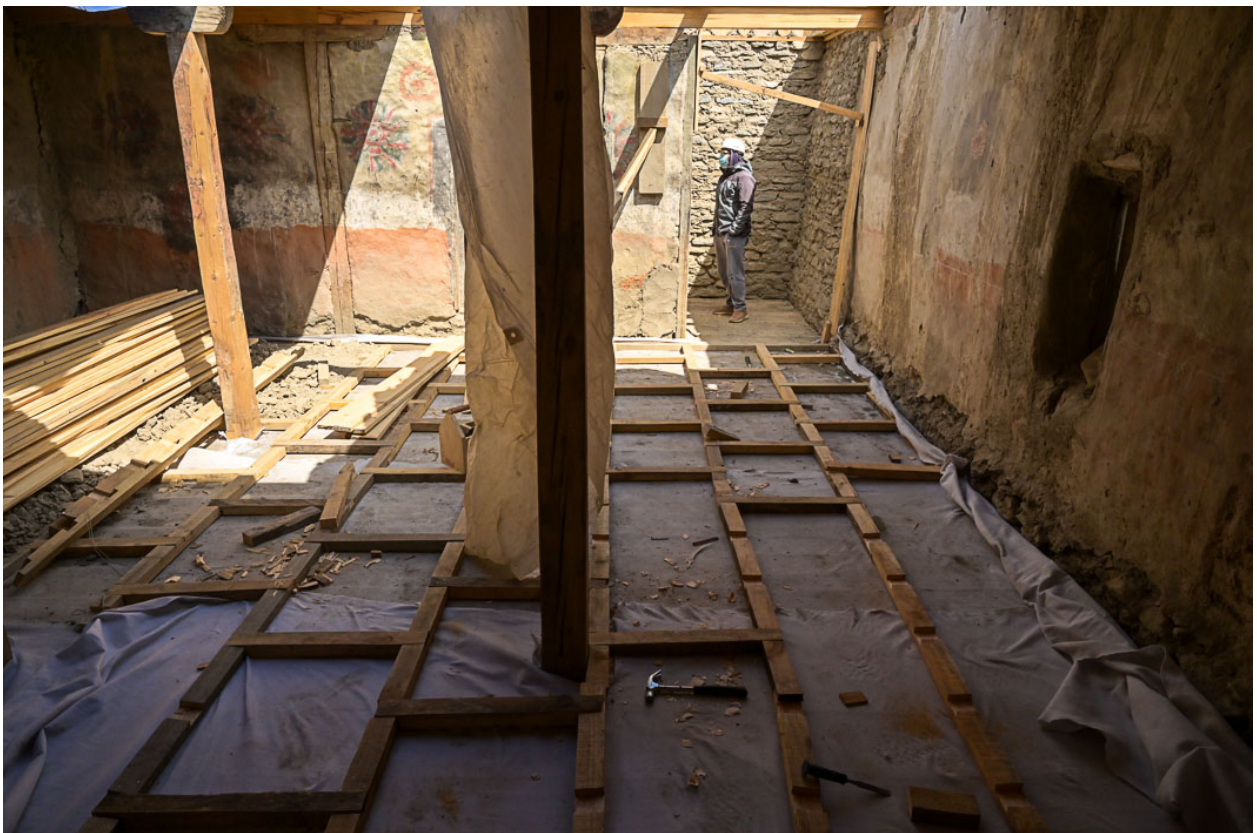
Figure 16: Preparing the wooden floor for the painted room of the south wing.

and floor finish, then we prepared the planks for the floor. Also, the decorative wooden band to finish the roof if the southeast room was done.

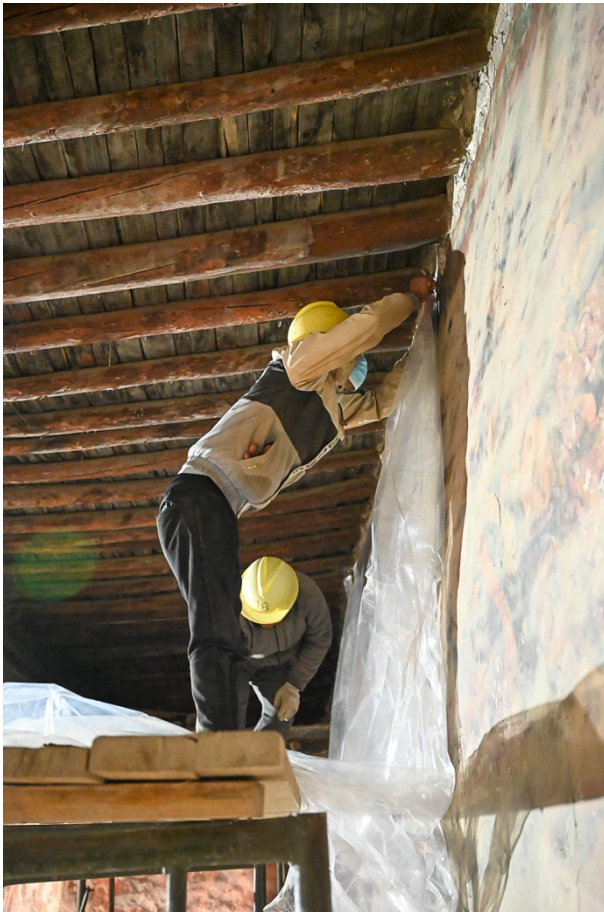
*Figure 17: Attaching the plastic sheets.*

As soon as sufficient labor was recruited, we covered all the paintings within the main temple with thin plastic sheets to protect the murals from the dust. Then, we started to dismantle the eastern half adjacent to the Entry Hall on March 18. Once that was completed, we began to level and strengthen the wooden support structure. All existing wooden splits used for the ceilings were cleaned and we will reuse them in the same area. Equally, all wooden members of the ground floor, including the painted beams were cleaned and prepared for reuse.

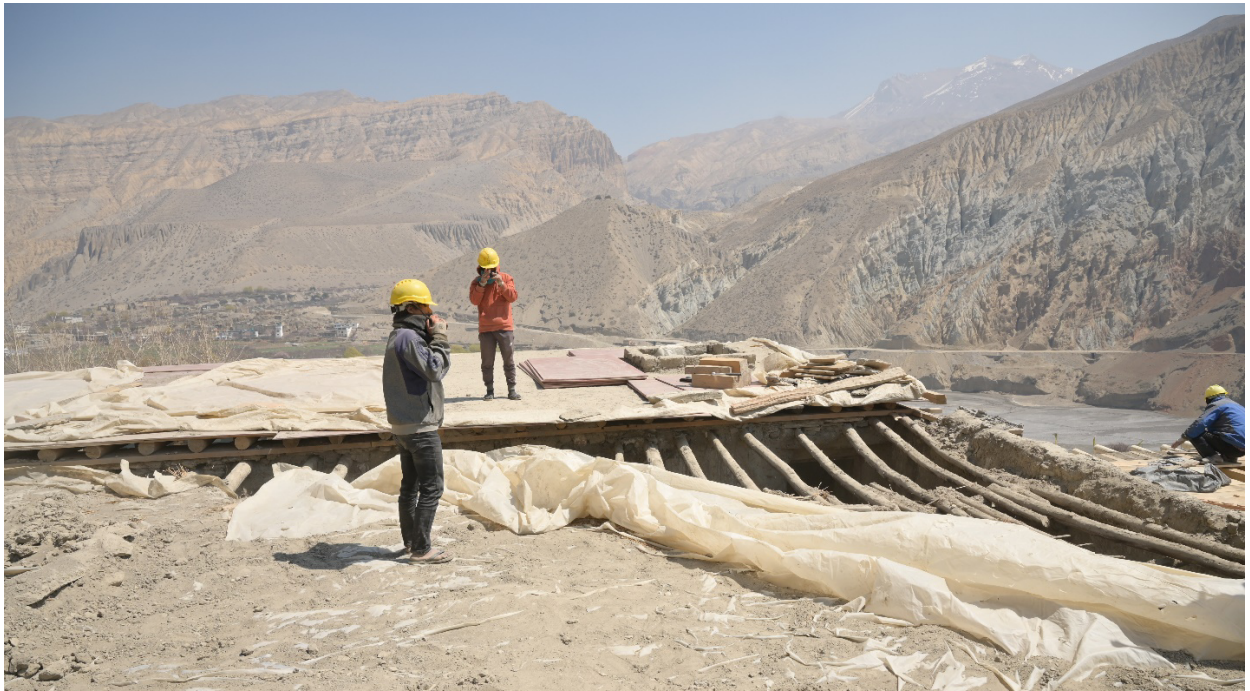
Figure 19: Removal of the roof above the Assembly Hall, including the plastic sheets added in an earlier village restoration.

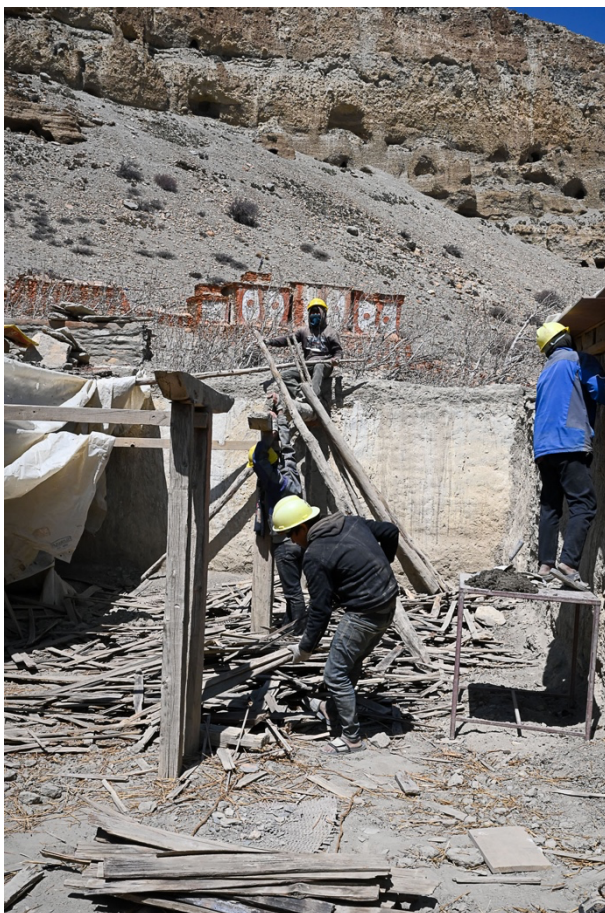
Figure 20: Dismantling the support structure on the upper level.

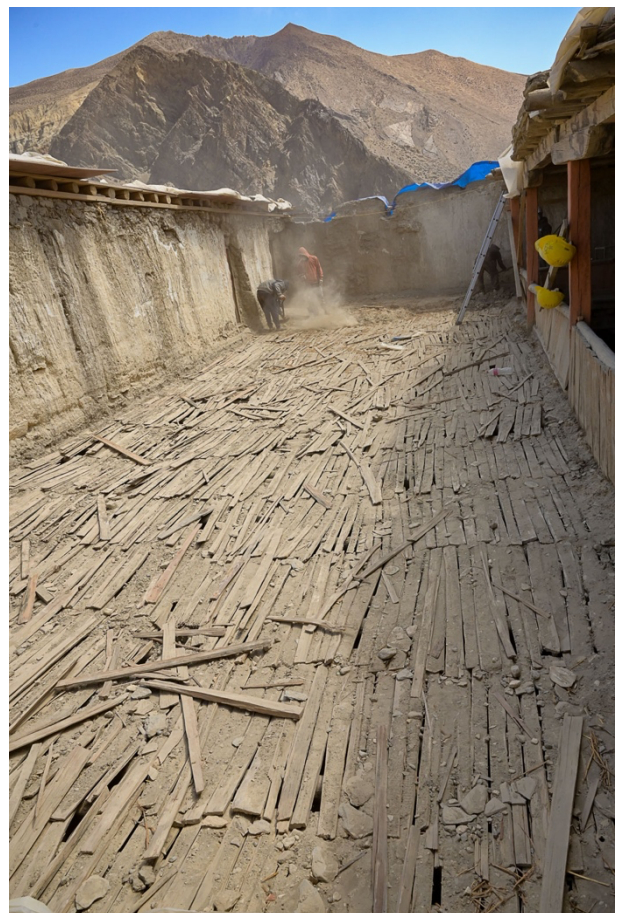
Figure 21: The wooden splits covering the ceiling of the lower level after removal of all the mud.g

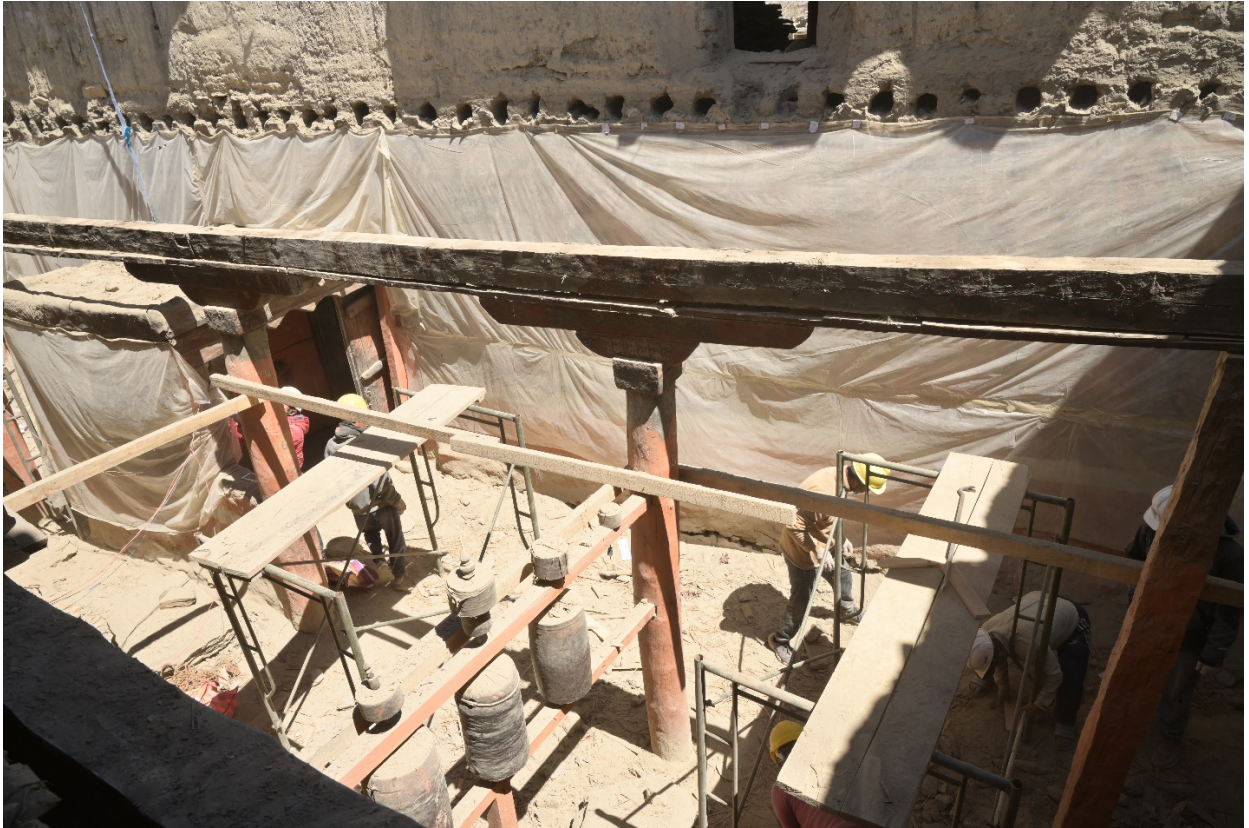
Figure 22: View into the entry area of the Assembly Hall after the dismantling of the two levels above it.

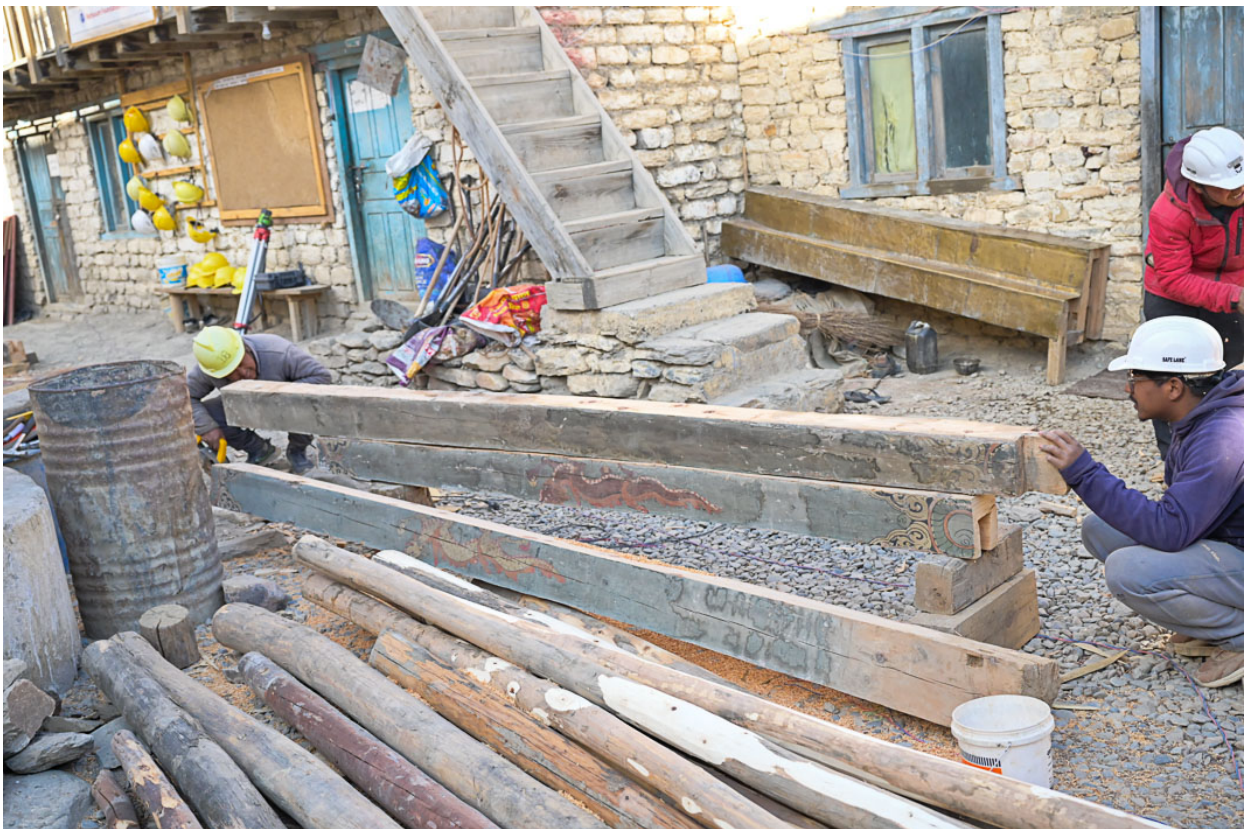
Figure 23: Inspection of the original wooden beams to prepare them for reuse.

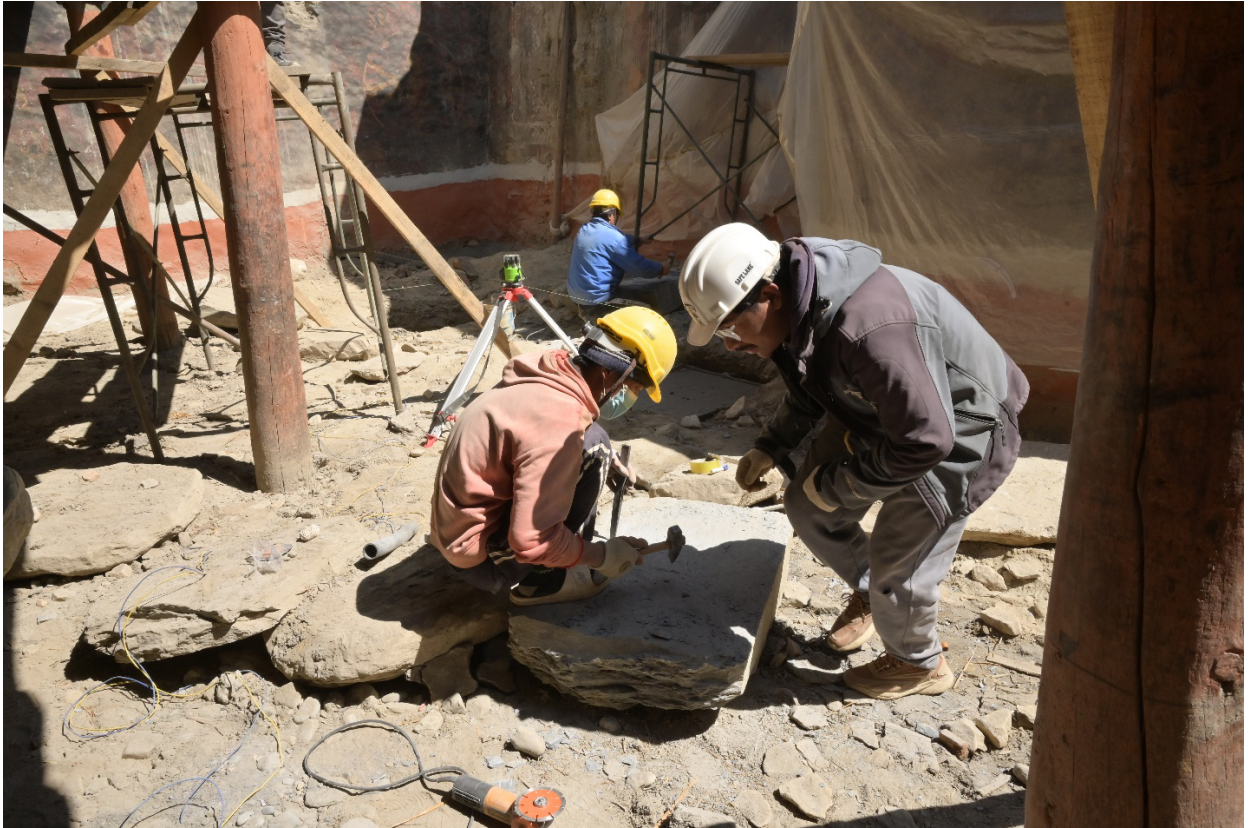
*Figure 24: Preparation of a new stone base for one of the columns.*

By the end of March works on the wooden members was still ongoing, as was the preparation for the stone bases for the columns. This is a rather complex task as in the end the ceiling needs to be level.

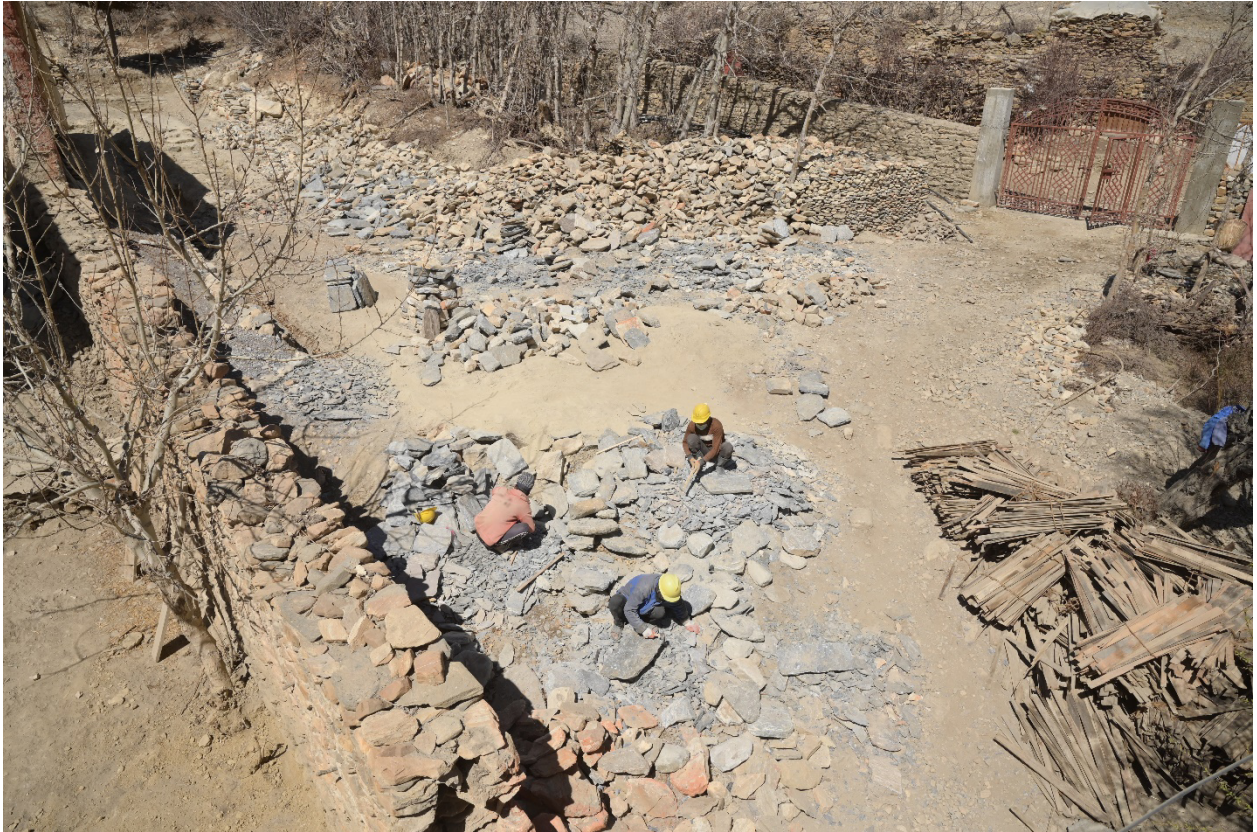
*Figure 25: Preparation of the stone panels for the drainage.*

Our stone mason suggested to first prepare all the necessary stone panels for the drainage. We thus started with this work. We also removed the stone from the dry-stone wall in the northeast corner of the temple.
