Architectural Restoration and Seismic Strengthening of Gönpa Gang

U.S. Ambassadors Fund for Cultural Preservation, Award No. SNP40022GR0039

Project Report, First Year – September 2022

Norbusum Foundation (NGO)

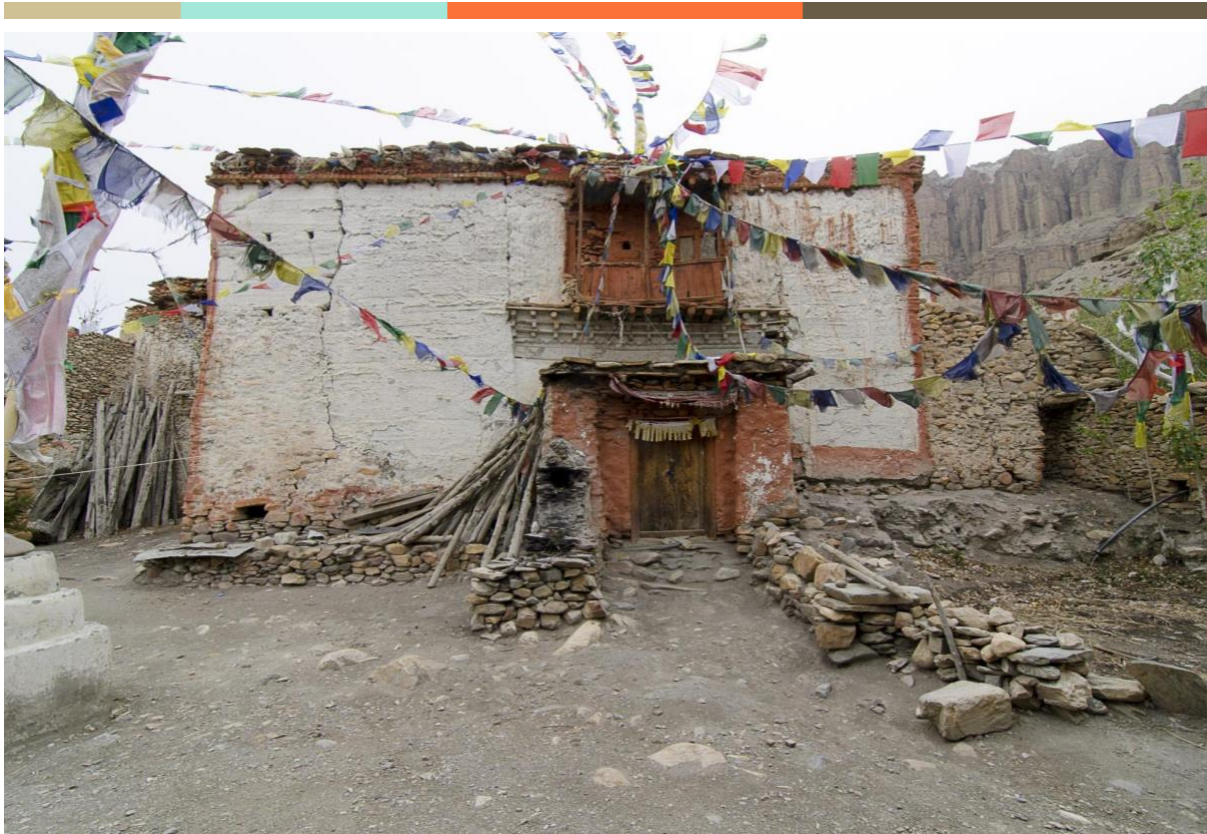
Figure 1: Entry side of Gönpa Gang with reconstructed balcony and staircase to the left.

In figure 1 you can see the room on a right side that is the one which clops.

While the monastery only had some humidity problems at the usual spots over the summer, the heavy rains at the beginning of October did affect Gönpa Gang. The simple structure to the right-hand side of the building's entrance (Figure 1) has partially collapsed and it is said that the crack on this side of the wall got bigger. Further, inside the Assembly Hall, in the niche behind the big Maitreya Buddha image, water entered the interior of the building.

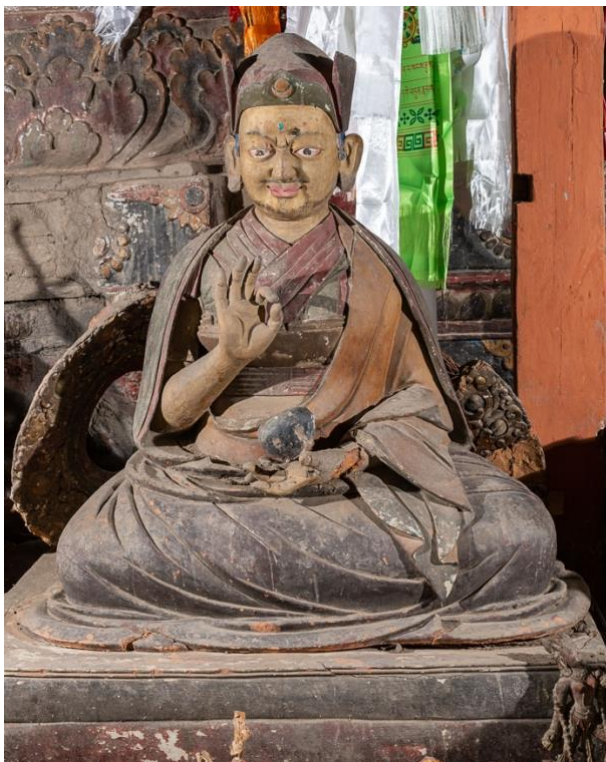
Figure 2: Clay sculpture of Katok Rikdzin Tsewang Norbu (kaḥ thog rig 'dzin tshé dbang nor bu; 1698–1755)

September 28 and 29 Kunjon Thakuri, Sienna Craig, Sonam Dorjee and Christian Luczanits returned from Upper Mustang and visited the site. While all the murals had been documented earlier and the sculptures had only been photographed as they are on display. This time the sculptures were documented in higher quality—smaller movable ones in a photo tent—from all sides and measured to have a detailed record of them (Figure 2).

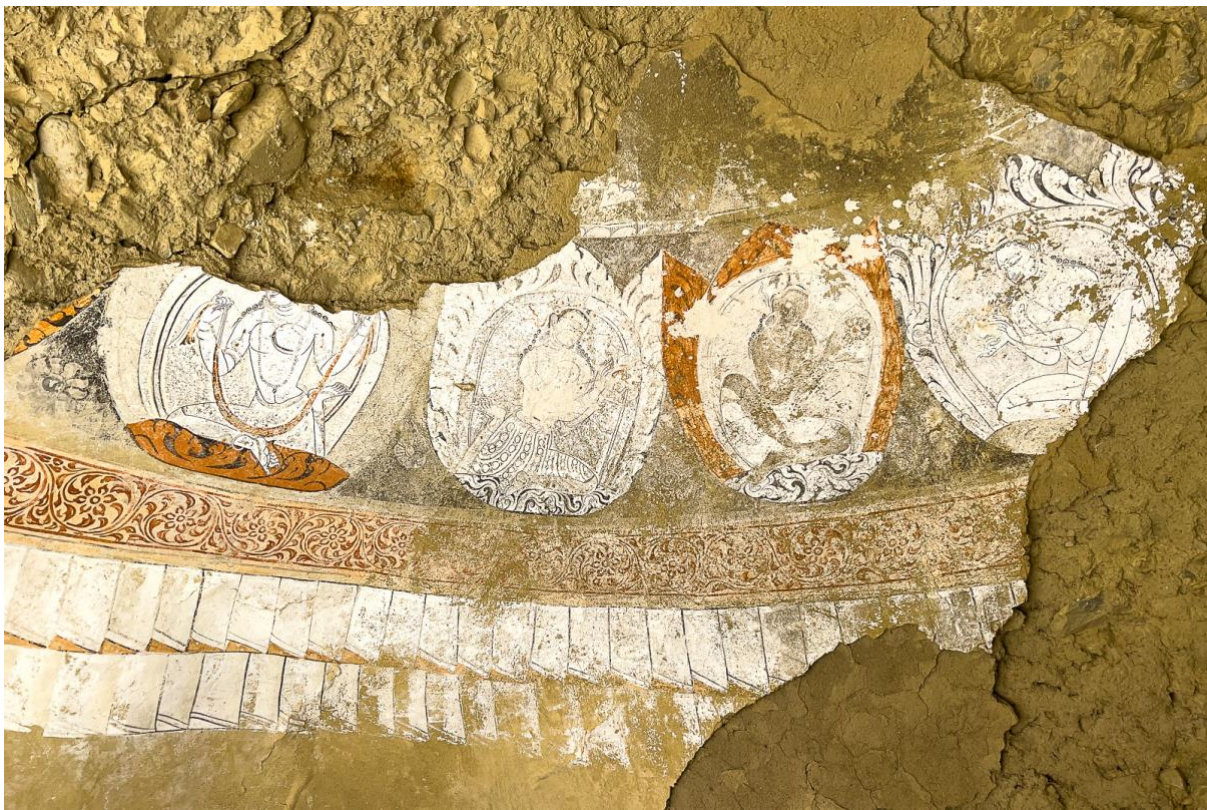
Led by Binod Gurung and another villager, Kunjon Thakuri and Christian Luczanits further visited a ruined cave site in the side valley behind the monastery, to assess its condition and potential for tourism. The cave is open on one side and filled with debris that covers much of the stupa inside. Further, the murals on the ceiling are extremely fragmentary. Nevertheless, the cave still has great potential for research, especially if the debris is excavated archeologically and the base of the stupa revealed. Remarkably, the upper parts of the stupa were made in papier mâché the fragments of which are still extant due to its durability. Further, the mural fragments allow for dating the cave to the fourteenth century (Figure 3).

Figure 3: Fourteenth century mural fragments in the stūpa cave above Gönpa Gang.

Christian Luczanits suggested to attempt to motivate the Department of Archaeology, Government of Nepal, to undertake an excavation there to fully assess the cave, and to make the cave accessible once that is done. Currently there is no path to reach the cave and access is extremely treacherous.

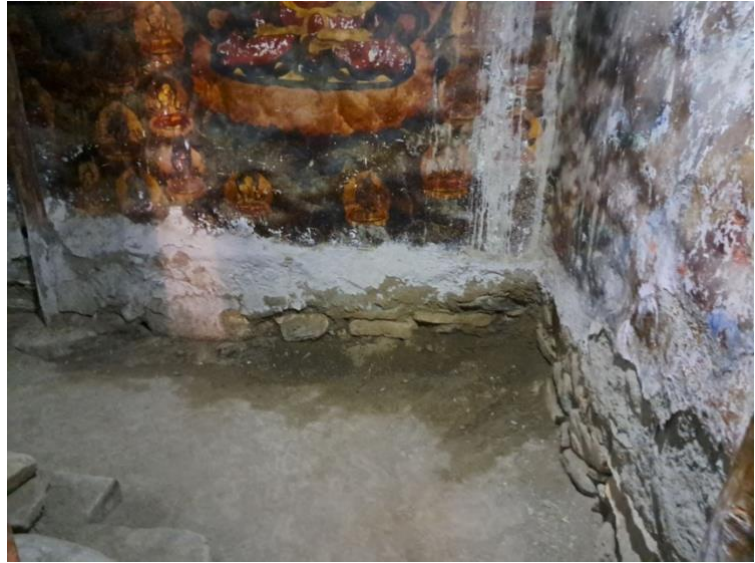
Figure 4: Water entered the building behind the main Buddha image as seen on October 15.
