Seismic Strengthening and Restoration of Lo Gekhar

U.S. Ambassadors Fund for Cultural Preservation, Award No. SNP40020GR0042

Project Report, First Year, Fourth Quarter – July to September 2021

Compiled by Christian Luczanits

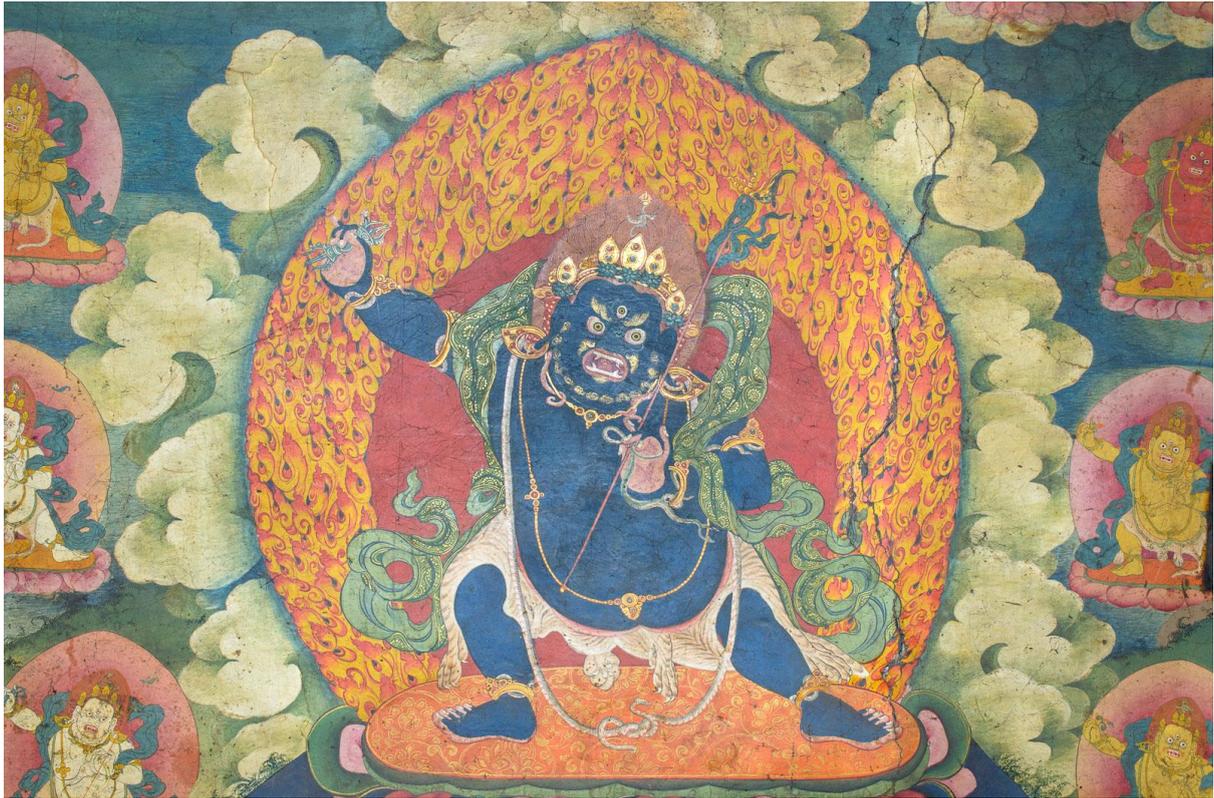
1. The protective deity Vajrapāṇi on the main wall of the Sanctum of Lo Gekhar; the original murals of the sanctum likely date to the mid 17th century.

A detailed study of the murals in the sanctum was equally rewarding and clarified that they most likely also date to the beginning of this period of flourishing, that is the mid-16th century (Figures 1, 5). While they do not provide a conclusive date for their making, the fact that they have been restored in the mid 18th century under Katok Rikdzin Tsewang Norbu (1698–1755) indicates that they predate his activities in the region, which are amply documented in other monuments as well. In contrast to the original murals, the mid-18th century restorations are painted on textile and are accompanied four times by small illustrations of Tsewang Norbu, who can be recognised by his distinctive dress (Figure 4). This further adds to the impact of this teacher's visit to Mustang.

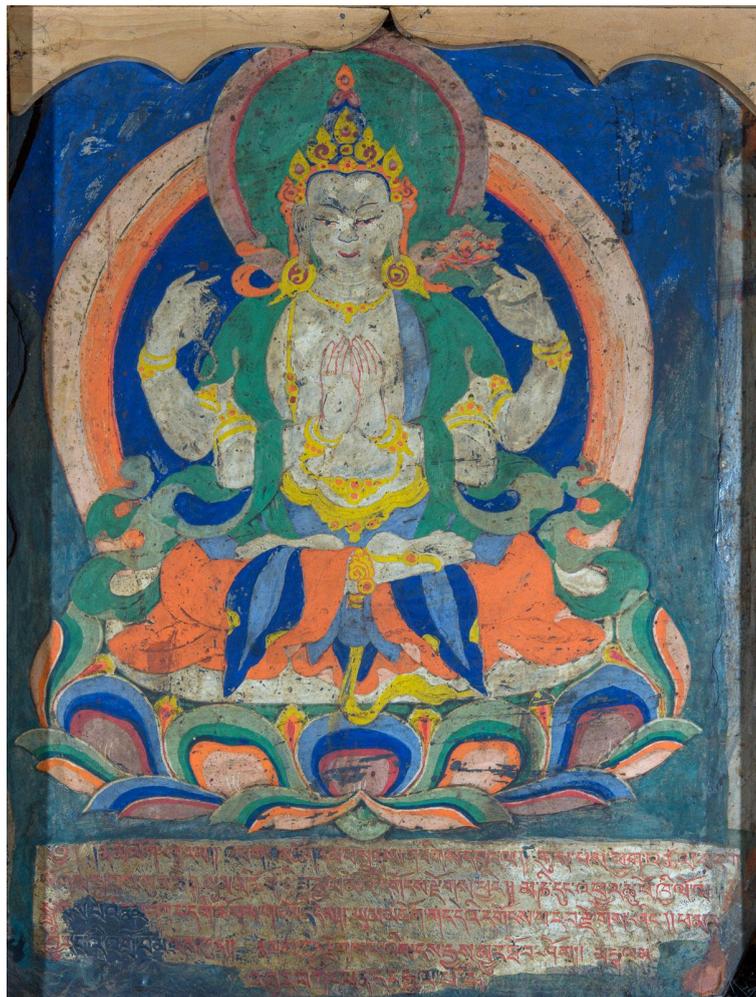
3. Panel with Śaḍakṣara Lokeśvara in the Chenrézik Lhakhang the inscription of which reads as follows:
 “Worship to Lokeshvara. We are taking refuge to and respectful bow to the most exalted, excellent Avalokiteśvara. To fulfil the intentions of the highest mother Nyida Gyelmo, [the recitation of] hundred million (*dung phyur*) mani were accomplished (*sgrub pa*) in the water male dog year (1682/83). Whatever very white merit was assembled [through this recitation] may the intentions of this highest mother thoroughly be fulfilled and may all beings who have become parents without remainder swiftly attain the omniscience of a Buddha. Auspiciousness. Relief design by Pandar Gyelpo.”

As such, these stone panels are an invaluable source of historical information that obviously still needs to be exploited in full. The inscriptions translated so far confirm what has already been proposed by other data but provide unprecedented precision. From these texts it is clear that the site flourished from the middle of the 17th century and the earlier assumption that the stone reliefs most likely date to the second half of this century can be confirmed. Further, the inscriptions provide approximate dates for the death of Queen Nyida Gyelmo in or before 1682/83 (Figure 3),¹ of her husband king

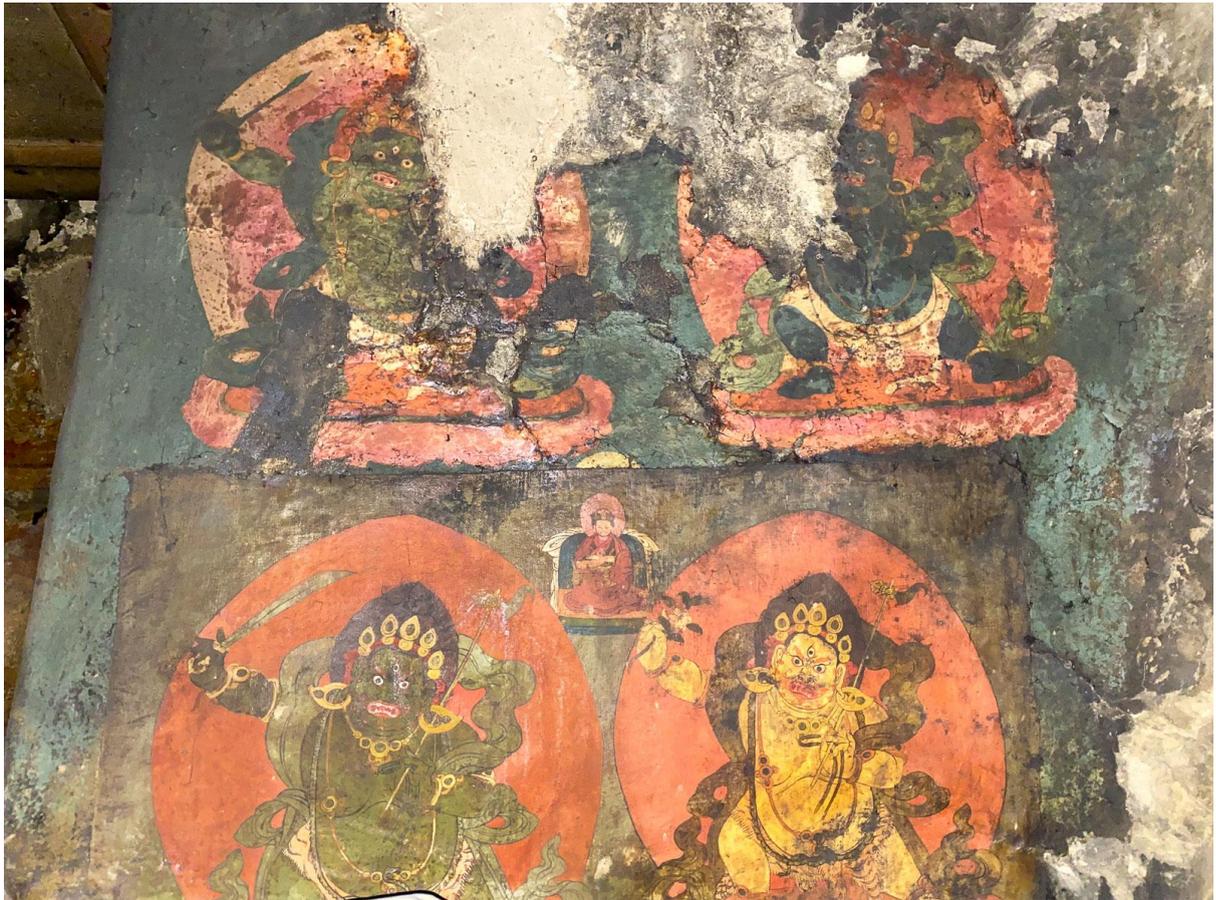
4. Original and restored sections among the murals in the sanctum of Lo Gekhar, the original paintings above painted directly on the wall, and the restored ones on canvas and glued to the wall. Often the latter is accompanied by a small portrait of Katok Rikdzin Tsewang Norbu (1698–1755), providing a clue for their approximate date.

Iconographically the walls of the sanctum are almost completely covered by the wrathful protectors of the five esoteric Buddha families, each deity having the colour and attribute that characterizes the respective family. Large depictions of them are distributed across the sanctum by direction (Figure 4) with two on the main wall flanking Padmasambhava representing the centre (Figure 1) and the eastern direction. Two teacher representations above these do not provide any definitive clue regarding their making. These main deities are complemented by Hayagrīva and another Vajrapāṇi represented in the niches flanking the main wall. Four female animal-headed gatekeepers flank the sides of the entrance. The origin of this unique iconographic program still needs to be clarified, but the seven main deities certainly do not represent the eight pronouncement deities—a group very prominent in Nyingma School monuments—as the caretaker assumes.

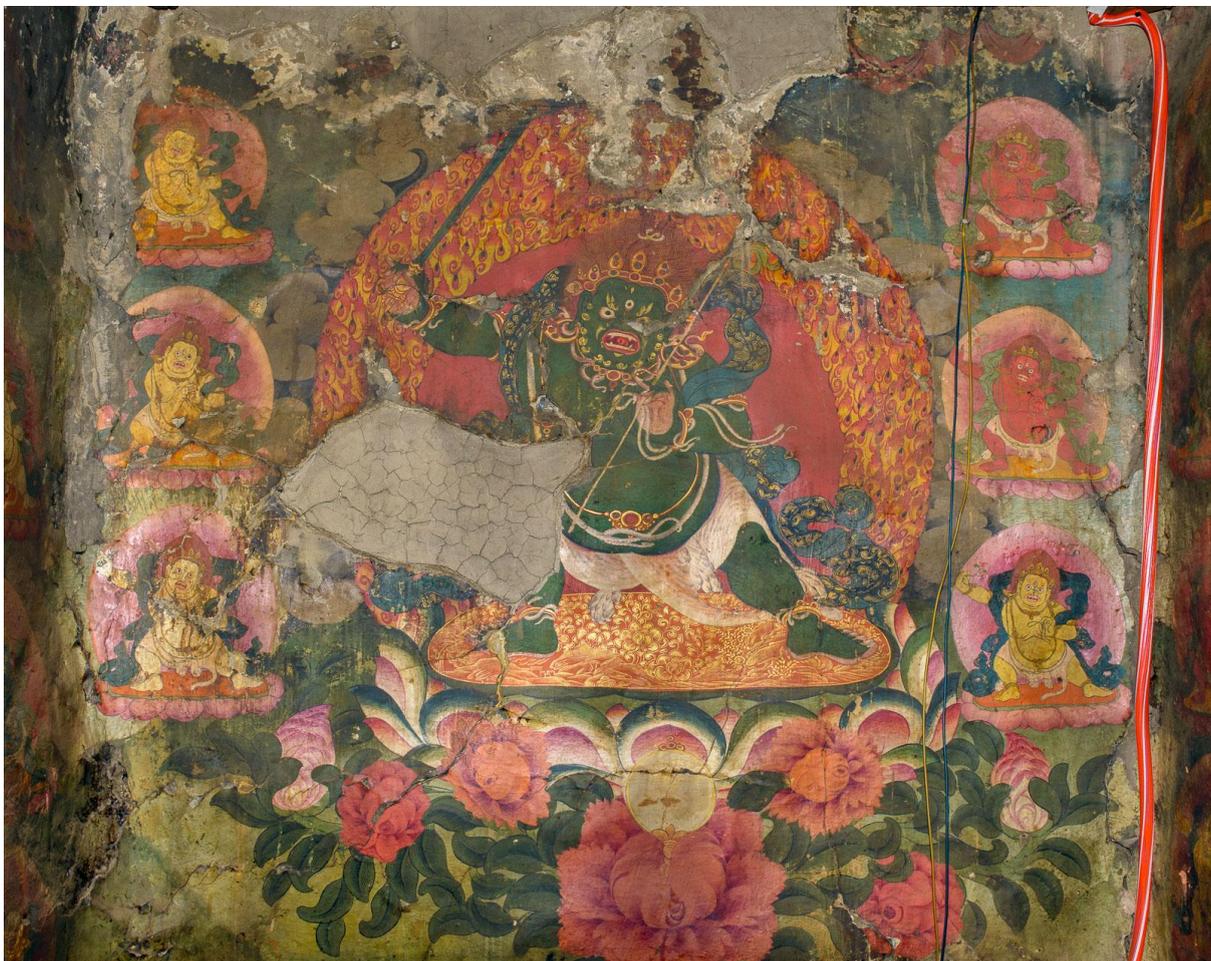
5. The green protector wielding a sword above the entrance to the sanctum.

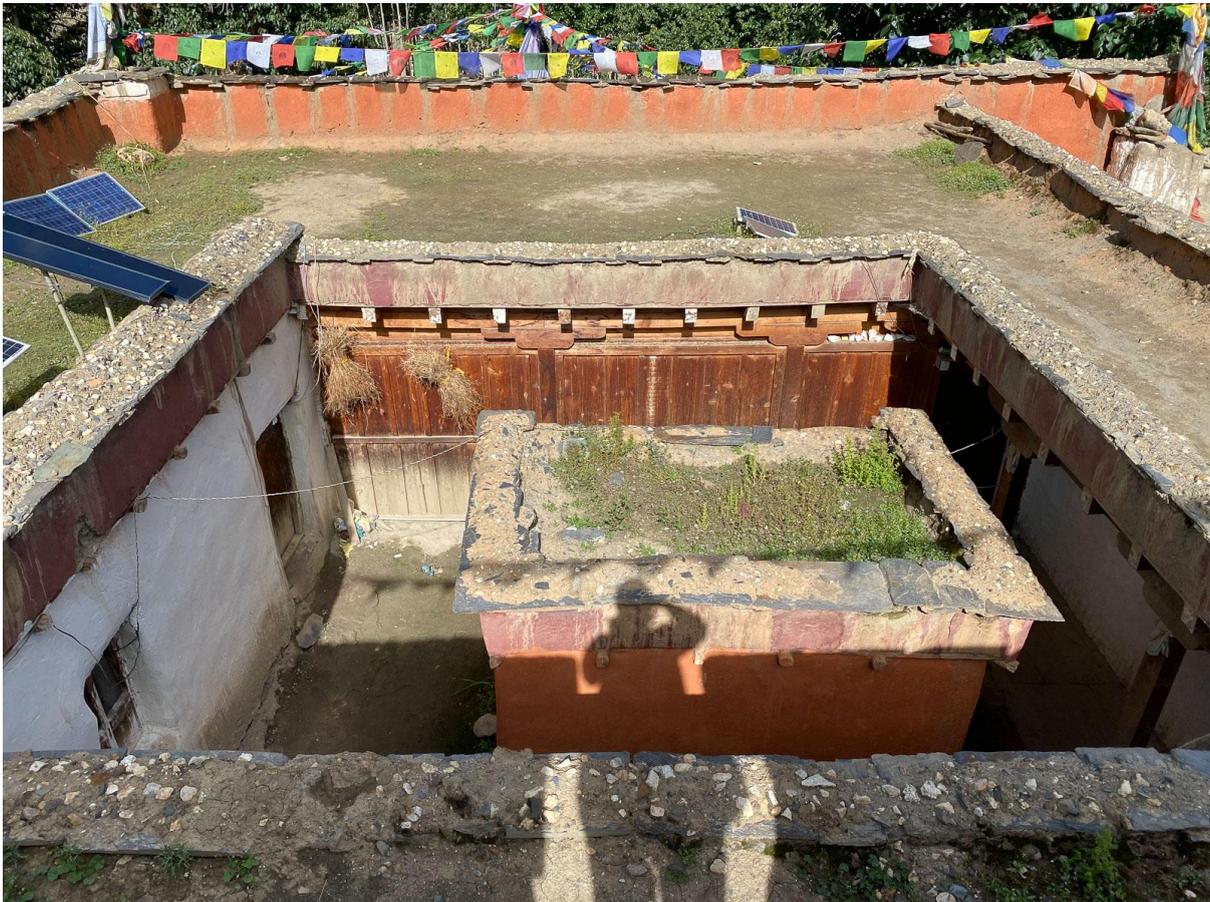
6. Condition of the courtyard on top of the assembly hall some hours after heavy rain, with large parts of the roof retaining the water for considerable periods and softening the clay. The image also documents the lack of regular maintenance.

The heavy rains preceding the visit also allowed us to assess the building under these conditions and see the problems first hand. These include pools forming on the roof, water seepage into the rooms underneath—including the “VIP room” we slept in—issues with the drainage, and a softening of the roof clay to a degree that it cannot be walked on anymore (Figure 6). Further, the photographic documentation of the main building and the site as a whole was updated and now includes the recent changes to the site, including the new construction directly in front of the main temple.

On the monastic's quarters side, the ceiling level will be slightly raised and levelled across all rooms to simplify drainage. We also consider an additional bathroom in the

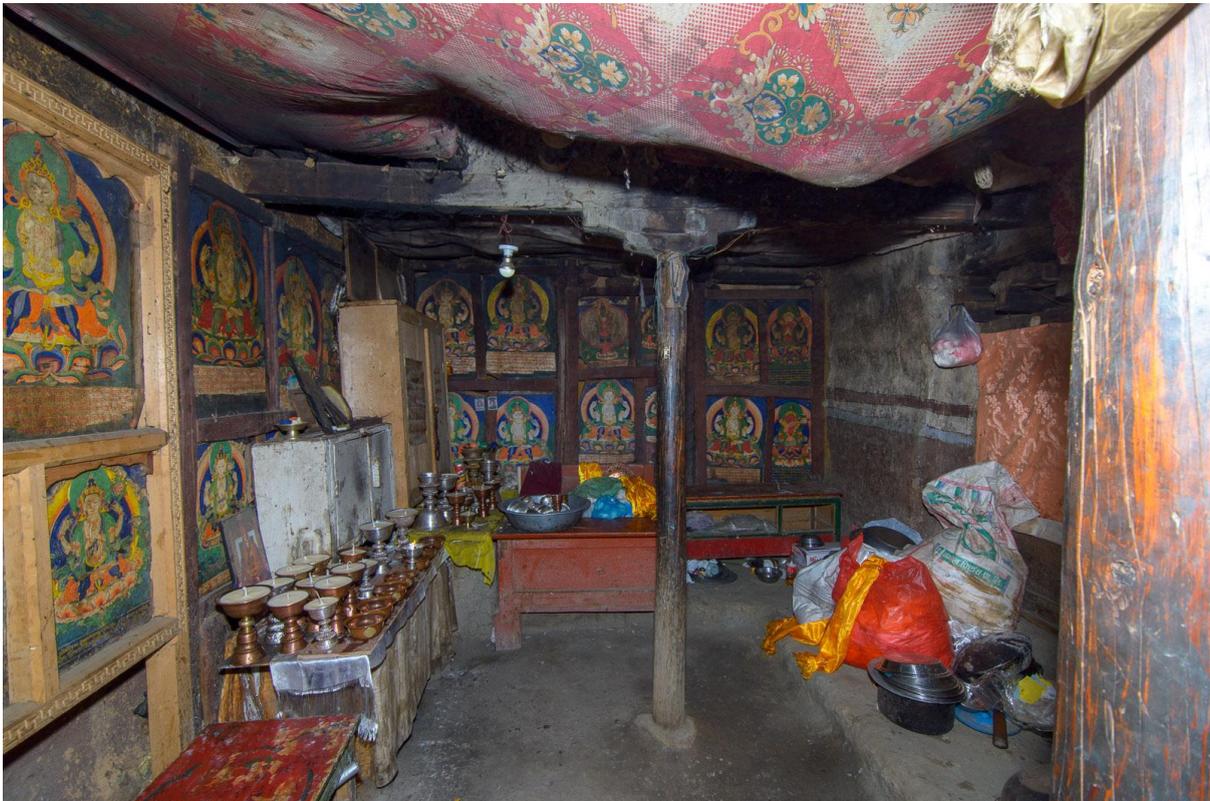
7. View of the Chenrézik Lhakhang that is also used as a retreat room. The seat in the back of the room is used by the practitioner and the wooden cabinets along the side are used to store the ritual offering cakes (*torma*).

On the upper floor, the stone panels of the Chenrézik Lhakhang (Figure 7; U15) and the Caretaker's room (U07) will be moved to rooms U04 and U05 above the assembly hall, which are currently used as storage. This separates the retreat rooms from those visited by worshippers and tourists and makes these panels accessible at all times. To facilitate the visit of these rooms the floor of U03 needs to be paved in some form, which also will improve drainage. We are also looking into the option of roofing the entire space U03 (Figure 6) with a modern solution that does not disturb the overall appearance of the temple. Further, the clay floor of the upper story of the sanctum (U01) needs to be replaced by a wooden one.

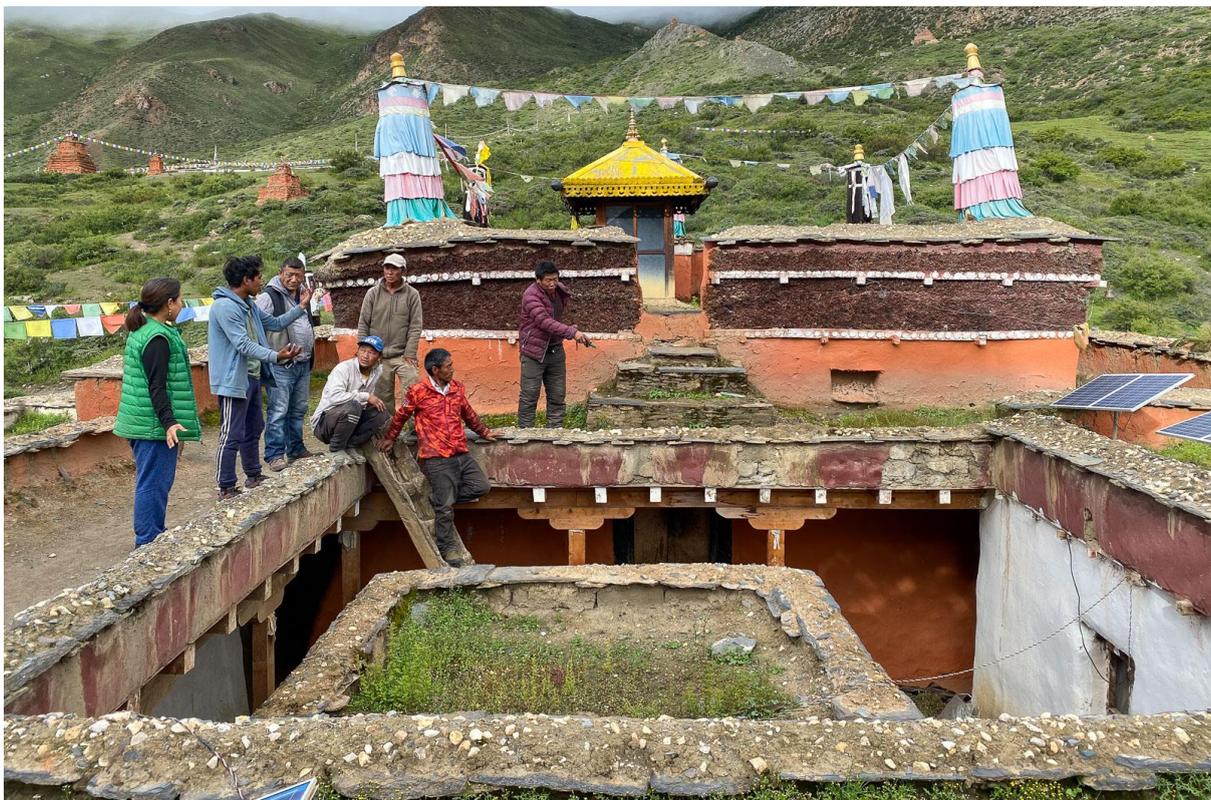
This summer, the left wing in front of the temple has been replaced by a modern structure in concrete (Figure 10). Not only is this structure encroaching upon the path in front of the temple, but it also is not integrated into the courtyard environment. Further, it needs to be noted that this construction was executed without any regard for the ongoing usage of the temple itself. Building materials and machines were placed directly on the access path or the circumambulation path around the temple affecting its religious usage even when no work was going on (Figure 11).

10. View of the courtyard in front of the temple with its left wing replaced by a new structure in concrete.

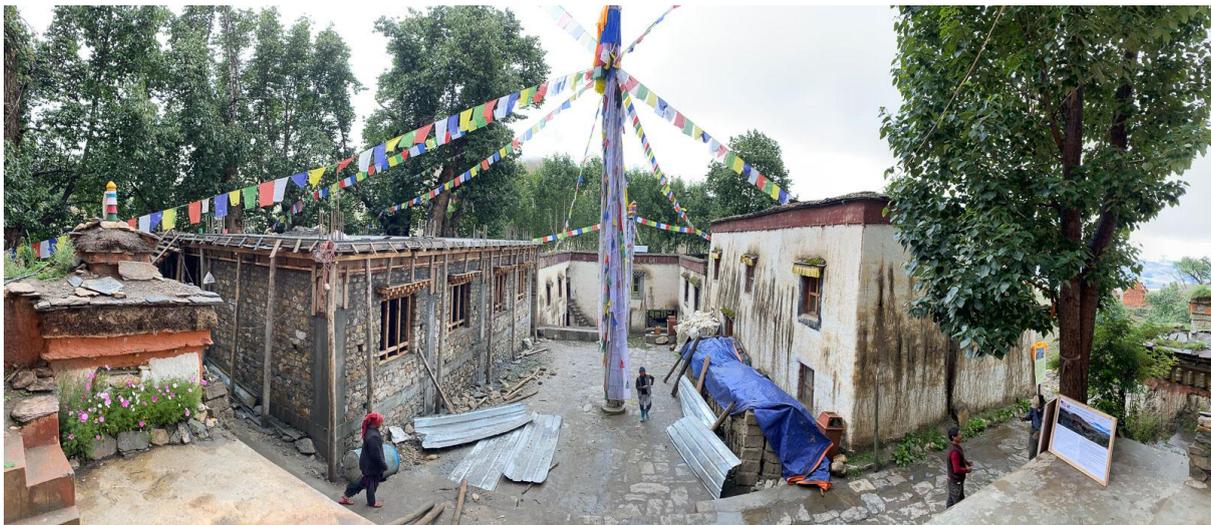
11. Building materials on the circumambulation path around the main temple.
