Seismic Strengthening and Restoration of Lo Gekhar

U.S. Ambassadors Fund for Cultural Preservation, Award No. SNP40020GR0042

Project Report, Second Year, Third Quarter – April to June 2022

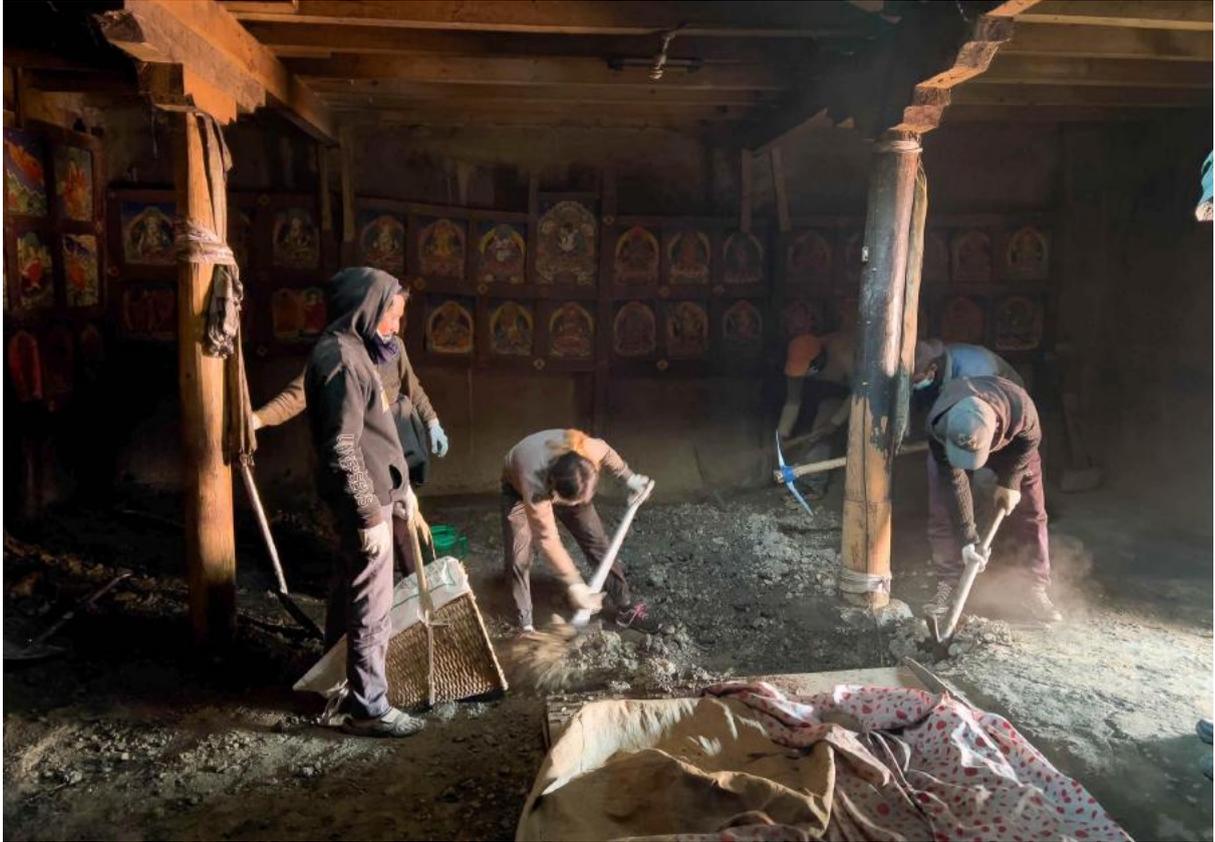
1. Removal of old floor inside the Upper Sanctum of Lo Gekhar in early April 2022.

Building work started on the first floor Guru Lhakhang, called the Upper Sanctum in this report to differentiate the two floors of the temple (Figures 18 and 19). First the mud layer was removed, in order to investigate the supporting timber structure which formed the ceiling of the inner temple sanctum below (Figures 1, 22, 23).

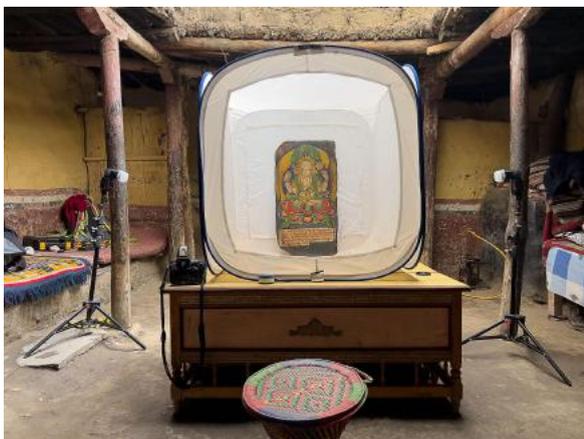
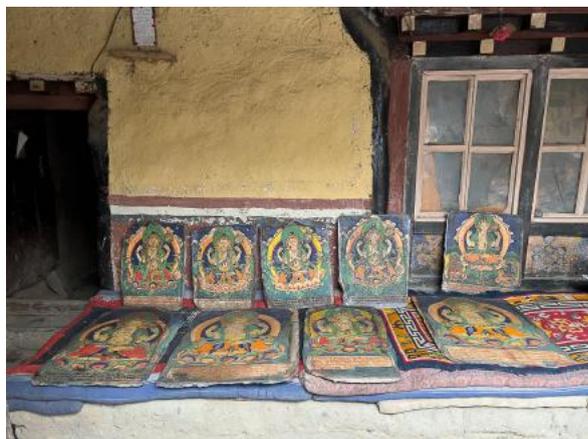
7. Documentation of the inscribed Avalokiteśvara stone panels.
8. A group of panels collected after documentation showing their different sizes.

Another set of key information is provided by the inscribed stone panels depicting different forms of the Bodhisattva Avalokiteśvara and collected in the temple named after him. The movement of this temple enabled the complete documentation of these panels on April 23-24 (Figures 7 and 8).

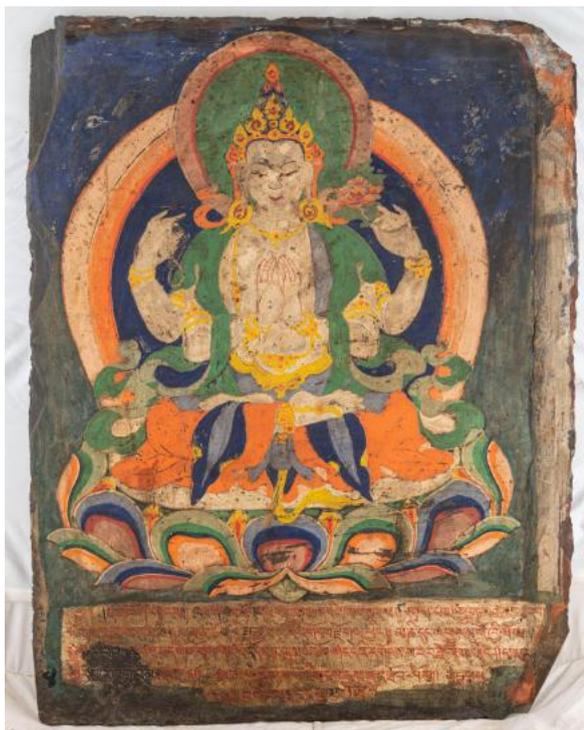
9. Panel of Śaḍakṣara Lokeśvara commemorating the completion of a *mani dunchur* in memory of queen Nyida Gyelmo in 1682/83.

Large thin panel with shallow carving
72 x 55.5 x 2 cm;
Photos D8360-62; D9510-18.

The inscription records the *mani* recitation in commemoration of Nyida Gyelmo, the Ladakhi wife of the Mustang king, in 1682/83 (56th year). The fifth line of this inscription refers to the carver Pandar Gyelpo.

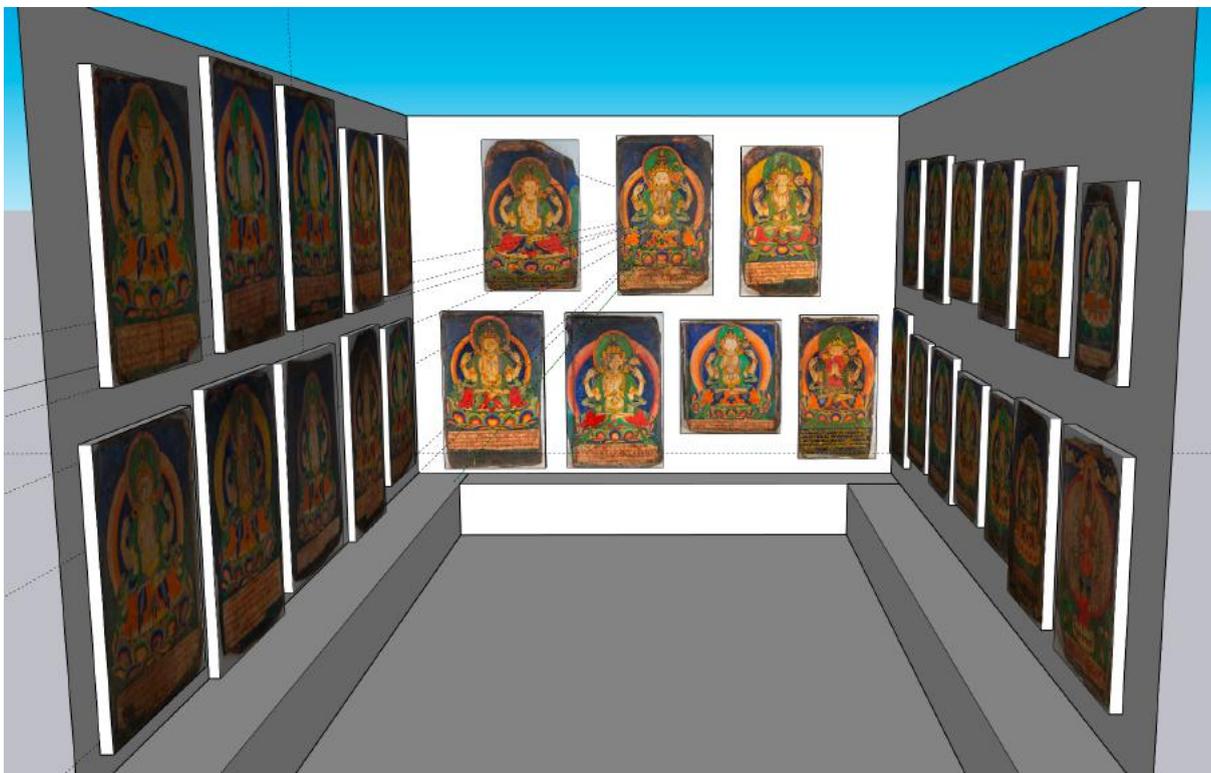
10. Distribution of the stone panels of the Avalokiteśvara Temple in the new location.

Essentially, the panels will be displayed on the back wall of an altar like case with large openings. The back will be made of thick plywood panels, strong enough to support the stone panels held by iron clamps. An open construction is necessary due to the great variation in panel sizes, and the shrine-like case (not drawn yet) emphasises the special religious efficacy of these panels. Incidentally, the new temple is located right above the room with prayer wheels, which are filled with the same mantra the panels are dedicated to (see the new plans below).

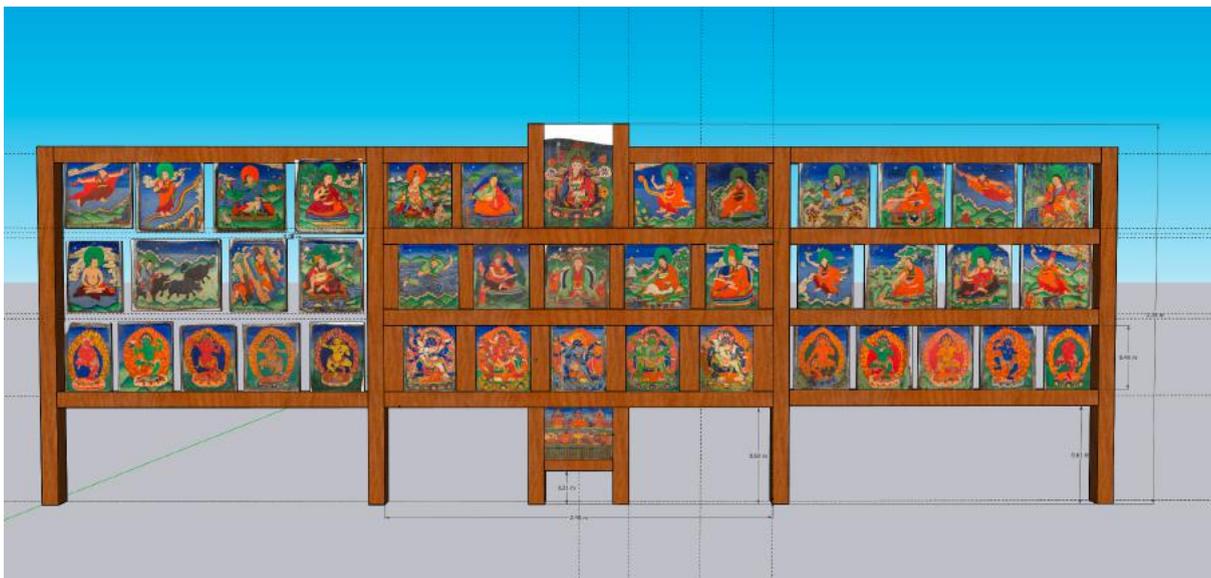
11. Plan for the new frame for the main wall of the Upper Sanctum, preserving the documented display of the panels but enabling the panels to be added once the frame is constructed.

The new frames are conceived in a way that the stone panels can be added to the frame after their construction, and that their respective height can be adjusted as needed through individual supports within the frame. Its horizontal elements consist of three layers, the middle ones thinner to form a base for the panel below and enable placing the panel above. The panels thus can be mounted by inserting them into the upper gap and then lowering them into the lower gap onto their prefabricated individual support. The gap between the panels will then be masked on the front side only, as is the case in the middle part of Figure 6. The white section above the main panel accounts for the fragment found that needs to be re-attached to the top of this panel.

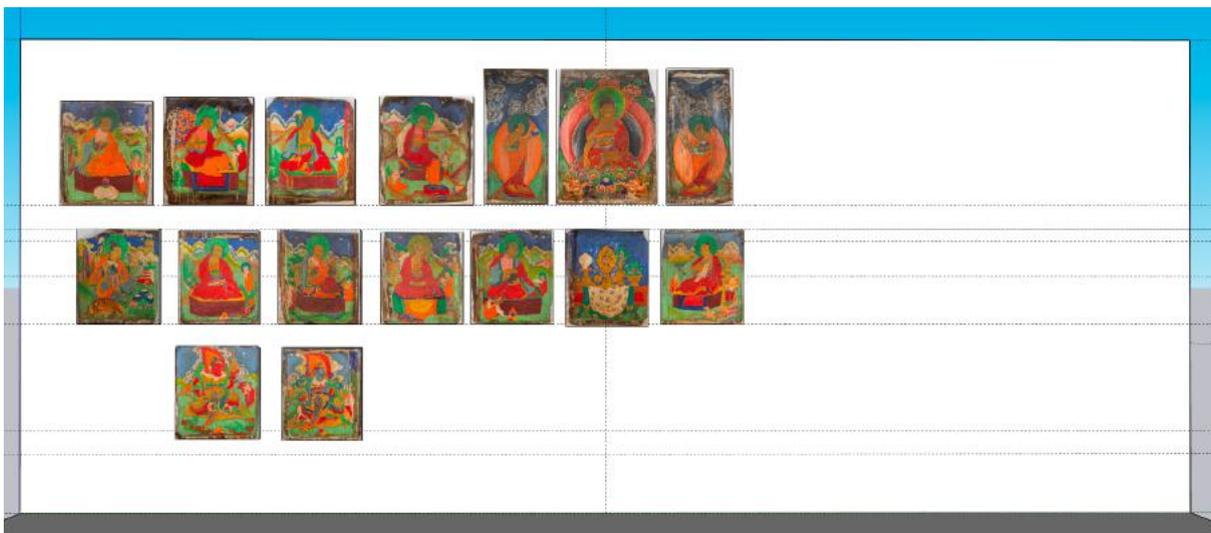
12. Partial reconstruction of the original display of the arhat panels to enable the planning of the frame.

While only partially reconstructed so far, it is clear that the panels followed a common arrangement and that the new frame can be planned similar to the ones in the upper sanctum with four uprights supporting the horizontal bases for the panels. The length of the wall does not allow for the four great kings to be displayed on the same level as the arhats, they will thus be placed underneath at the sides of the walls.

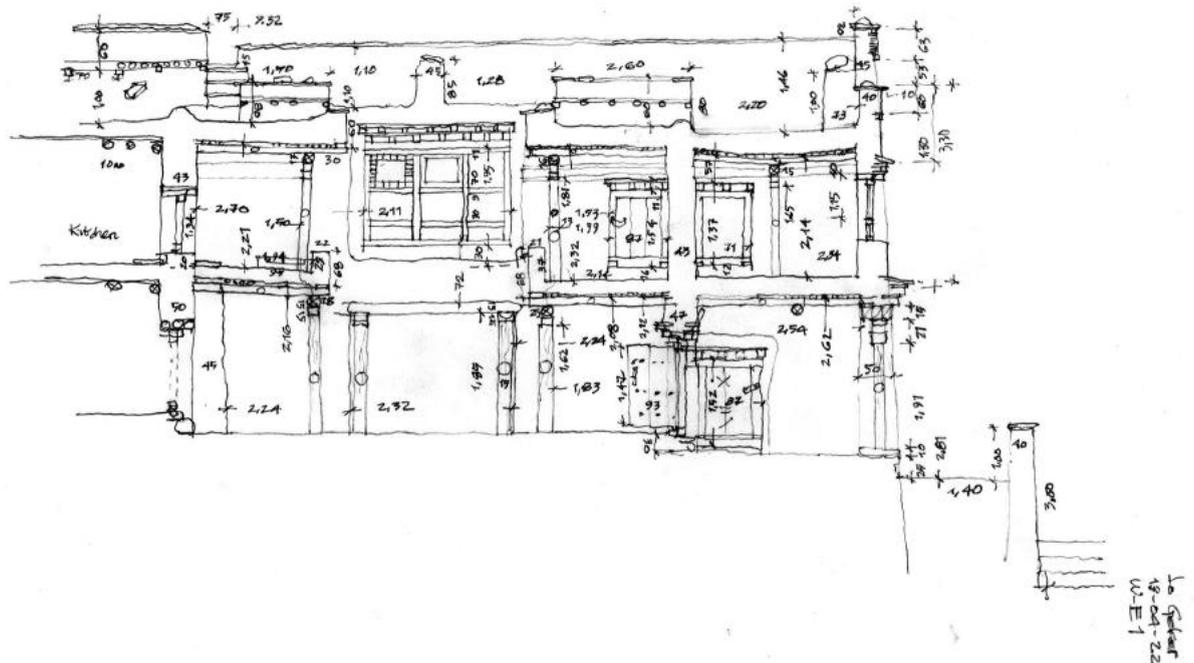
13. Example for the detailed measured survey for the plans and cross-sections.

In addition to guiding and supervising the construction work from April 7 to May 20, John Harrison made a detailed measured survey of the building complex in order to produce revised floor plans for upper and lower floors, and five sections drawn through the building. These plans would supersede his 1996 plans, made in a short two-day visit, which had been digitised for the 2021 application report prepared by Thomas Schrom.

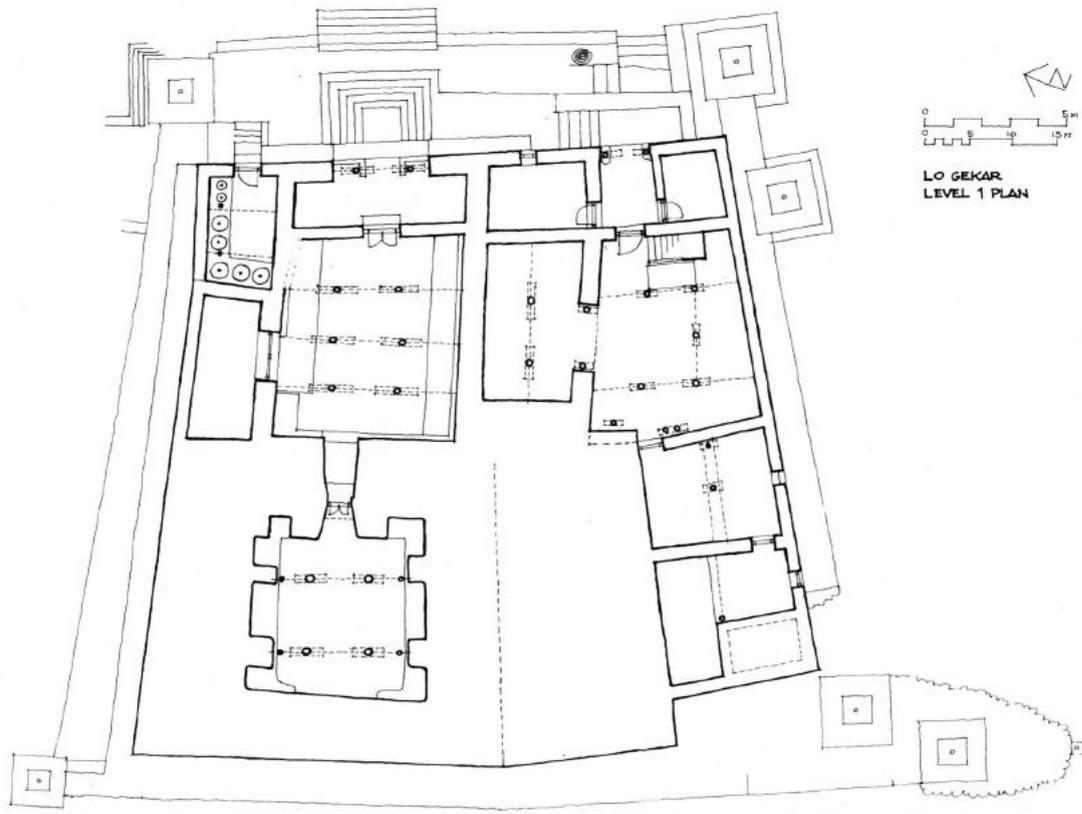
14. New ground plan of the lower level.

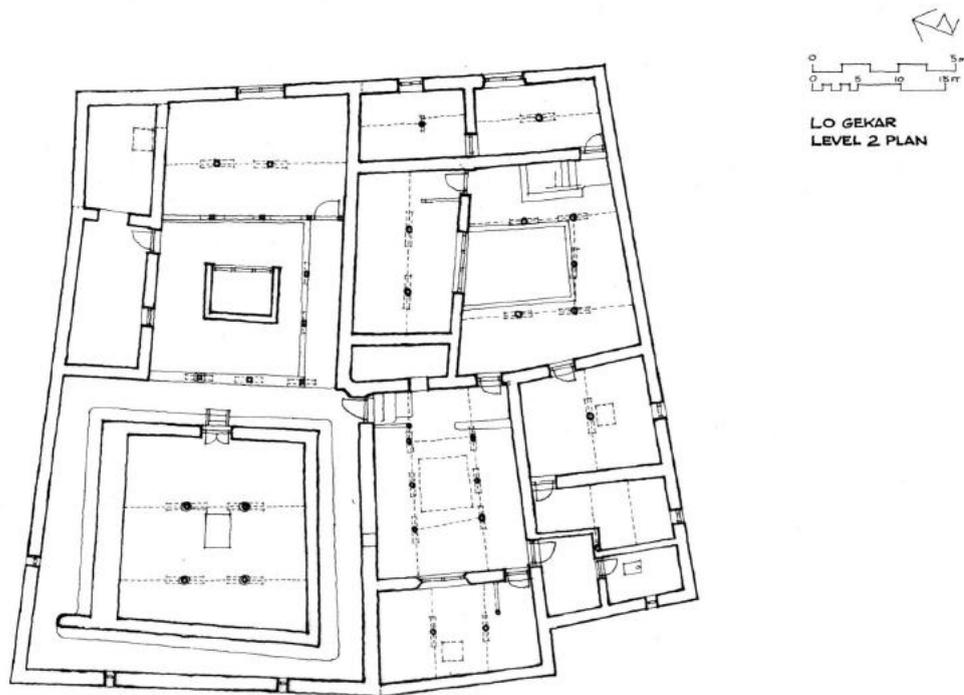
15. New ground plan of the upper level.

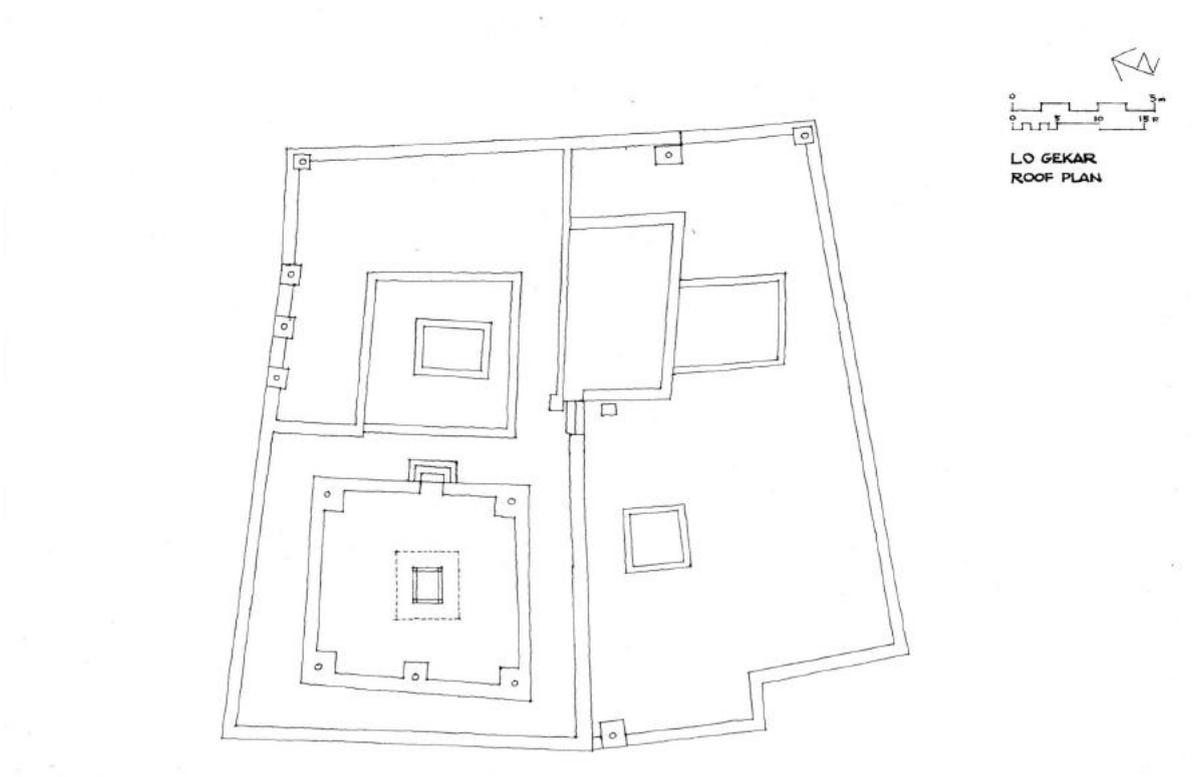
16. New plan of the roof level.

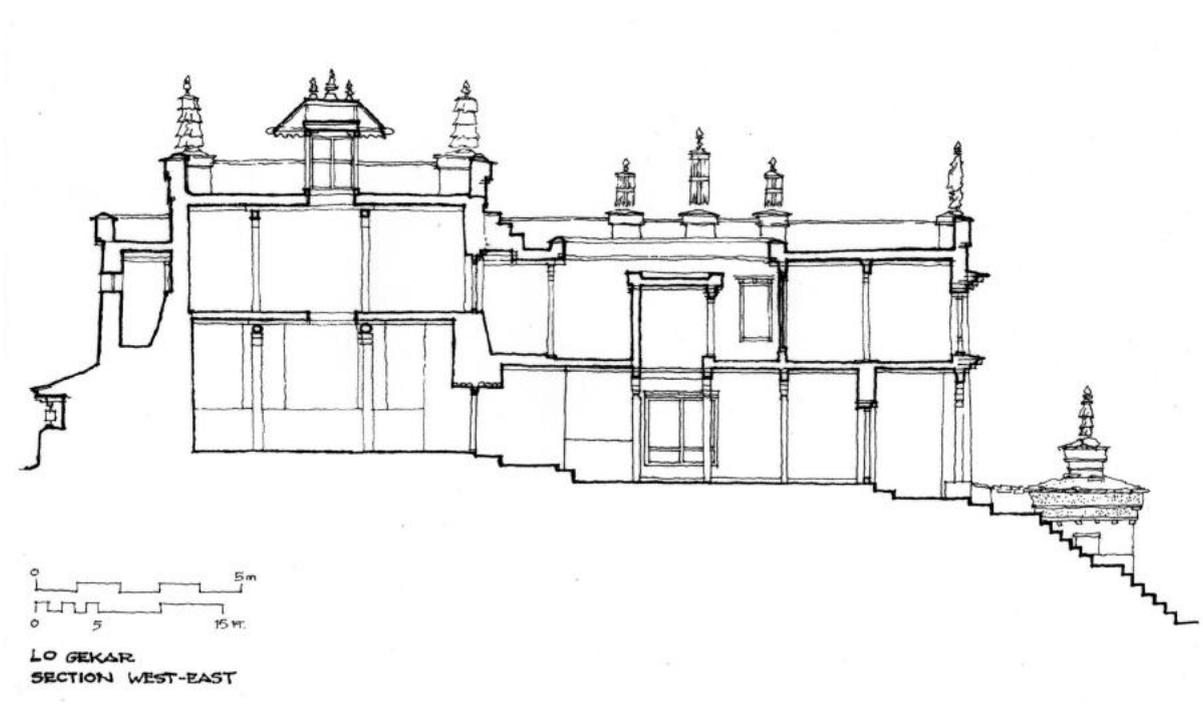
17. New west-east section of the temple.

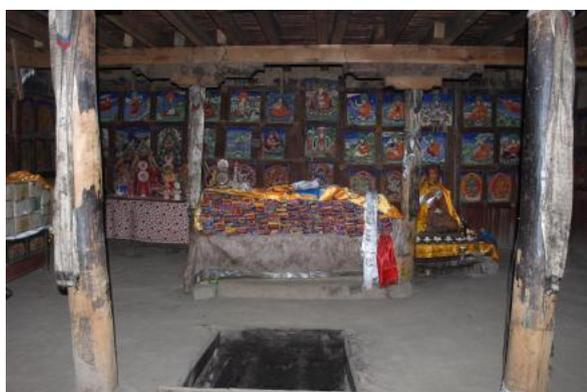
18. The Upper Sanctum before restoration with its mud floor.

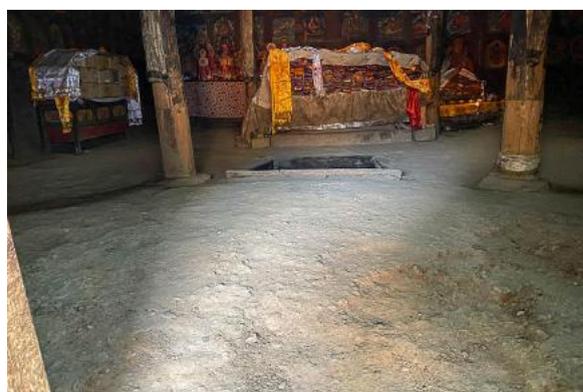
19. The uneven mud floor inside the Upper Sanctum before restoration.

In the course of this work it became clear that all mud on the floor needed to be excavated. Thus, the carved stone slate panels and their supporting wooden framework covering the main and side walls had to be removed. Accordingly, they were carefully dismantled and all the 108 stone panels were documented one by one (Figures 20, 21).

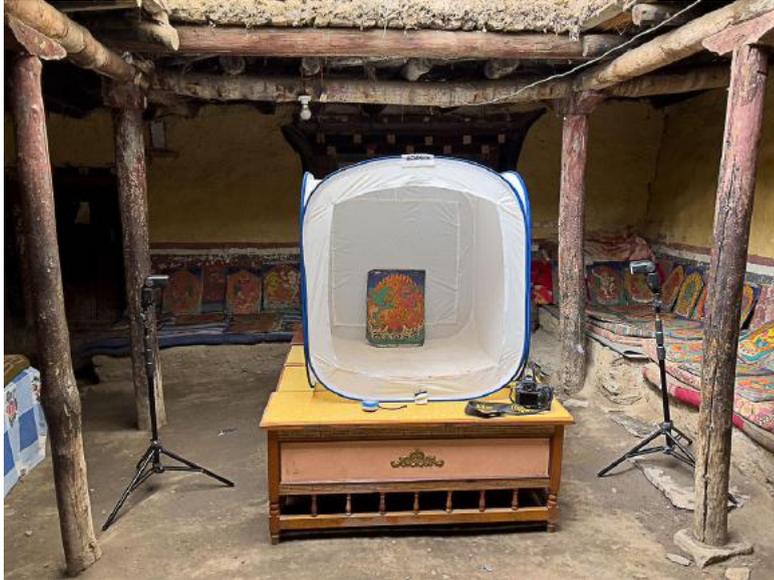
20. Documentation of the stone panels in the back courtyard of the caretaker's quarters.

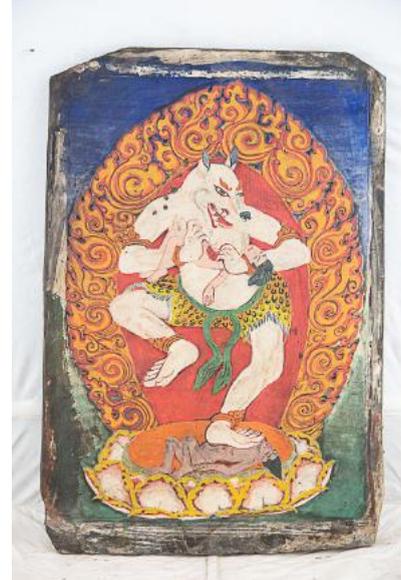
21. Shvanamukha, one of the eight *tramen* goddesses among the wrathful deities of the intermediate state.

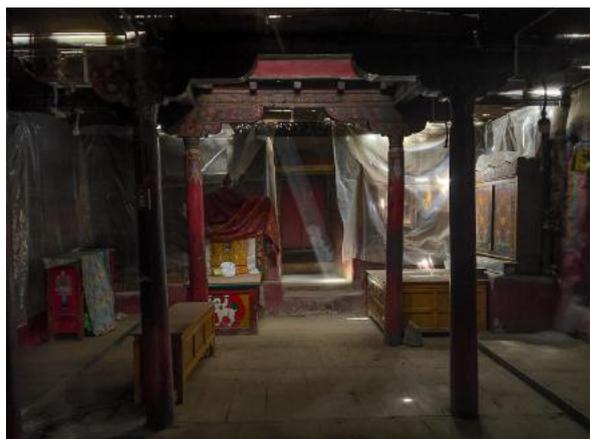
23. Also the stone panels in the Assembly Hall were covered by plastic sheets.

The principal Guru Lhakhang figure and all the sculptures in the sanctum, and the carved slate panels in the adjoining Dukhang on the ground floor, were covered with polythene sheeting for protection during the work on the floor above (Figures 22, 23).

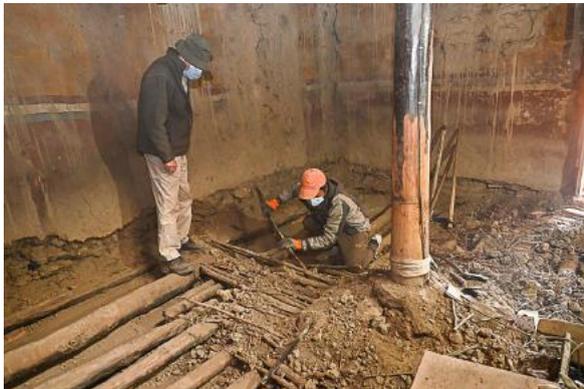
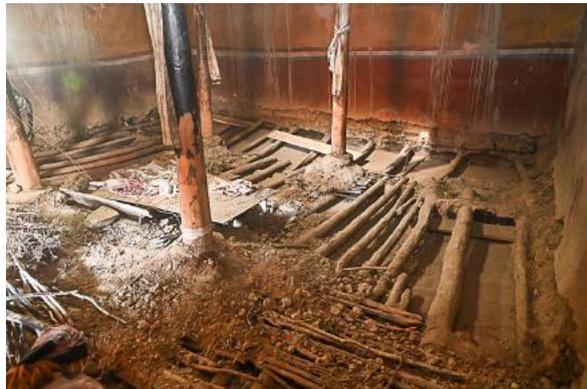
Once the mud floor was completely removed along with the round wooden sticks traditionally placed on the joists the structural issues of this room became apparent. The mud layer turned out to be very thick, resulting in considerable weight on the joists and beams underneath. The joists were not only bent, but in some areas there were

wide gaps between them. Some of these gaps have been filled by the earlier restoration from below, but others, in particular above the main images, remained.

24. The Upper Sanctum with the mud floor partially removed revealing the wooden sticks underneath.
25. Removal of the mud floor revealing the joists and the wide gaps between some of them.

It had been hoped that the recent ceiling boards fitted by the village in the sanctum to prevent dust dropping through could be removed to reveal the original (?) beams, and then lay new ceiling boards above the beams. However, the existing beams were found to be extremely uneven in form and dimensions, and some had been replaced by squared beams during repairs in 2004 (Figure 26). So it was decided to leave the recent lower ceiling boards in place. To even the gaps between the beams, it was necessary to add several new ones (Figure 27). Then a secondary timber floor structure was built up to avoid excessive weight on the original beam structure.

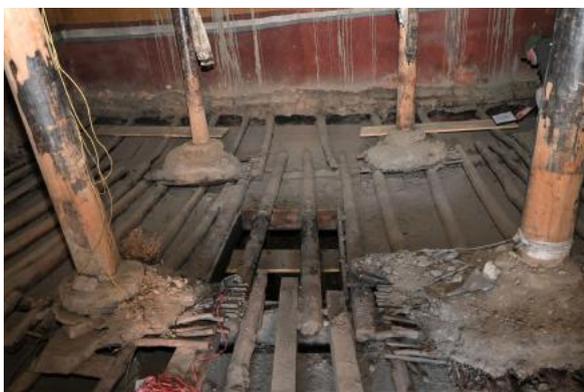
26. The four columns on their fragile supports.
27. Wooden frames were built around the foot of the pillars and filled with mud.

Further, it turned out that the four columns supporting the roof actually stood on clay and the wooden sticks underneath, representing an obvious structural risk (Figure 26). Rather than replacing them by longer ones it was decided to support their base by square frames around the foot of the columns. To enable these, the sticks were carefully trimmed with a hand grinder where necessary. The square frames were then built and filled with mud and aggregate mortar (Figure 27).

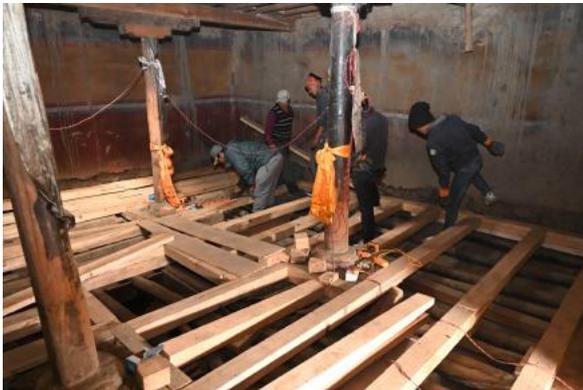
28. The new wooden frame being installed above the old joists.

A new wooden timber frame made of 4 x 5 inch members needed to be constructed on top of the old ones to support the new floor and also the new square frames around the foot of the pillars (Figure 28). All the square joints of the new frames were prepared

in the wood working facility and then installed with screws to avoid damage to the murals in the main sanctum underneath. The new timber frame supported ½ inch plywood sheeting screwed down as a seismic measure (Figure 29).

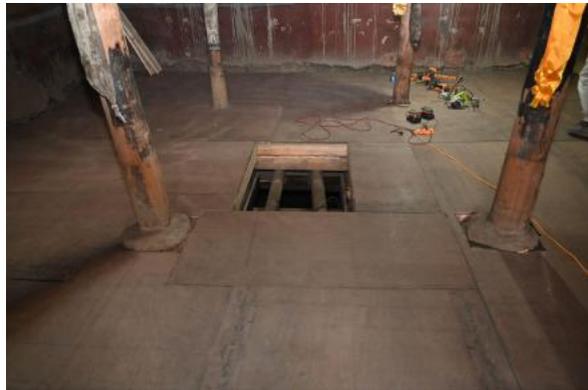
29. The plywood panels installed on top of the new frame for seismic protection.

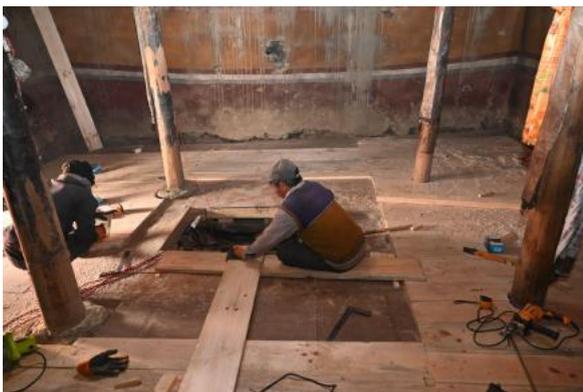
30. The wooden floor was installed above the plywood layer.

Then 1 inch thick pine wood floor panels were screwed on top to form the actual floor (Figure 30, 31).

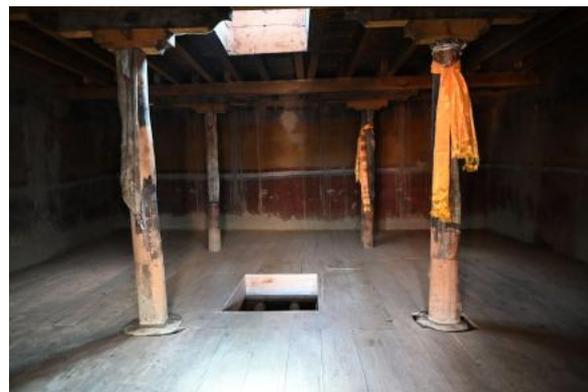
31. The room of the upper sanctum with the new floor.

The plastering of the wall and the reinstallation of the stone panels in the room are still to be done.

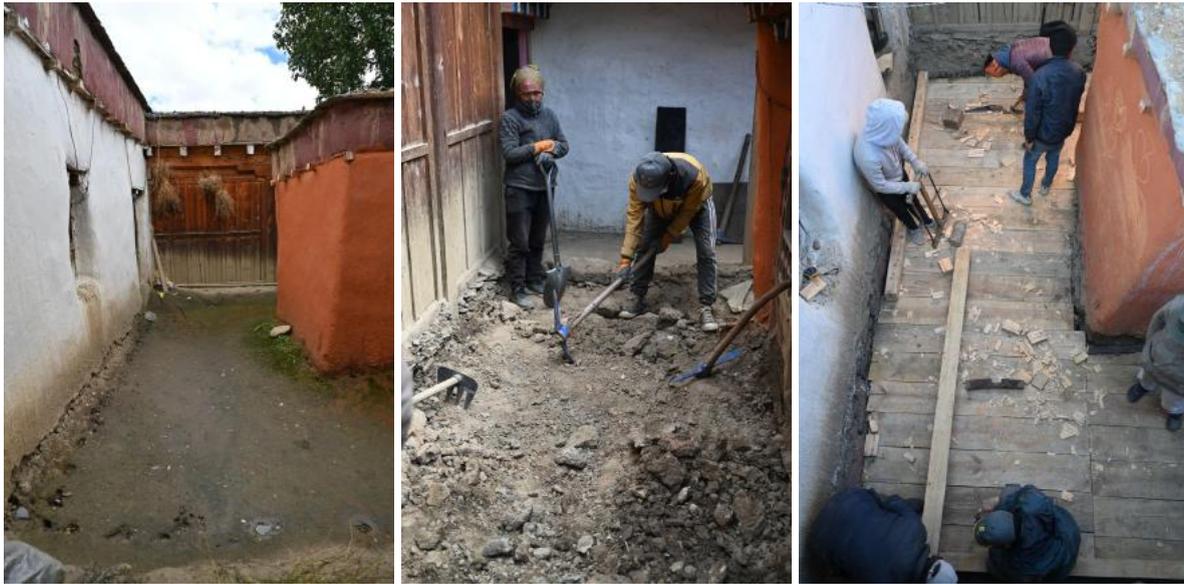
32. North side of the courtyard with the panel rooms before restoration.

Shortly after the Upper Sanctum, work also commenced on the courtyard immediately in front of it (Figure 32). While the project is considering covering the entire courtyard with a transparent roof in a second phase, its floor was completely restored to make it waterproof for all eventualities.

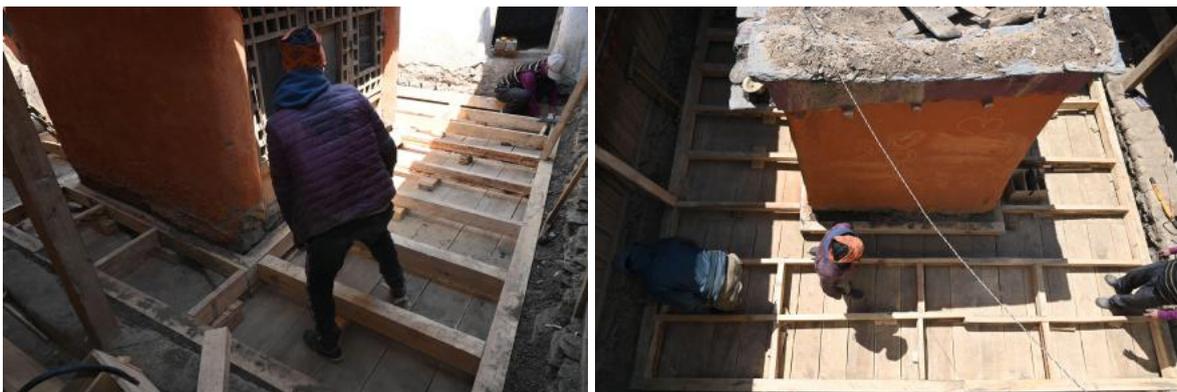
35. Installation of the ceiling boards above the joists.

As in the sanctum itself, in the courtyard the mud floor was completely removed (Figure 33) and the original joists and recent ceiling boards of the Dukhang were exposed. The thin plastic waterproofing membrane, fitted in 2004, was removed. New ceiling boards were then fitted and screwed above the joists (Figure 34). To reach the original drainage level, a timber frame needed to be installed around the lantern (Figures 35, 36). The frame itself already has the necessary inclination towards the drainage spout on the east side.

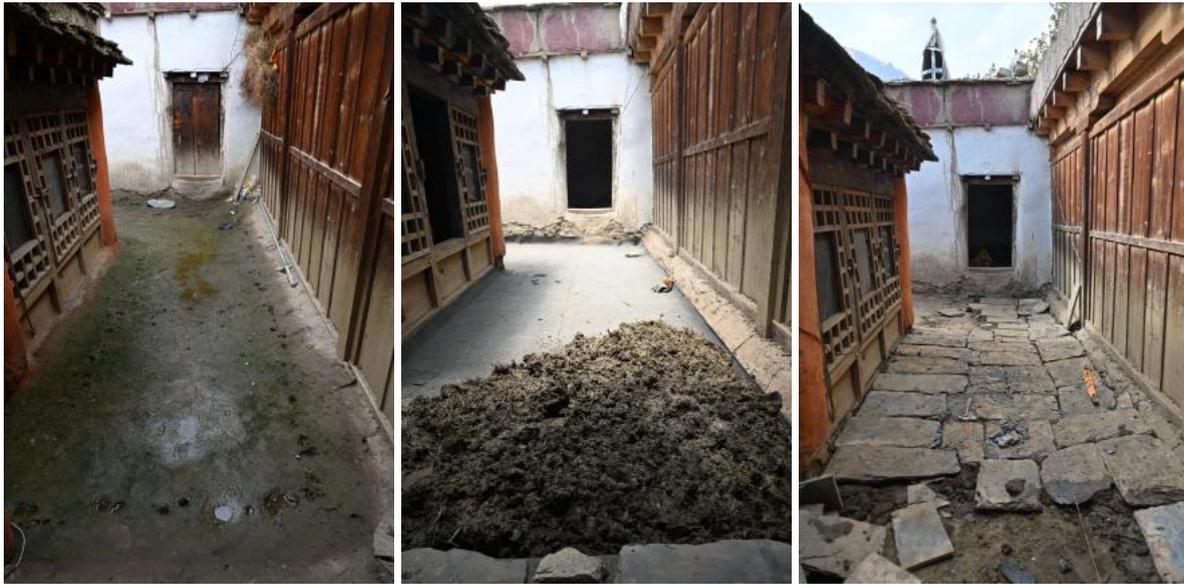
37. The area in front of the lantern during a rainy day before restoration.
38. The area in front of the lantern after the installation of the new floor with mud being laid on the waterproof bitumen membrane.
39. The area in front of the lantern with the new stone floor being installed.

Plywood was then screwed over the prepared frame. It was then covered with a Sika waterproof membrane using bituminous paint and a blowtorch. Finally, the membrane was covered with a mud mortar mixed with chopped straws and the floor was laid with flat stones to form the new top most layer of the floor (Figures 37–39). The drainage pipe was carefully inspected by temporarily removing a few floor boards in the guest room in front of the courtyard to make sure it is not clogged.

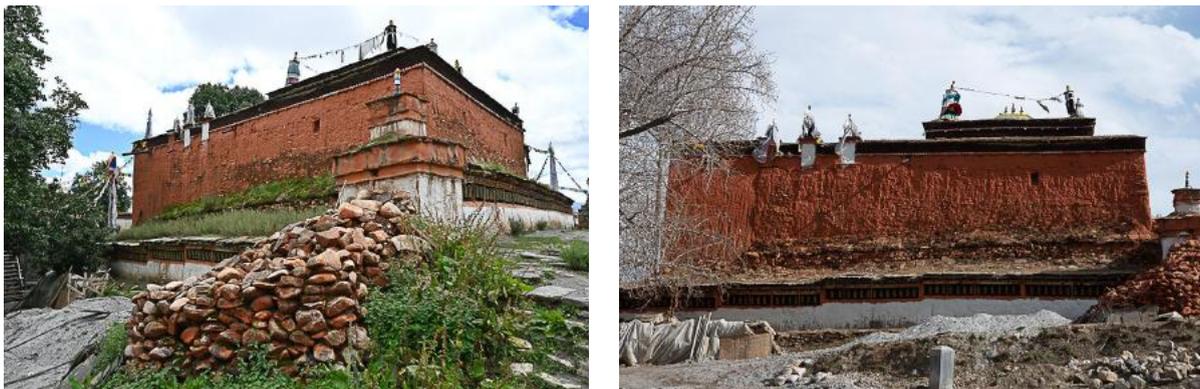
Continuous lines of *mani* wheels surround the building on three sides, with stupas at the four corners. The *mani* at the north was in poor condition (Figures 40, 41). As carpenters were not immediately available in April, work on the temple rooms progressed slowly initially. Thus, a group of the workers were employed to restore the northern *mani* along the main temple.

40. The north side *mani* wall with grass growing on it in September 2021.
41. The same wall in early April 2022 before the restoration.

There is a two layered construction with mani stones and prayer wheels running along the entire wall, which was covered with mud and grass. The prayer wheels have been pushed outwards by the weight of the construction, and parts were damaged by the exposure to the waterflow from the roof. Further, there are indications that occasionally humidity reaches the murals inside the sanctum on this side of the wall, damaging the murals on this side. Therefore it was decided to restore this part in entirety.

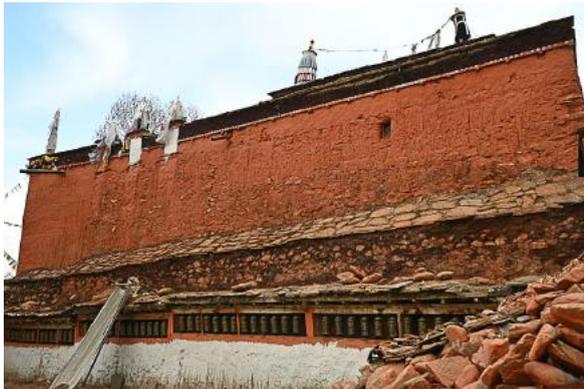
42. The upper layer of the wall was cleaned and repaired.

In a first step it was made sure that the stones of the upper layer are placed correctly, and mud plaster covers the areas in between the stones (Figure 42). The supporting wall was also consolidated. Then the entire superstructure of the prayer wheels was taken off, the prayer wheel construction pushed back in an upright position, and the roof was newly laid. Wooden sections supporting the roofing were replaced and a plastic sheet was introduced underneath the mud layer to protect the wooden construction underneath (Figure 43). Finally the area behind the prayer wheels was newly plastered.

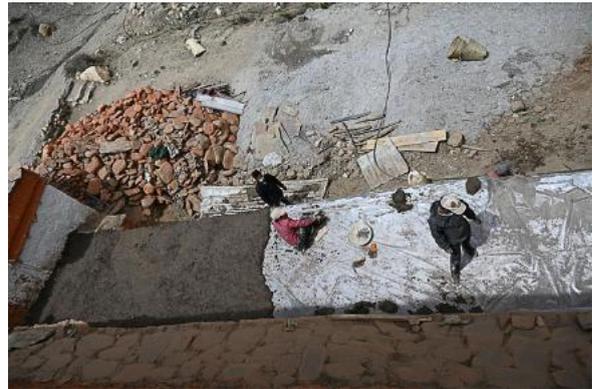
43. The lower part of the wall was reset and a new roof was constructed.

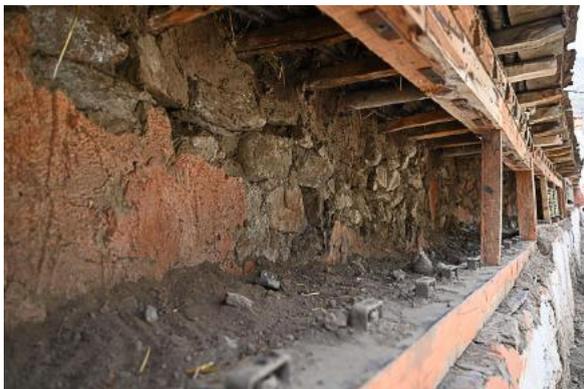
44. The wall behind the prayer wheels before restoration.

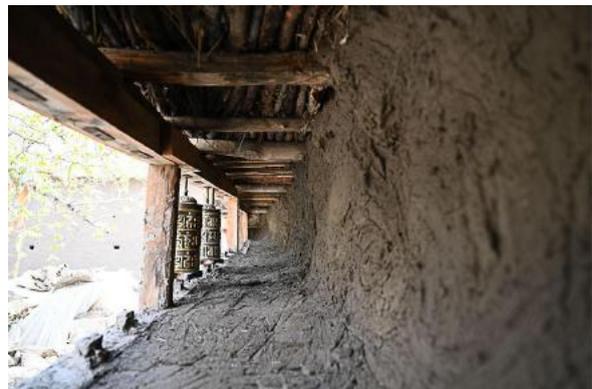
45. Replastering the wall behind the prayer wheels.

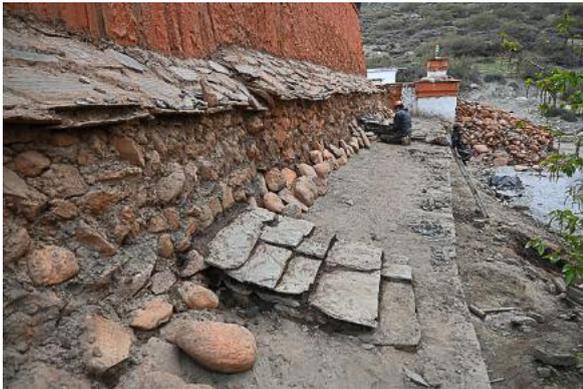
46. Additional stone panels installed to receive the water flow from the roof.

Special attention was paid to those areas that receive the water from the roof via their drainage spouts. These were covered with additional superimposed stone panels forming a stepped construction (Figure 46). Finally, the wall was repainted with the traditional colours (Figure 47).

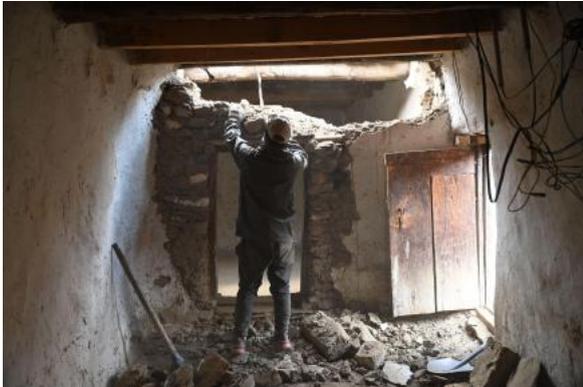
48. Dismantling the original door between the two panel rooms to widen it and bring its threshold to floor level.

To enable their usage as temple rooms, the entrance between the two rooms had to be widened and reinforced with round joists (Figures 48, 49). This happened in April. For these rooms, it was decided that it is not necessary to remove the floor in its entirety, as it was relatively thin and the construction underneath, in the protectors' chapel and the room with the payer wheels, was stable. Thus, only a few inches of mud were removed before the frame for the new wooden floor was installed. To accommodate the joists of the frame, trenches were dug into the remaining mud floor (Figures 50, 51, 52).

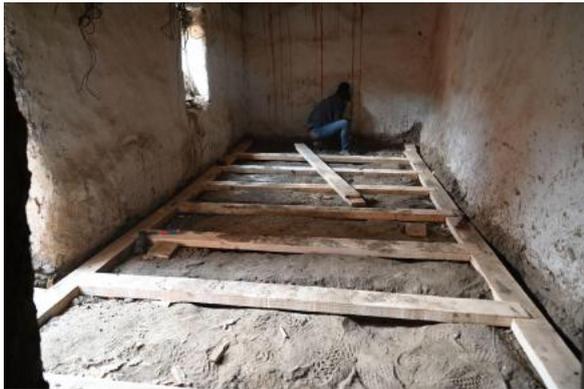
50. The frame for the new wooden floor being installed in the room that will feature the arhat panels.

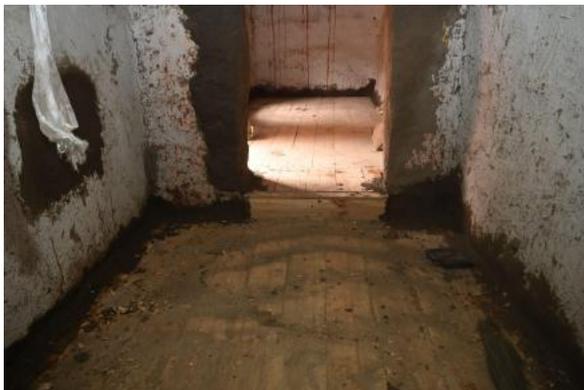
52. Both panel rooms with their new wooden floors.

Then floorboards were screwed over the prepared frames. A new skylight has been built over the roof of the corner room (U05) which had no natural light source.

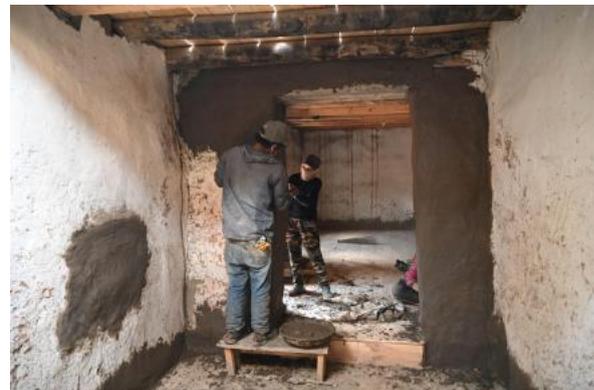
53. Refining the plaster between the two panel rooms.

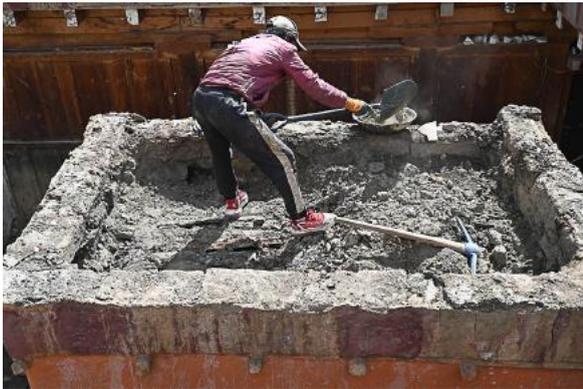
54. Removing the old roof from the large lantern in the centre of the courtyard.

Also the lantern roof had to be redone to make sure that there is no further damage to the murals it contains. Accordingly, the old roof was taken off until the joists, a plywood layer was added above a frame and the roof was rebuilt to its original appearance (Figures 54–57).

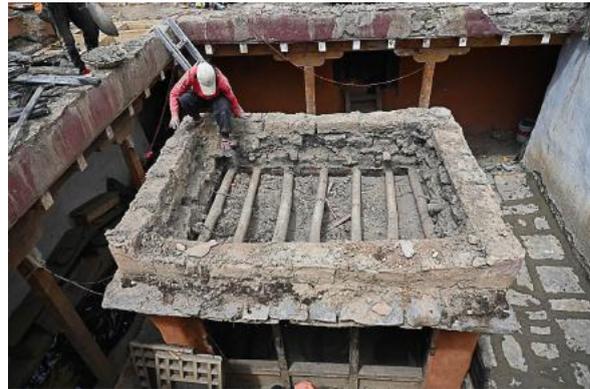
55. The layer of joists revealed after the removal of the mud.

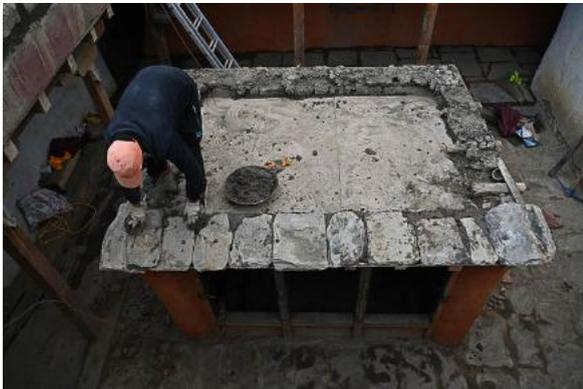
56. Installing the plywood layer above the frame and base of the parapets.

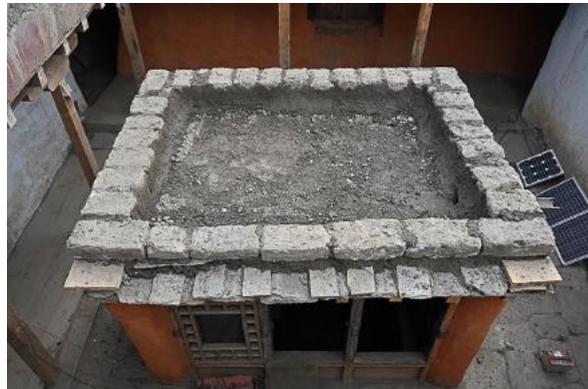
57. The lantern after restoration and before the application of plaster.

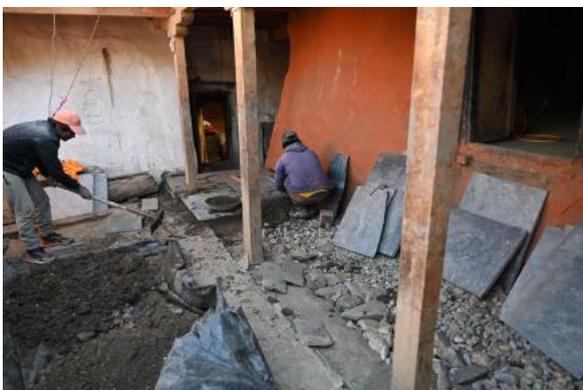
58. The stone panel pavement being installed in front of the Upper Sanctum.

In late May and early June, a stone pavement was added around the Upper Sanctum, its circumambulatory path. For these rectangular cut stone panels sourced from Gobang, Lower Mustang, were used (Figures 58, 59).

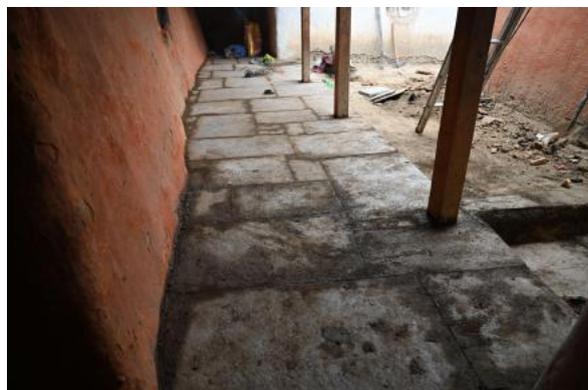
59. The stone panel pavement completed in front of the Upper Sanctum.

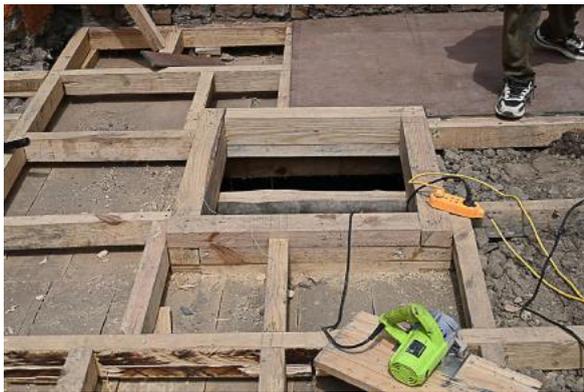
60. A new skylight has been opened up above the Avalokiteśvara Temple.

Once the new panel rooms were largely restored, the roof around the courtyard was restored. A new skylight needed to be opened up above the Avalokiteśvara Temple to provide a natural light source to the room underneath (Figures 60, 61).

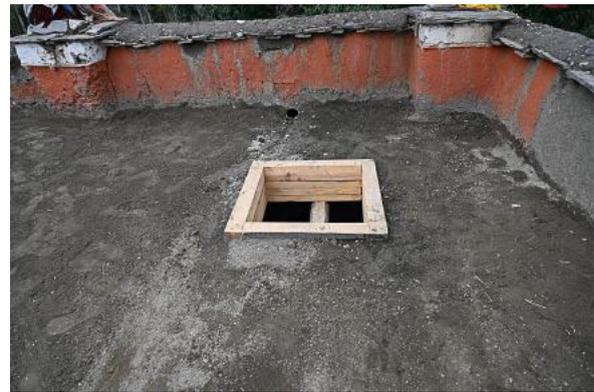
61. The base for the new skylight projecting the roof around it.

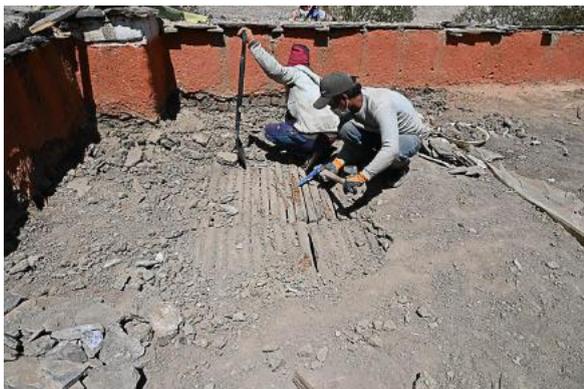
62. Beginning of the removal of the mud from the old roof.

To reduce weight, the top layer of mud was removed. The 2004 plastic sheeting was removed and rotten wooden joists were replaced as needed (Figures 62, 63). Some of the earth layer was retained to support the slope towards the drainage points.

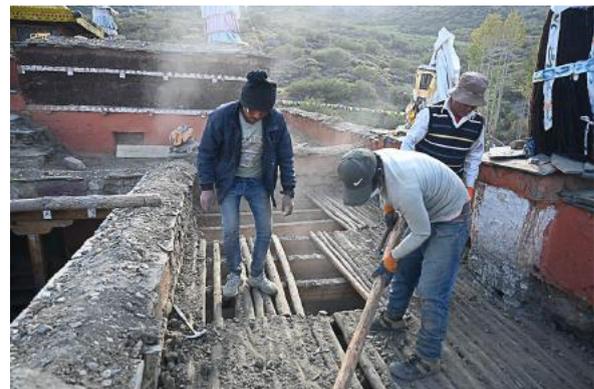
63. Replacement of rotten joists atop the panel rooms.

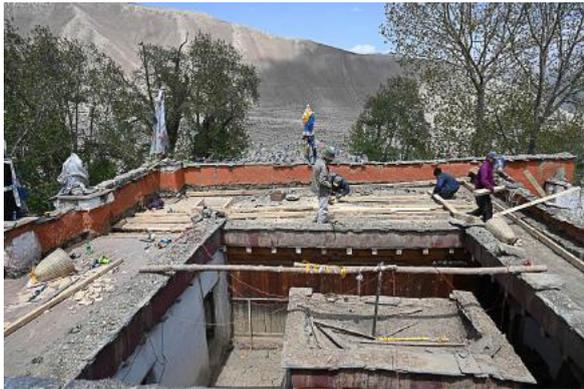
64. Construction of the wooden frame along the east part of the roof.

Then frames were prepared sloping toward the drainage spout on the north side (Figure 64, 66). The work was begun on the east side and gradually moved west towards the back of the temple. Once the frame was constructed plywood boards were screwed to this frame (Figure 65) and the Sika waterproof membrane was applied to its flat surface (Figure 67). Finally a thin mud layer was applied to the top (Figures 68, 69).

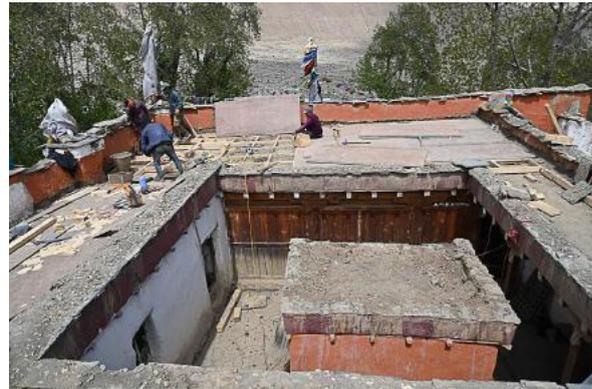
65. Installation of the plywood boards in the east part of the roof.
