Seismic Strengthening and Restoration of Lo Gekhar

U.S. Ambassadors Fund for Cultural Preservation, Award No. SNP40020GR0042

Project Report, Second Year, Third Quarter – April to June 2022

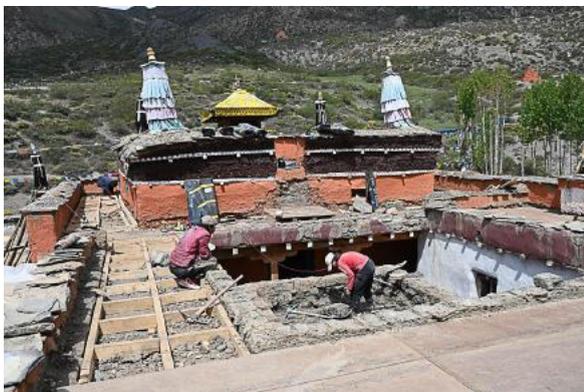
66. Construction of the frames around the courtyard and the sanctum.

Then frames were prepared sloping toward the drainage spout on the north side (Figure 64, 66). The work was begun on the east side and gradually moved west towards the back of the temple. Once the frame was constructed plywood boards were screwed to this frame (Figure 65) and the Sika waterproof membrane was applied to its flat surface (Figure 67). Finally a thin mud layer was applied to the top (Figures 68, 69).

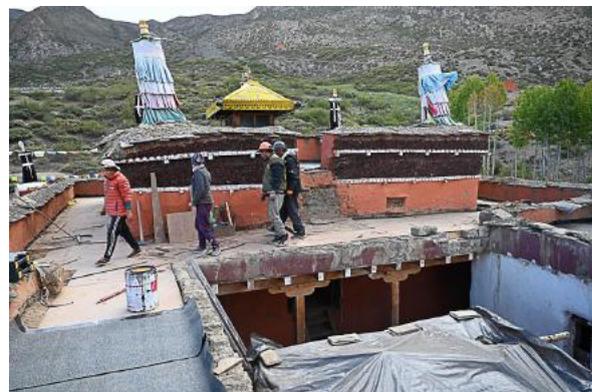
67. The same areas with the plywood installed and the added bitumen sheet in the foreground.

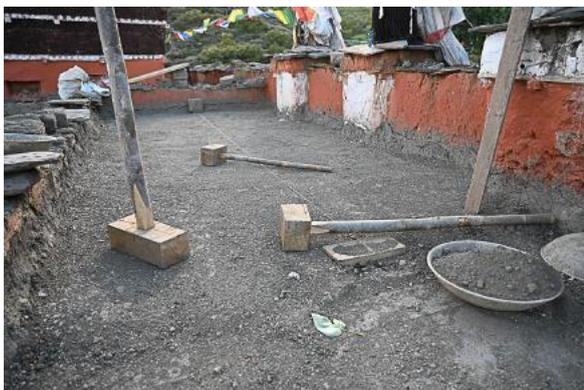
68. Application of mud on top of the new roof above the panel rooms.

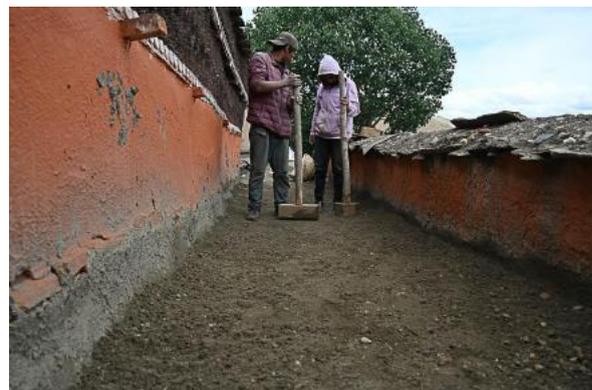
69. Application of the final mud layer in the space around the sanctum.

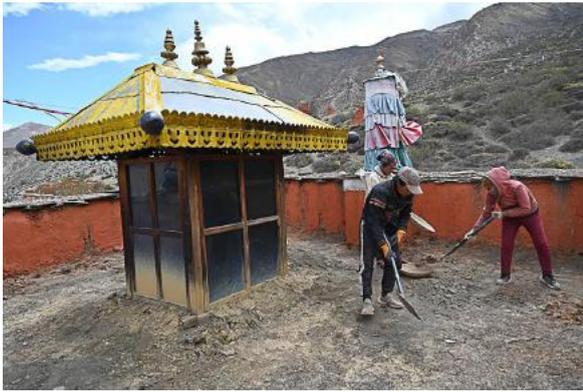
70. Removal of mud on the roof on top of the sanctum.

Also the roof above the sanctum was completely replaced and a plywood layer added for seismic strengthening and waterproofing. Again a part of the top layer of mud on the roof was partially removed. Then, frames were prepared sloping toward the drainage spout on the northeastern corner (Figures 70, 71, 72).

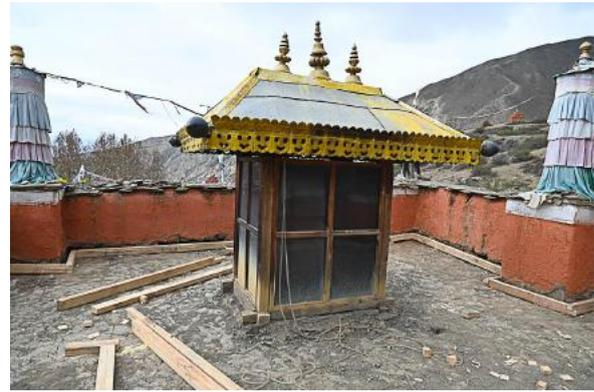
71. Installation of the outer rims of the new frames.

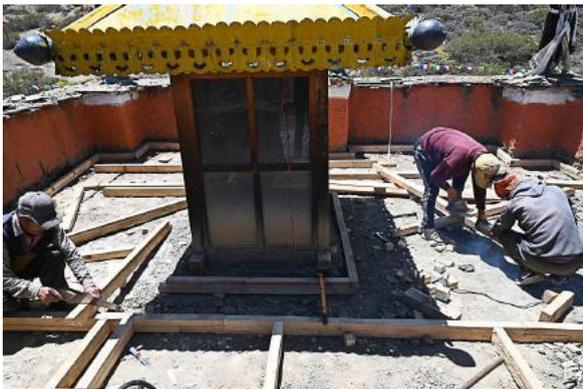
72. Construction of the frames at an angle for optimal drainage.

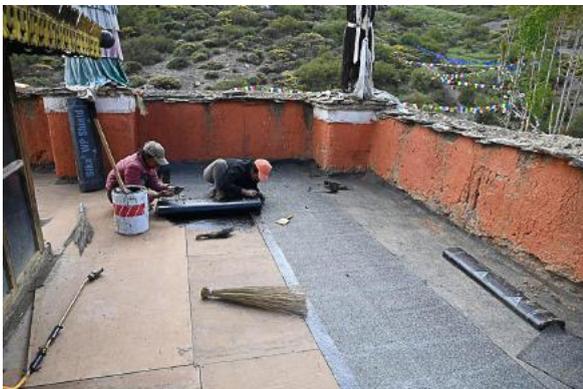
74. Application of the waterproof membrane on top of the plywood.

Plywood boards were then screwed over the frames to form a smooth sloping surface (Figure 73). On top of these the Sika waterproof membrane was applied. To protect the waterproofing layer and conform to the original appearance, the final layer is a bit more than an inch of clay covering the entire roof (Figures 74, 75). This clay was sourced from Kagbeni and is being compacted to form a waterproof layer in itself.

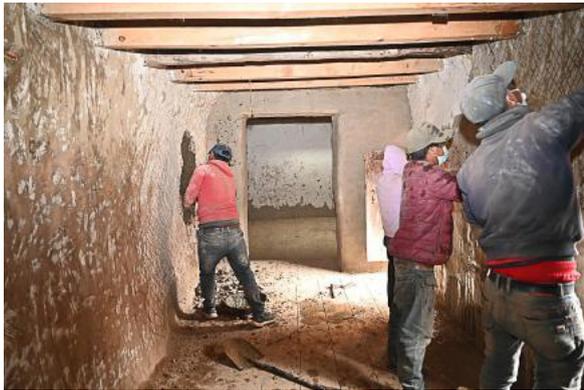
76. Workers preparing the walls of the panel rooms for holding the new plaster.

Late in June the plastering of the Temple rooms started. We began work in the panel rooms and then moved on to the Upper Sanctum. As a first step, the walls have to be prepared to hold the new plaster, which is documented in the images below (Figures 76, 77). The actual plastering happened in July and thus is not documented here.

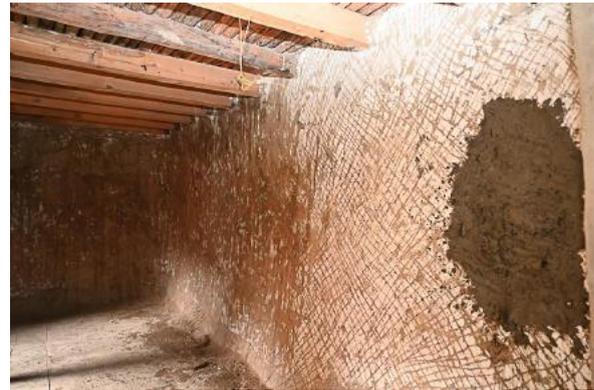
77. The wall that will feature the stone panels of the sixteen arhats prepared for the plaster.

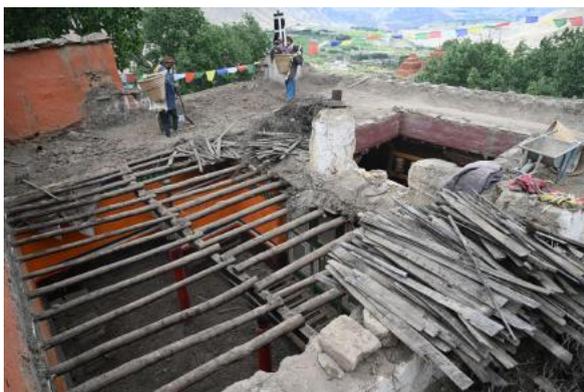
78. The mud roof over the east side of the caretaker's quarter was removed starting with the VIP room.

While digging the roof layer until the joists, it exposed the two feet thick mud layer that had been piled on the roof over the years to prevent seepage. This layer has added a tremendous amount of weight to the walls and the main beams. The mud bricks below some of the main beams had been squashed and cracks had developed.

The reconstruction will floor the plans as proposed. To reduce stress, the main beams will be supported with wall plates to distribute the weight horizontally over the walls. Also, the rammed earth walls with cracks will be reinforced with installation of horizontal plates. The squashed mud bricks will be replaced by new ones.

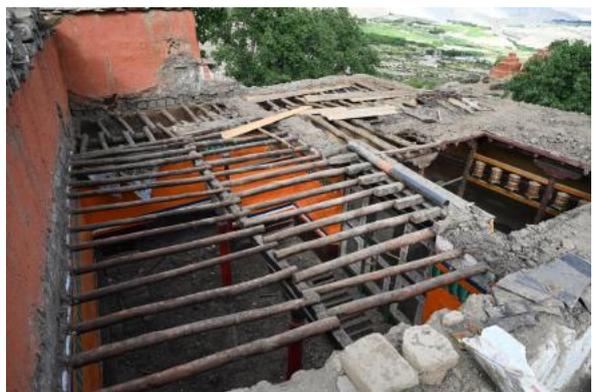
79. The removal of the roof exposed the joist constructions stemming from different periods.

In the second half of June, the restoration work on the caretaker's quarters started with taking the roof off (Figures 78, 79). For the safety of the workers, the dismantling was planned in two phases; firstly, the east side with the VIP room, the atrium and the deity rooms and secondly the kitchen, the former Avalokiteśvara temple and the toilet. This also provided a safe passage for the workers while moving back and forth with brushwood, joists and other debris that was moved to the west side of the mansion.

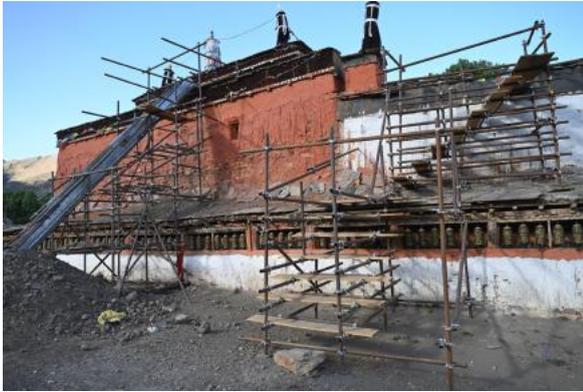
80. A scaffolding ladder installed for the safe mobility of the workers.

A slide was built on the southern side of the quarter out of scaffolding to discard the broken mud bricks and the mud roof. Similarly, a scaffolding ladder was erected on the west side for the safe mobility of the workers (Figures 80, 81). The purchased props

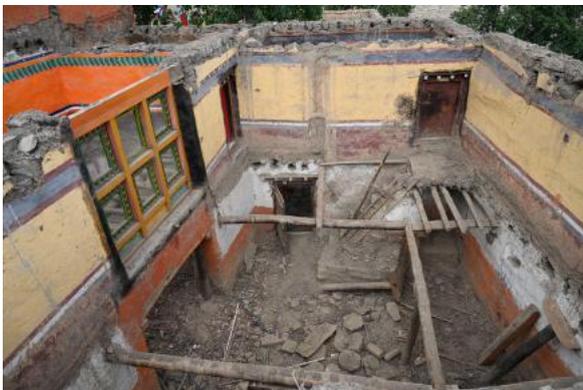
82. The atrium area with the roofs and middle floor almost entirely removed.

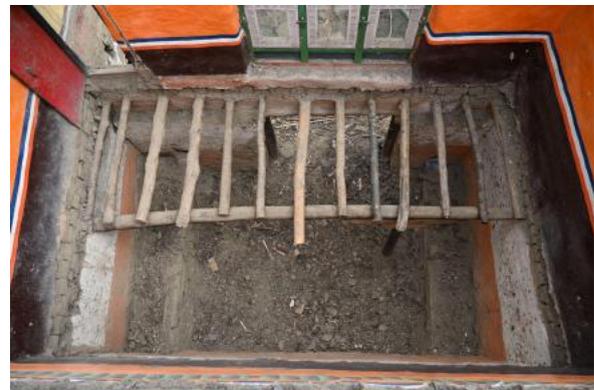
83. View on the room underneath the VIP room, once its floor was removed.

Once exposed the entire roof layer was removed to make way for the floor underneath, which also was removed as much as needed for reconstruction (Figures 82, 83).
