Seismic Strengthening and Restoration of Lo Gekhar

U.S. Ambassadors Fund for Cultural Preservation, Award No. SNP40020GR0042

Project Report, Third Year, Third Quarter – April to June 2023

Norbusum Foundation (NGO)

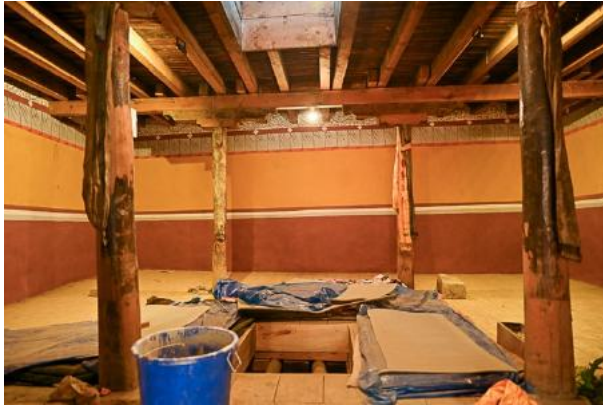
Once sourced, these natural colors need to be hand ground, sieved, and soaked in water before application. All colors—maroon, yellow, white, and blue—were soaked in water and mixed with a water-soluble glue. The maroon color was further boiled with sugar and then sieved again on a muslin cloth before application. Temple spaces, like the Guru Lhakhang were painted with the usual border motives, namely a cloth valance at the top and multicolored stripes marking the bottom of the main area (Figure 6).

Figure 6: The Guru Lhakhang room after its walls were painted with natural colors.

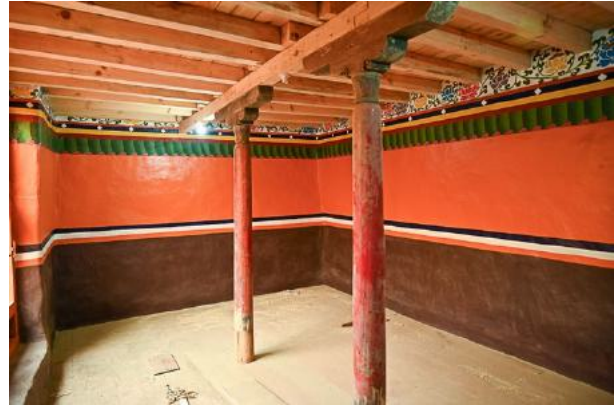
Figure 7: The VIP room restored to its original appearance.

Acrylic paints were used to restore the wall painting of the VIP room (Figure 7), the window of the VIP room (Figure 8, Figure 9), and the window in the guest lobby following their original decoration (Figure 10, Figure 11).

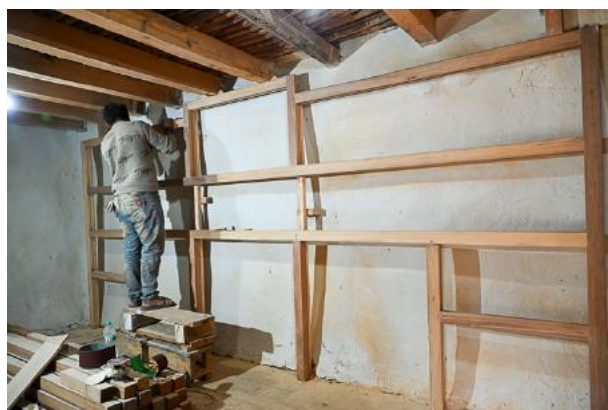
Frames of this type are foreseen for all the three walls of the Guru Lhakhang (Upper Sanctum) as well as the Arhat panels. This quarter the frames for the Arhat panels have been completed (Figure 12, Figure 13, Figure 14), while those for the Guru Lhakhang are still under construction.

Figure 12: The frame for the Arhat panels under construction.

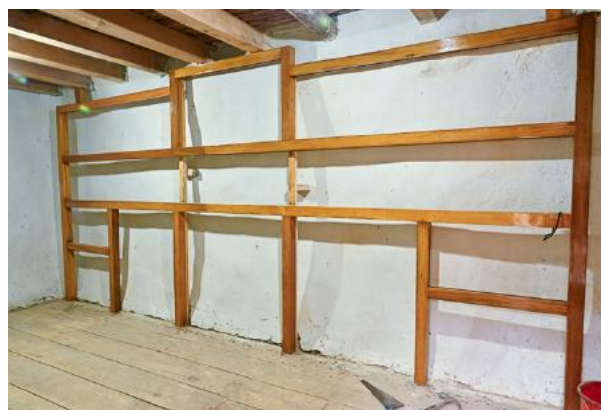
Figure 13: The completed frame for the arhat panels before mounting them.

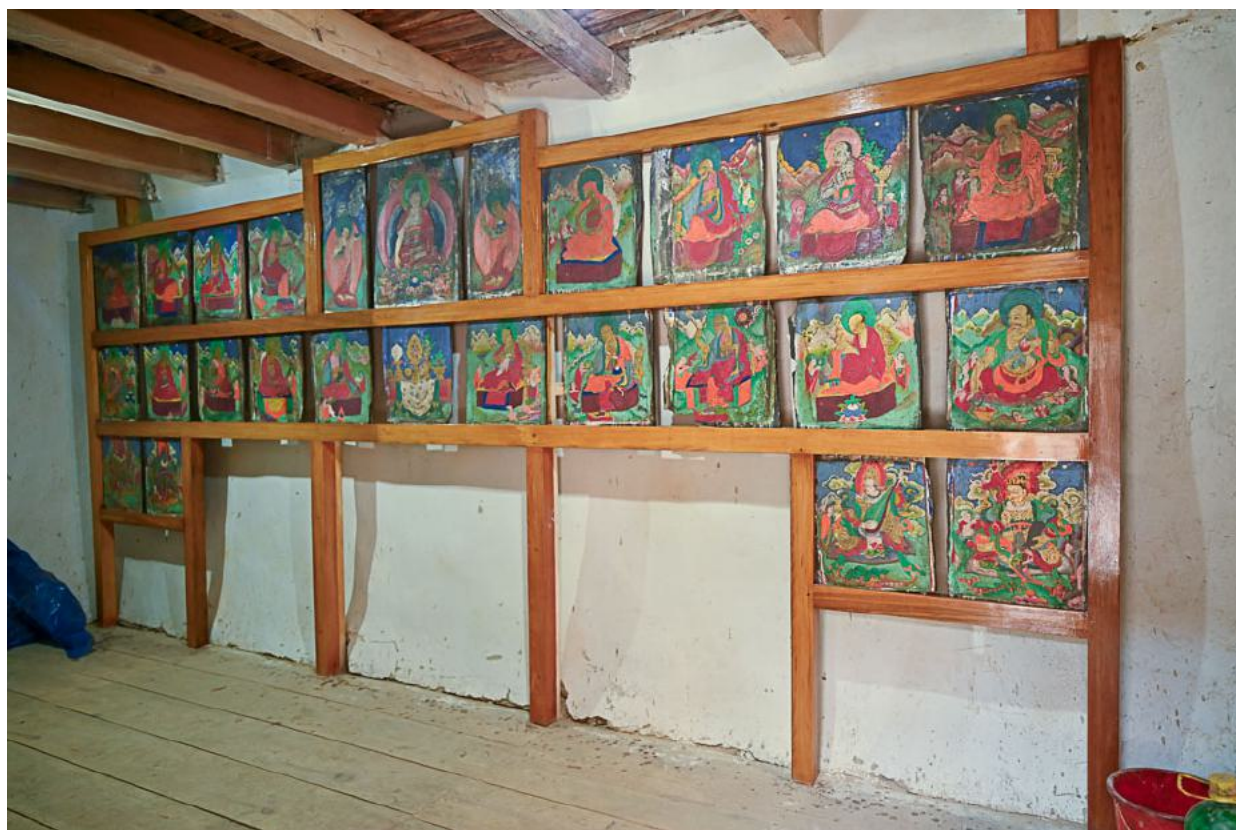
Figure 14: The Arhat panels mounted in their original composition within the new frame.

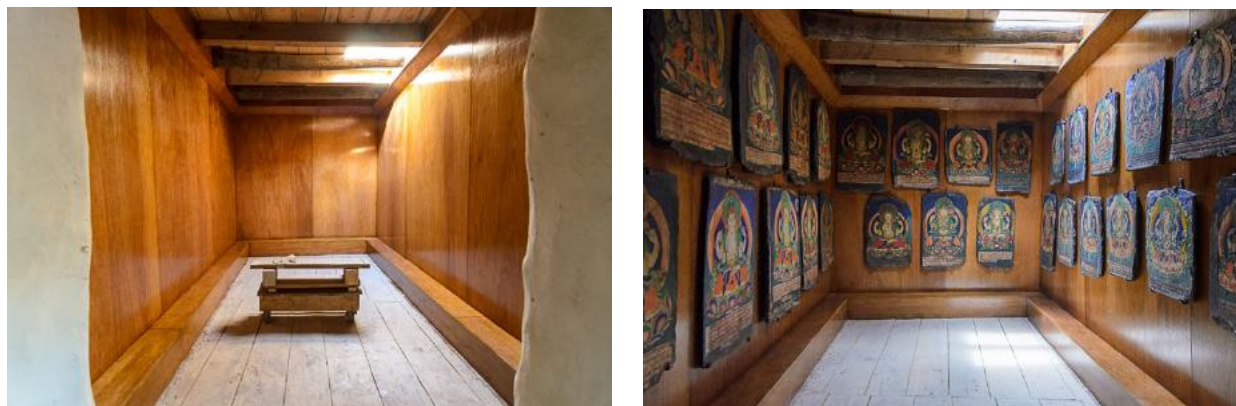
The solution for the Avalokiteśvara panels needed to be different as here the panels are of considerably different sizes. This fact also resulted in many of them being damaged in the past to fit them in the previously used frames. Instead, Christian Luczanits proposed to mount them with iron clamps on sturdy plywood support forming a shrine like environment. This also enables to display these panels in their historical succession from the left side of the entrance to the room clockwise.

Accordingly, the carpenters constructed this support structure using a double layer of waterproof plywood supported by vertical rafters. The structure further was attached to the floor and beams to increase its sturdiness. Once constructed, the surface was sanded and several layer of shellac polish were applied (Figure 15). Strong iron clamps of custom width according to the varying thickness of the panels were prepared in Kathmandu. Two of these clamps support the stone panels from the bottom and hold its weight, while another one placed in the top area secures it in place. Again, there is no pressure on the panel beyond their own weight. The panels were mounted in this way in June 2023 (Figure 16), and Christian Luczanits supplied labels for each of them.

Figure 15: Avalokiteśvara Temple room prepared for the stone panels.

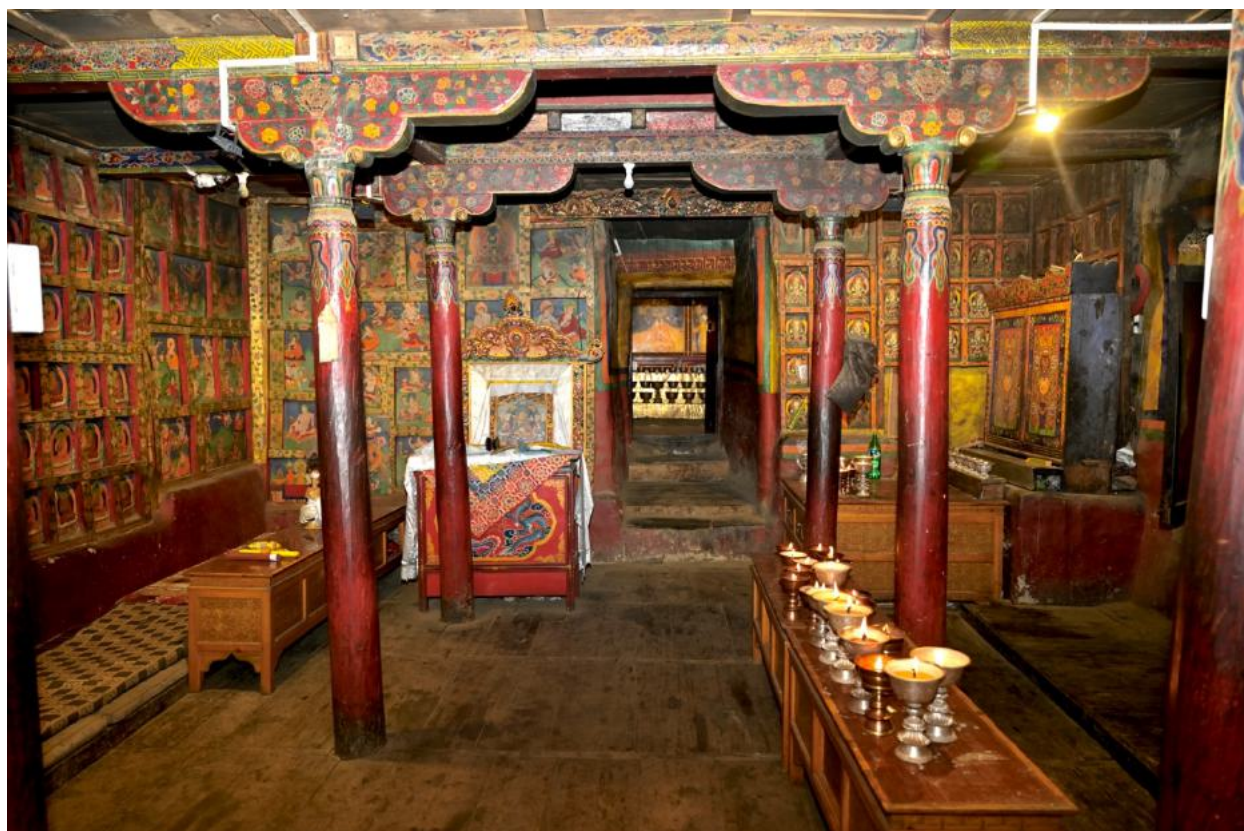
Work began with the removal of old wiring, light points, and unused solar lines (Figure 17). Then new lightings were installed in the temple. Two flood lights were installed on the two sides of the main statue, while a center light was installed for backup solar power (Figure 18). Focus lights were used to light the statues on the left and the right sides in the main shrine that previously had no dedicated lights and were not properly visible to the pilgrims and visitors. The stone panels in the assembly hall were also lit using flood lights installed on the capitals (Figure 19).

Figure 19: View of the Assembly Hall and the sanctum in the back when electricity is available and all lights are turned on. The white bulb in the centre is from the solar backup system.

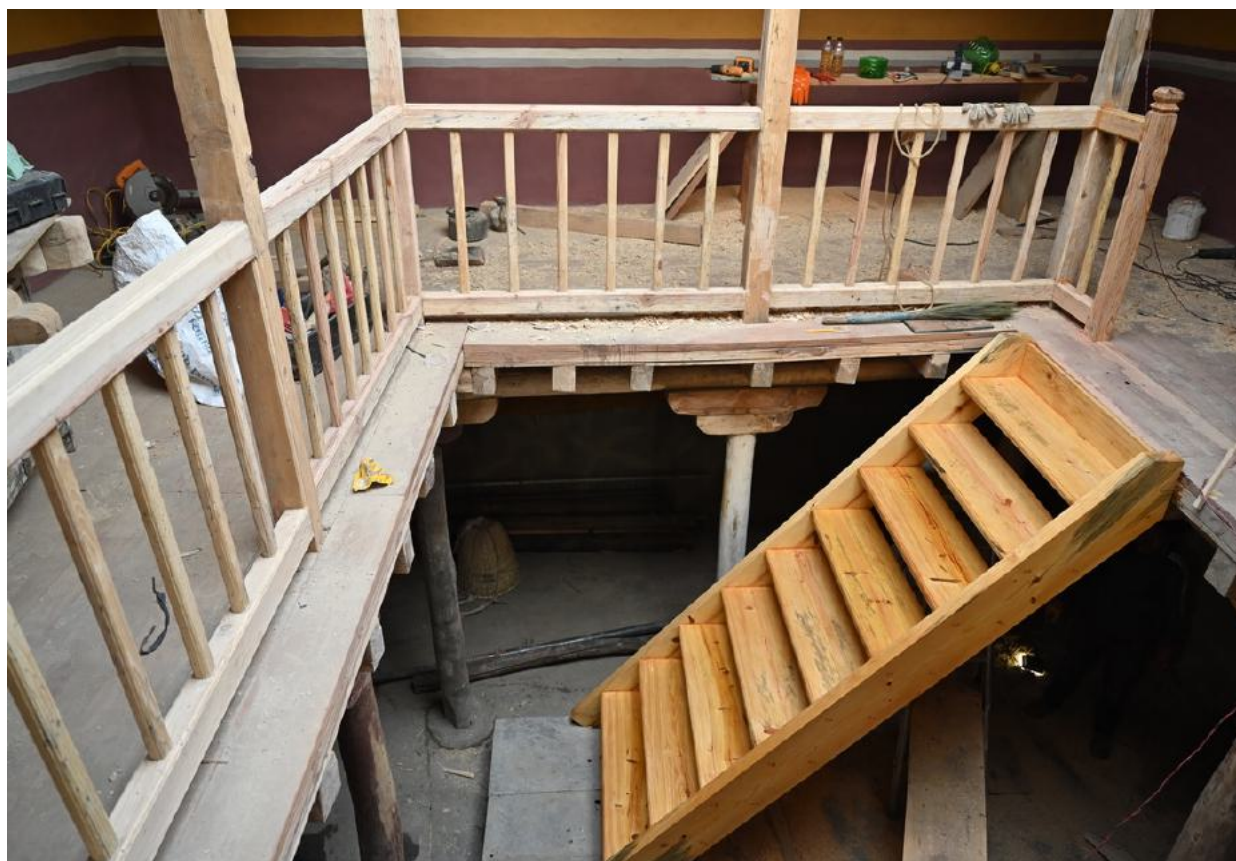
In the atrium of the caretaker's quarter, the old adobe parapet walls have now been replaced by a wooden railing.

The staircase to the upper floor was also moved to a more accessible location from the middle of the courtyard. A wide wooden staircase was designed by Thomas Schrom and

constructed in this quarter. The base platform on which it is resting was built of stones. The staircase was completed with a linseed oil polish (Figure 20).

Figure 20: View of the new railing and staircase in the atrium of the caretaker's area.

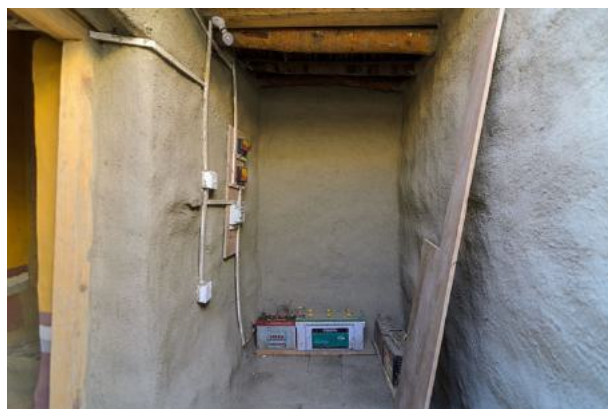
The new access to the roof has been built from a room on the caretaker's mansion that was formerly used to store firewood and dried cow dungs by the caretaker. The same room is now used to store the batteries for solar lights and the main power control system is also installed here (Figure 21). A new wooden staircase was prepared by the carpenters. The access to the roof has been designed as a wooden trap door with fiber sheets on the top (Figure 22).

Figure 21: Battery storage and main electrical power control in the room that also allows access to the roof.

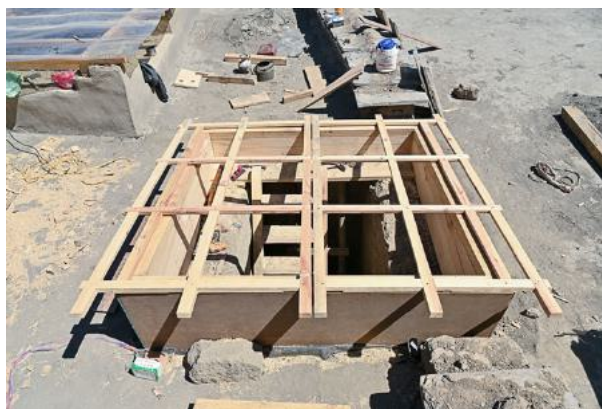
Figure 22: The access to the roof is covered by a wooden trapdoor, here under construction.
