Seismic Strengthening and Restoration of Lo Gekhar

U.S. Ambassadors Fund for Cultural Preservation, Award No. SNP40020GR0042

Project Report, Fourth Year, First Quarter – October to December 2023

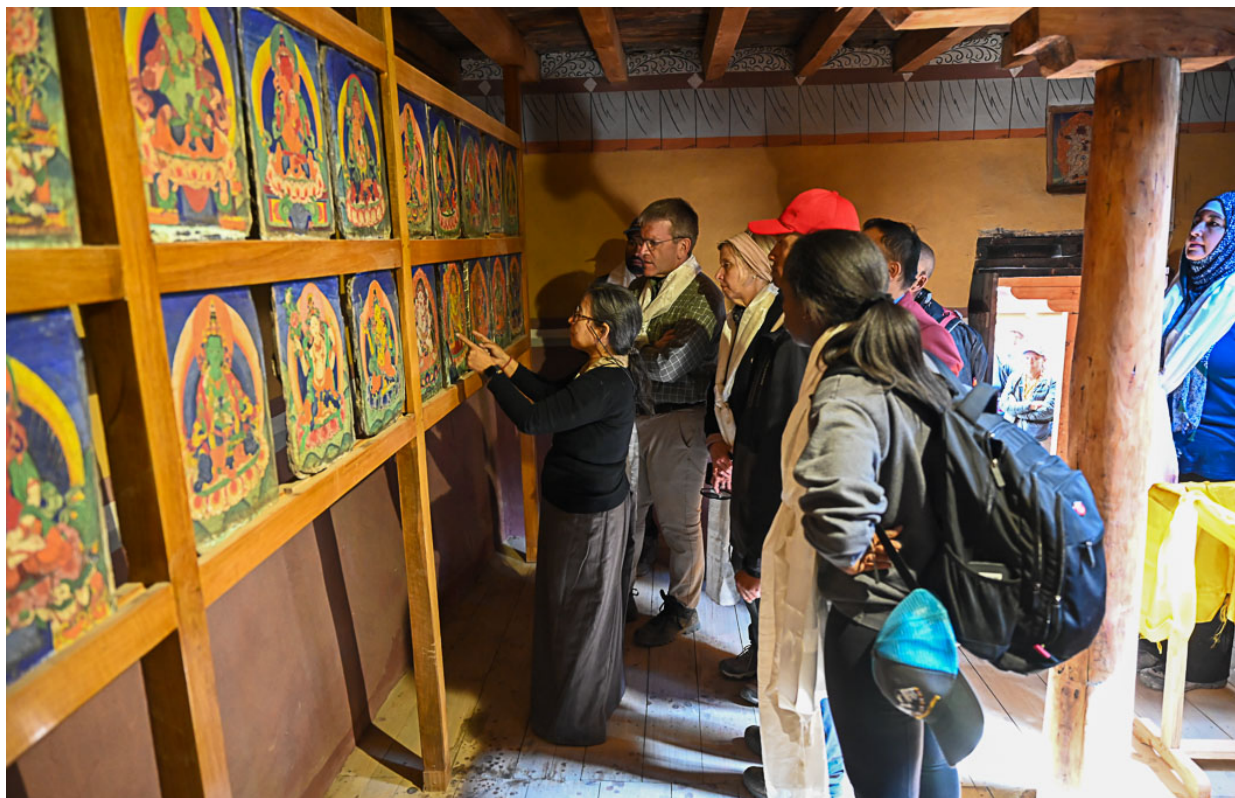
Figure 3: Members of the US Embassy examining the installation of the stone panels in the Guru Lhakhang.

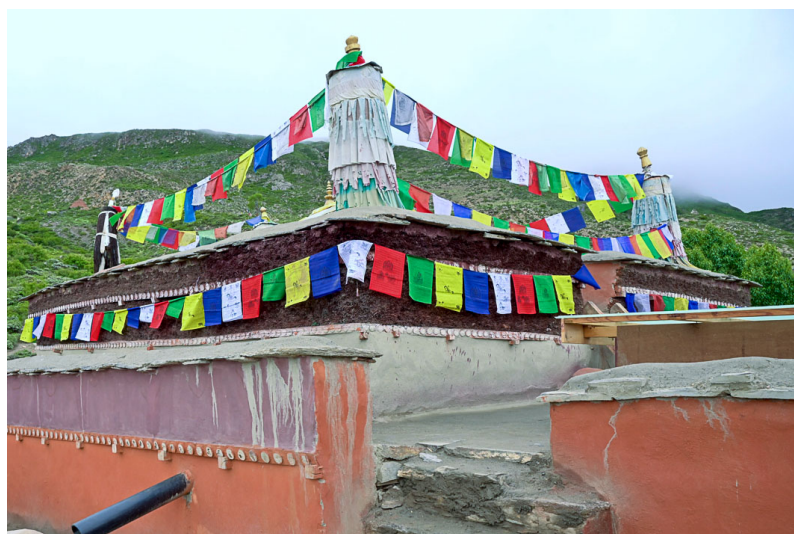
Figure 5: The temple roof with the worn-out cloth on the victory banners.

Further, the fabric of three victory banners on the roof had worn out and was replaced with new ones purchased from Kathmandu.

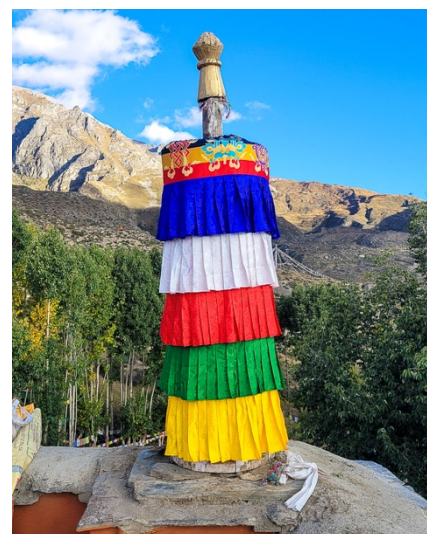
Figure 6: One of the victory banners with the new cloth.

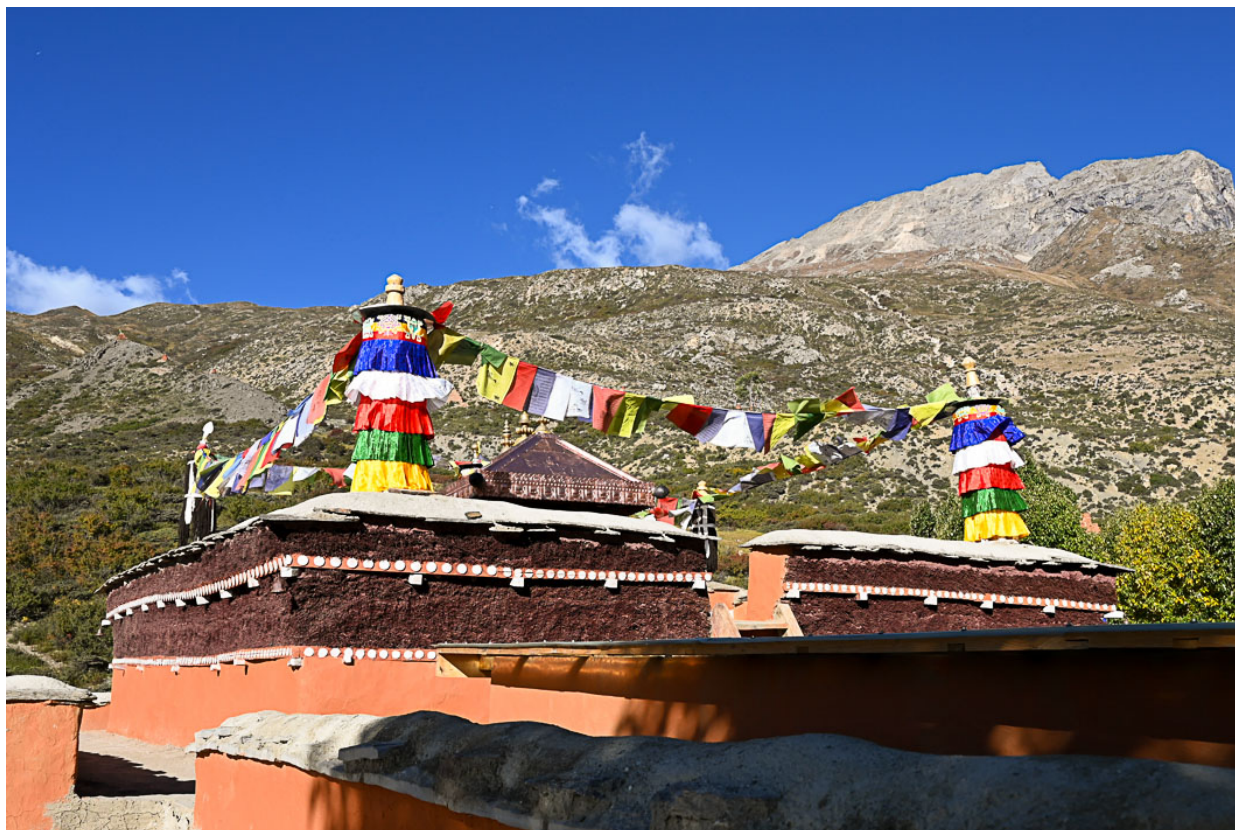
Figure 7: The temple roof after replacing the cloth of the victory banners.

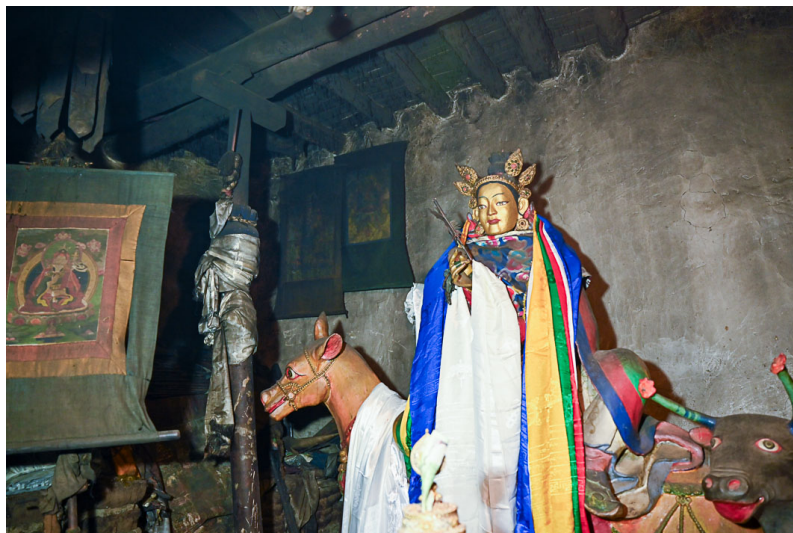
The protector deities' room, the Gönkhang, to the right of the Assembly Hall also received a thorough cleaning and the walls were given a whitewash. The walls had collected soot over a long time and the mud floor had numerous rat holes. The soot and the spider webs were all removed using a broom. Two coats of white chalk were applied over the walls. The mud floor with rat holes was compacted with aggregates and mud mortar. The front area of the room where the caretaker makes the butter lamp offering was completed with flagstones. The rest of the floor was plastered with mud mortar.

Figure 8: The soot covered walls of the protector deity room before cleaning and painting.

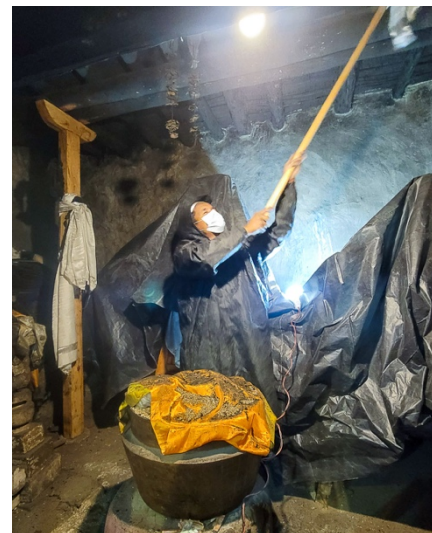
Figure 9: The protector deity figures covered with plastic sheets during the cleaning.

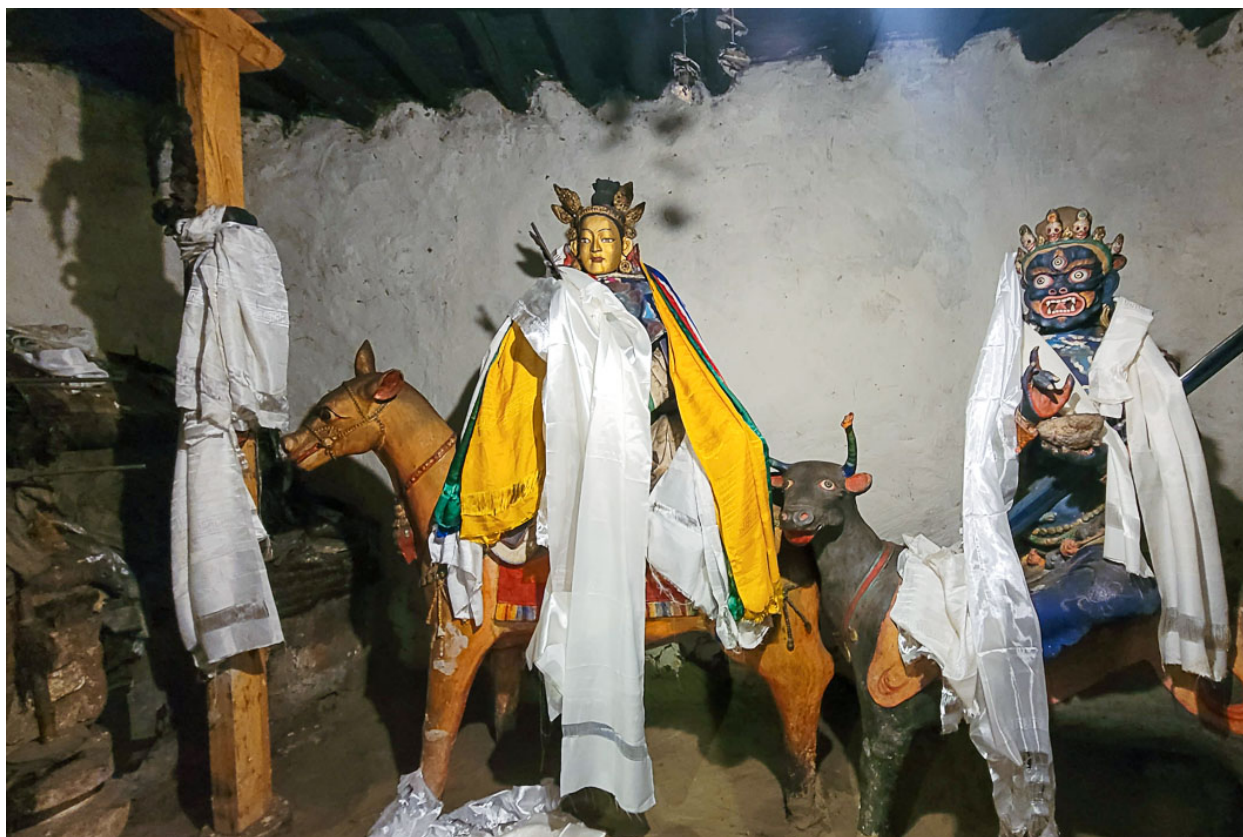
Figure 10: The protector deity walls after the cleaning and fresh paint. The image also shows the old column replaced with a new square one.

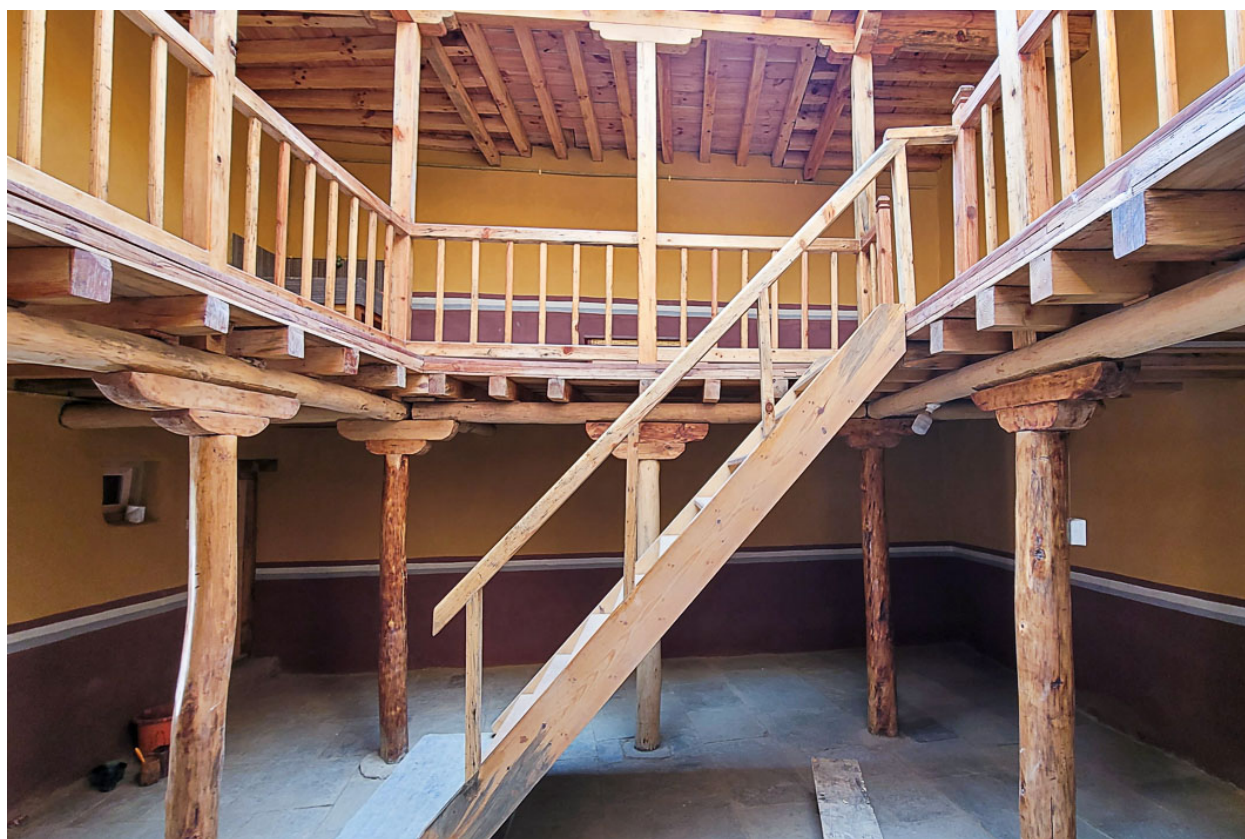
Figure 11: The wooden staircase leading to the upper floor in the caretaker's residence completed with a wooden rail.

A wooden staircase in the caretaker's atrium leading to the upper floor was originally conceived without handrails. However, it was suggested afterwards to add a handrail to the stairs to assist the elderly during their visits. Once added, the handrail was sanded and linseed oil was applied to complete it.
